Bulletin No.: PIC5428F

# Service Bulletin

**Subject:** EBCM Wheel Speed Sensor Diagnostic Aid for ABS Message -Click Or Ratchet Noise- Service Traction Message - Service Stabilitrak Message - Service Steering Message

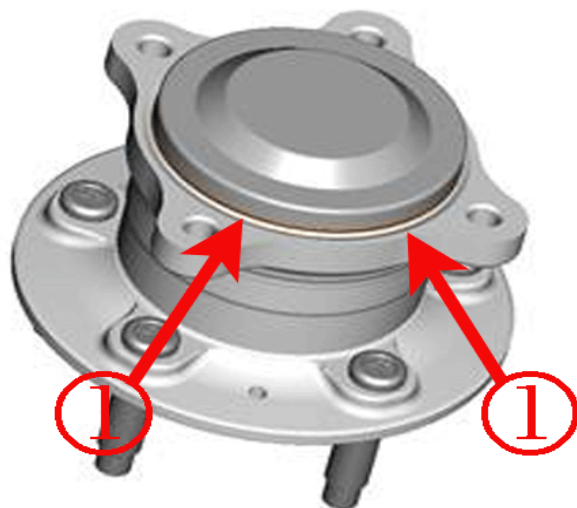
3765975

**Note:** NOTE: THIS INFORMATION IS NOT APPLICABLE TO CAPPED WHEEL BEARINGS.

(1.) Capped Wheel Bearing  
Background Information:

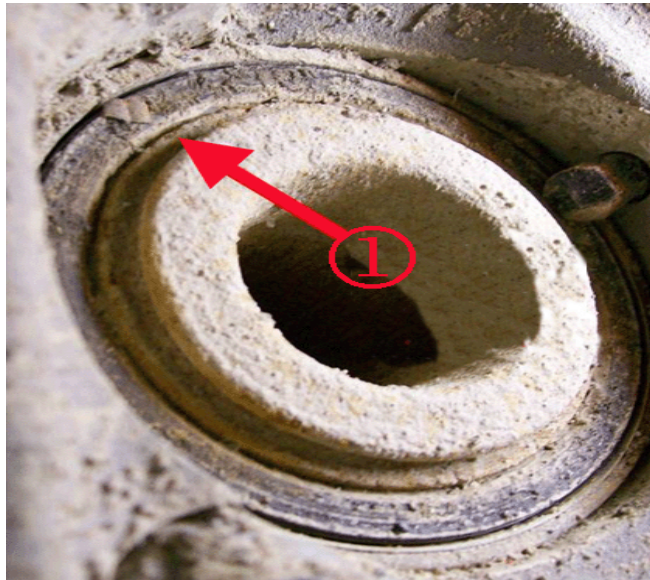
2596037

The latter two conditions correspond with no reported EBCM / ABS / Stability DTCs set current or history. These conditions may be caused by single or multiple pieces of ferrous metallic debris stuck to the wheel speed sensor magnetic encoder ring. This magnetic encoder ring is now part of the inboard bearing hub assembly.

**BEFORE CLEANING**

(1.) Sample Debris

1. Based on the specific EBCM module Wheel Speed Sensor DTC code; inspect the appropriate corner magnetic encoder ring for possible debris.
  - C0035 Left Front Corner
  - C0040 Right Front Corner
  - C0045 Left Rear Corner
  - C0050 Right Rear Corner
2. If debris is found, perform the following cleaning recommendations.

2.1. Gently using a dry nylon soft bristle brush, remove the foreign debris off the magnetic encoder ring. If debris was removed, proceed to step 3.

2.2. If debris still remains, wash the encoder ring using a mild soap detergent and wipe dry.

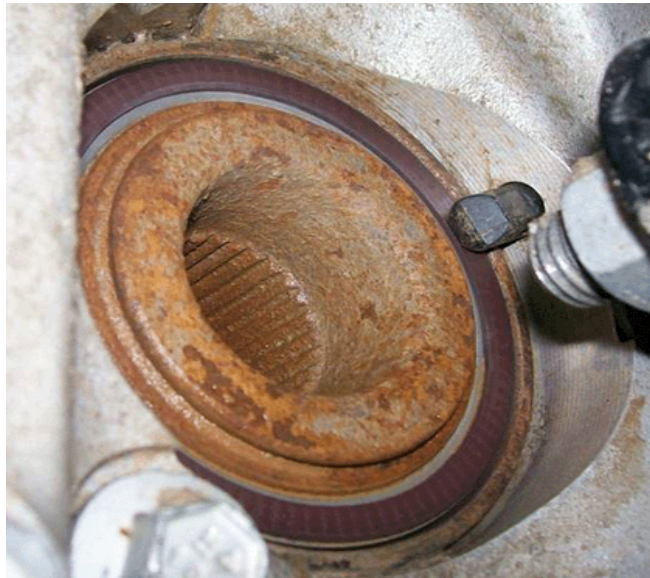
2596035

AFTER CLEANING

1. Connect a scan tool to the vehicle. Turn ON the ignition. Clear the DTCs.
2. Perform vehicle diagnostic repair verification procedure for DTC: C0035-C0050. Refer to SI.
