Service Bulletin

SPECIAL COVERAGE

SUBJECT: Special Coverage Adjustment – Heating, Ventilation, and Air Conditioning Blower Not Fully Functional or Inoperative

MODELS: 2003-2006 Chevrolet Avalanche, Suburban Tahoe
2003-2007 Chevrolet Silverado
2003-2006 GMC Yukon, Yukon XL
2003-2007 GMC Sierra
Equipped with Manual HVAC (CJ3) or Heavy Duty Heater (C42)

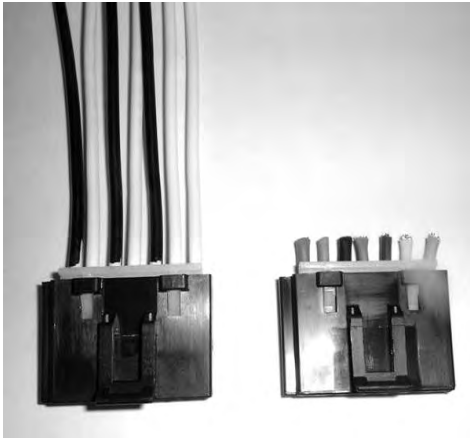
1709080

4. Remove the tape from the wiring harness to expose the wiring.

5. Cut the wires back far enough from the connector to eliminate any melted insulation on the wire.

Note: Use the old connector as a map for splicing the wires for the new connector. Be sure to use the correct crimping tool from the terminal repair kit J 38125. Use only Duraseal splice sleeves. Other splice sleeves may not protect the splice from moisture or provide a good electrical connection.

6. Install the new connector. Use the yellow splice sleeves provided with the connector.
7. Install the new blower motor resistor.
8. Reinstall the fuses. Test the blower motor to make sure all speeds are functional.
9. Reinstall the hush panel/close-out panel.
