■ Applies To: **2011–12 Odyssey with Navigation** – Check the iN VIN status for eligibility
2012 Pilot with Navigation – Check the iN VIN status for eligibility

April 6, 2012

Product Update: CD or DVD (RES) Restarts When the Ignition Switch Is Turned OFF and ON

(Supersedes 11-070, dated December 22, 2011, to revise the information marked by the black bars)

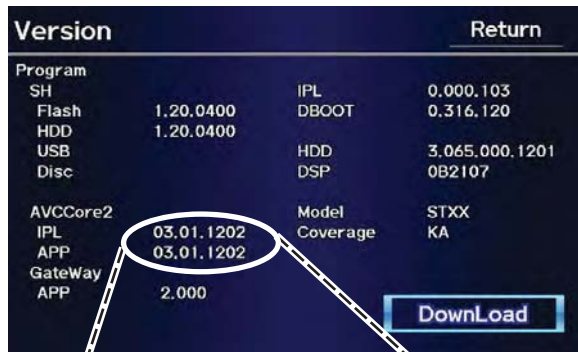
6. Under AVCCore2, check that the fourth digit of the IPL and APP version numbers is **1**.

XX.01.XXXX
XX.01.XXXX

NOTE: If it is a 2, the AVC software was already updated. Select **Return** to go back to the **Detail Information & Setting** screen, then go to step 5 of the **CD Drive Update**.

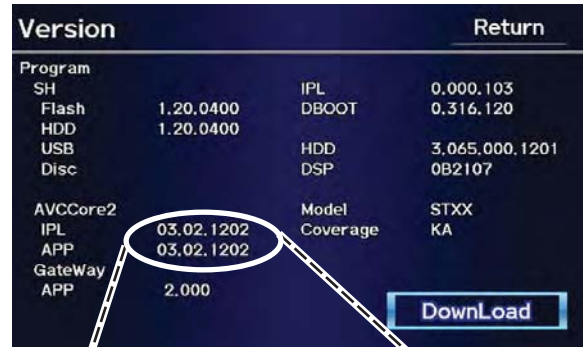
12. Under AVCCore2, check the fourth digit of the IPL and the APP version numbers.

XX.02.XXXX
XX.02.XXXX

- If it is still 1, turn the ignition switch to LOCK (0), then go to step 1, and repeat the update.
- If it is now 2, turn the ignition switch to LOCK (0), then go to **CD Drive Update**.

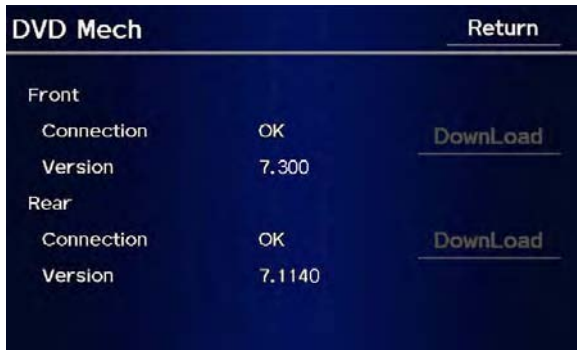
- Confirm that the front mech software version is **7.300**.

- If the vehicle is equipped with RES, go to the **DVD (RES) Drive Update**.
If the vehicle isn't equipped with RES, center-punch a completion mark above the first character of the engine compartment VIN:

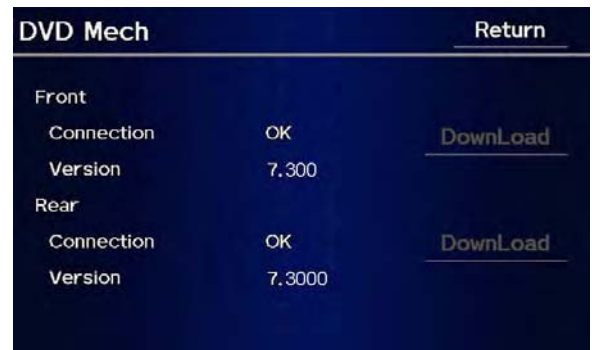
- Confirm that the rear mech software version is **7.3000**.

- Center-punch a completion mark above the first character of the engine compartment VIN:
