# Technical Service Bulletin

**01 MIL on (DTC P310B, P129F, P008B, P129E, P008A, P2540, P0087)**

01 11 34 2027417/2 November 9, 2011. Supersedes Technical Service Bulletin Group 24 number 11 – 00 dated November 9, 2011 for reasons listed below.

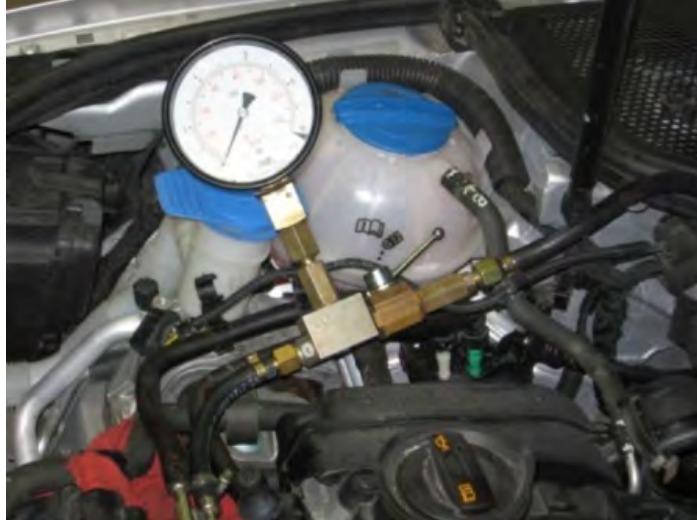
4. To check the low-side fuel pressure sensor G410, measure the fuel pressure with a mechanical gauge using the following method:

- c. Keep the ignition on.
- d. Measure actual low-side fuel pressure via mechanical gauge (VAG 1318) on the low pressure supply line in the engine compartment (Figure 1).

*Figure 1. VAG 1318 gauge installed on an A3 2.0L TFSI.*

5. Add 1 bar to the value obtained from the mechanical gauge to calculate the adjusted gauge measurement value.
6. Compare the adjusted gauge measurement value to the Actual Value stored in MVB 103 field 1.
7. If the MVB 103 field 1 value deviates more than  $\pm 1.0$  bar from the adjusted gauge measurement value then the DTC was likely triggered by a faulty G410 low-side fuel pressure sensor. In this case, document the adjusted gauge measurement value and MVB value on the Repair Order and perform the *Sensor replacement procedure* below.

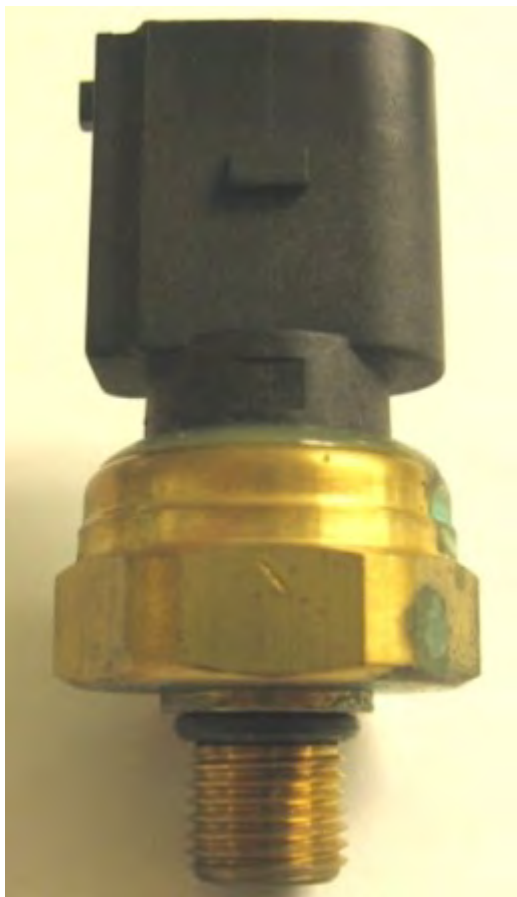
Due to fuel intrusion into the low-pressure system fuel pressure sensor (G410), a false signal may be sent to the controller, resulting in a reading that is out of tolerance.

Improvements to G410 fuel pressure sensor.

*Figure 2. Improved fuel pressure sensor  
06E 906 051 K.*

- Inspect if the latest fuel pressure sender **P/N 06E 906 051 K** (Figure 2) is installed, if not replace the old style component with the new style component and run Basic Settings 103 to adapt system.
- If you are *not* performing this TSB because of a reference from TSB 2016868 or 2015505; proceed to Step 2.

1. Replace the G410 low-side fuel pressure sensor with P/N 06E 906 051 K.
