<b>2.0L—OVERHEATS—LACKS A/C—COOLING FAN INOPERATIVE—FUSE 17 OPEN</b>	<b>TSB 12-1-14</b>
--	--------------------

**FORD:**

2010-2012 Transit Connect

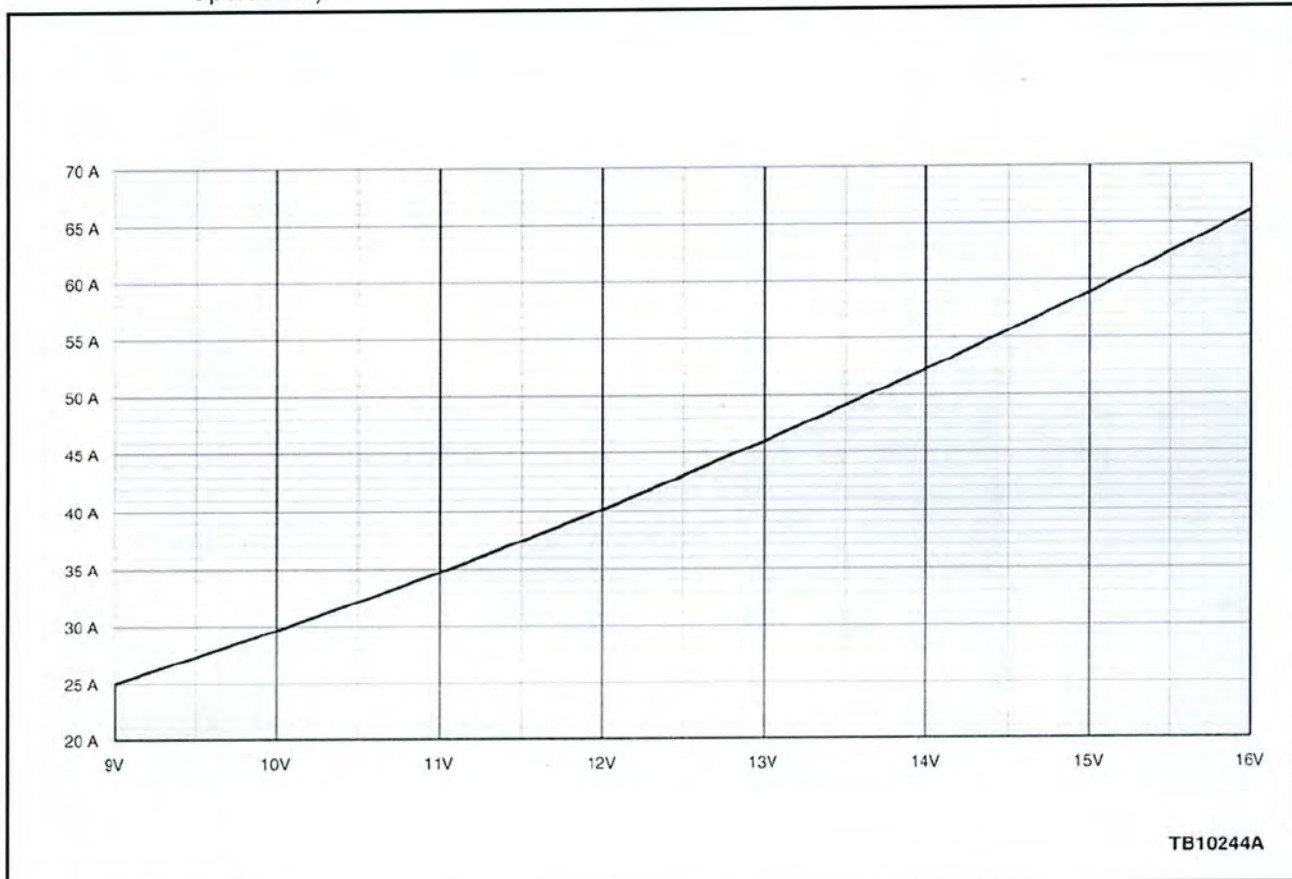
Figure 1 - Article 12-1-14

- d. Compare recorded readings to the chart. (Figure 1) Does your measured reading for voltage and amperage lie within the shaded area of the graph shown? (Figure 1)

- (1) Yes - Do not replace the cooling fan. Fan operating as intended. Proceed to Step 5.
    - (2) No - Replace the cooling fan and shroud assembly. Proceed to Step 5.
