Service Bulletin

Bulletin No.: PI0671

Subject: Power Steering Fluid Leak at Fluid Reservoir or Reservoir Connection

Models: 2012 and Prior GM Passenger Cars and Light Duty Trucks
Condition/Concern

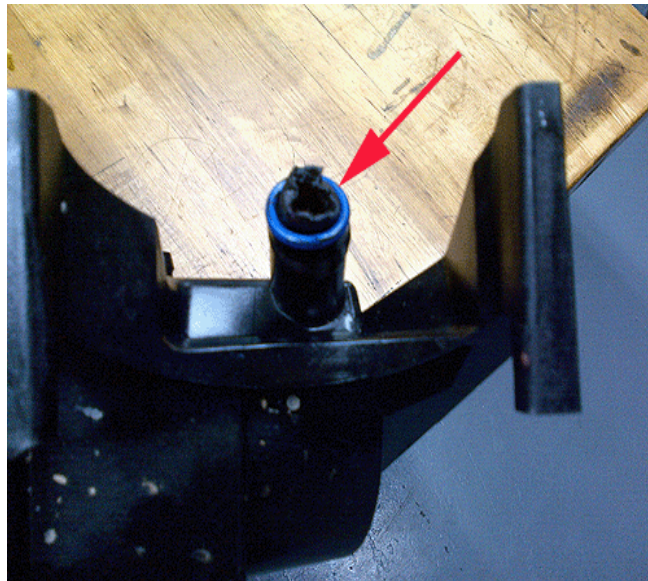
2759939

When diagnosing power steering fluid leak conditions, the technician may find a heat damaged fluid reservoir. When a power steering reservoir or reservoir seal is damaged, it's important to make sure that potential associated issues are addressed. Conditions that are the result of super heated power steering fluid may involve multiple components. These additional components may not have any apparent issues at the time of the initial diagnosis.

Fluid temperatures sufficient to distort or damage the reservoir may cause damage to the power steering pump affecting durability.

When replacing a power steering reservoir for a leak condition, if the condition appears to be caused by super heated fluid, it's important that the power steering pump also be replaced to prevent a subsequent concern, resulting in customer dissatisfaction. In addition, it's necessary to advise the customer that certain operating conditions generate these excessive fluid temperatures and they must be avoided to prevent future issues.

- Holding the steering against the "stop" or end of travel for more than 5 seconds at an engine speed in excess of 1,500 rpm.
- Doing continuous spin-outs, "cookies" or "doughnuts" with the steering against the end of travel or close to the end of travel for more than 5 seconds at a time at an engine speed in excess of 1,500 rpm.
