**star bulletin**

Date: February 8, 2012  
Order No.: T-B-47.10/62  
Group: 47

**SUBJECT: MY-All, Models 463.237 /249 /271  
Bleed Hose for Filler Neck on Fuel Tank**

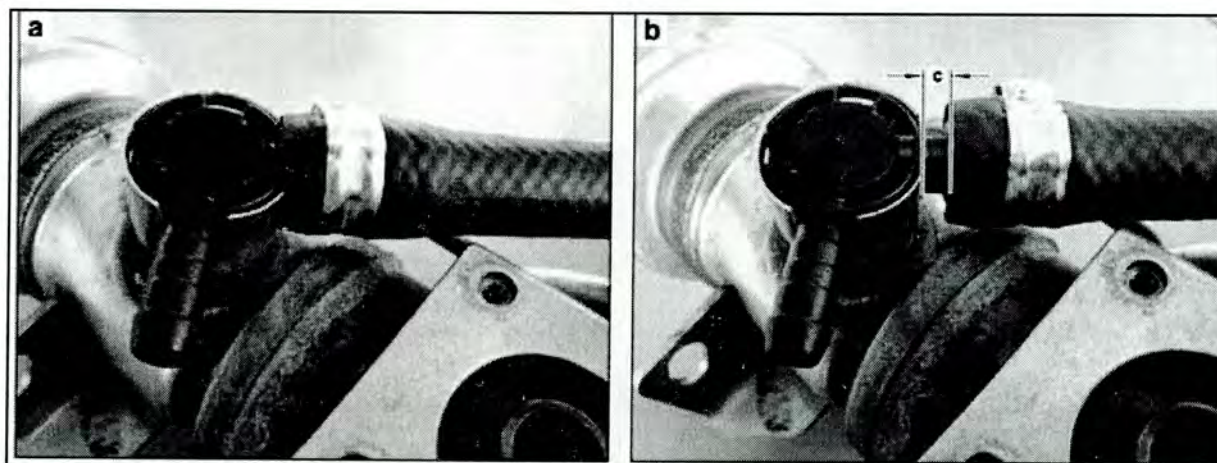
**Figure 1.**

When installing the bleed hose on the fuel tank filler neck maintain a distance of 5mm (Figure 1) (c) from the switchover value; otherwise, damage or leaking can result.

- a. Bleed hose incorrectly installed  
b. bleed hose correctly installed  
c. Distance, 5 mm

If the vehicle came with a complaint of ECL and DTC fault codes for purge control system leak in the EVAP, the nipple at the switchover vent valve must be carefully inspected for cracks before repositioning the hose. If a crack is found, the filler assembly must be replaced.
