T-SB-0016-12

MIL "ON" P043E, P043F, P2401, P2402, & P2419 Due to Water Intrusion into Charcoal Canister

YEAR(S)	MODEL(S)	ADDITIONAL INFORMATION
2007 – 2011	Yaris	Body Type(s): 4Dr. Sedan

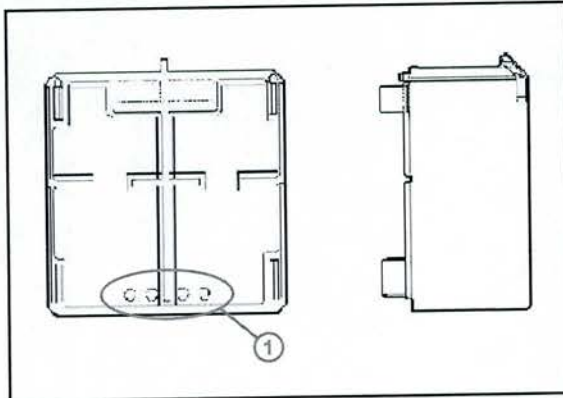
Figure 1. Fuel Tank Filler Pipe Cover: PREVIOUS Design

5. For 2007 Yaris, follow this procedure, all other model years proceed to step 7. Inspect the fuel tank filler pipe cover holder for the presence of the drain hole shield that is included with the updated fuel tank filler pipe cover holder as shown in Figures 1 and 2 below.

1	4 Holes
---	---------

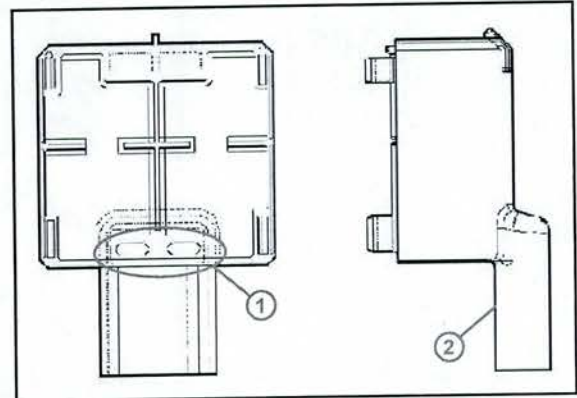
Figure 2. Fuel Tank Filler Pipe Cover: CURRENT Design

1	2 Holes
2	Drain Hole Shield

6. If drain hole shield is present, proceed to step 7.

If drain hole shield is NOT present, replace the fuel tank filler pipe cover and cover holder with the updated parts.

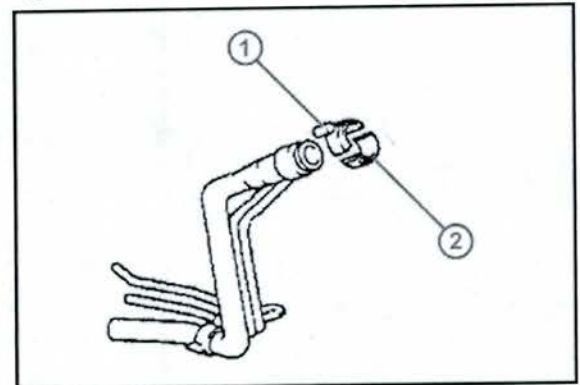
Figure 3.

1	Fuel Tank Filler Pipe Cover
2	Fuel Tank Filler Pipe Cover Holder

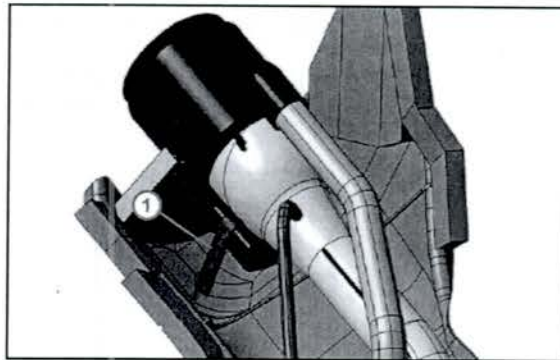
Figure 4.

1 Zip Tie

7. Replace fuel tank filler pipe protector with updated part. Slide the supplied plastic tie over the fuel tank filler pipe cover holder then reinstall original fasteners.

Do NOT adjust the length or tension of zip tie.
