Service Campaign Bulletin

Campaign No. 2012010006, February 2012

SUBJECT: **Model 221, Model Years 2011 - 2012**
Check Tire Pressure Monitoring Coding, Update if Necessary

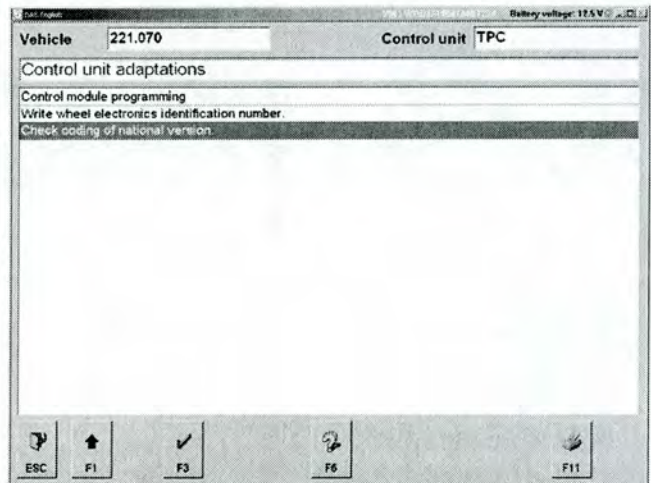
Figure 1

1. Connect Star Diagnosis to vehicle.
2. Check variant coding in TPM (RDK) control module: Control units/Chassis RDK tire pressure control/Control unit adaptations/new menu item Check coding of national version.

When selecting the new menu item, the national coding of the CGW [ZGW] is compared with the NHTSA coding (enabled or disabled) stored in the TPM [RDK]-SG in the background.

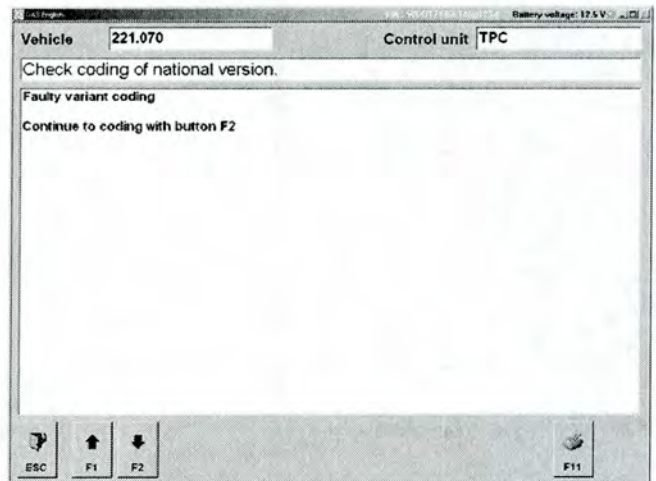
Figure 2

3. With faulty coding, the following screen (Figure 2) is shown. By pressing the F2 button, the coding is automatically corrected in the background.
