Service Bulletin

Bulletin No.: 08-07-30-021G

Subject: Loss of High Speed GMLAN Communications, Intermittent No Crank, IP Gage Fluctuation, Intermittent Door Lock Cycling, Intermittent Chime Operation, Various IP Warning Lamps Illuminated, Transmission May Not Shift, Communication DTCs U0073, U0100, U0101, U0102, U0109, U0121 or U0140 Set (Repair Terminals in Transmission Harness Connector, Repair Open or Shorted GM High Speed LAN Circuits, Open or Shorted Data Link Resistor, Corrosion or Poor Connections in Various Control Module Connectors)

Models: 2007–2010 Cadillac XLR
 2007–2012 Cadillac Escalade Models
 2009–2012 Cadillac Escalade Hybrid
 2007–2012 Chevrolet Avalanche, Corvette, Silverado, Suburban, Tahoe
 2008–2012 Chevrolet Silverado Hybrid, Tahoe Hybrid
 2007–2012 GMC Sierra, Yukon Models
 2008–2012 GMC Sierra Hybrid, Yukon Hybrid
 2008–2009 HUMMER H2
 Equipped With Gasoline Engine and 6 Speed Automatic Transmission 6L80 (RPO MYC) or 6L90 (RPO MYD)
 Equipped With Hybrid Propulsion (RPO HP2) and Two Mode 2ML70 Automatic Transmission

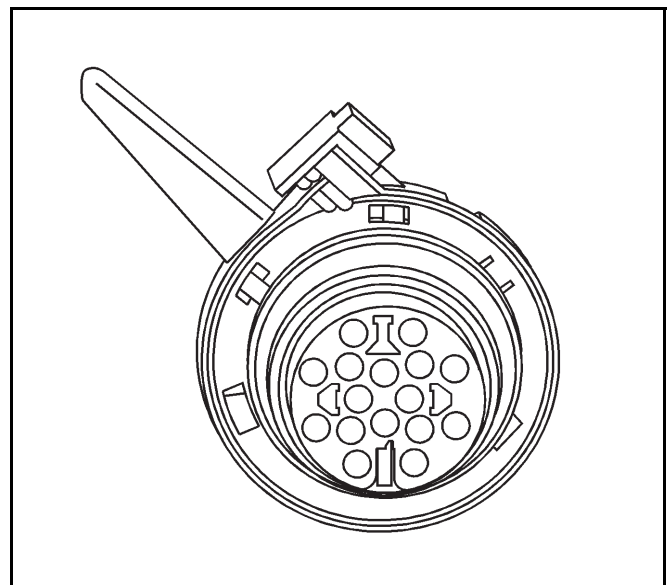
1921876

5. **Before** disconnecting the 16-way connector, **inspect** for any backed out terminals (1) as shown. Fully seated terminals (2,3) are shown for comparison.
 - 5.1. If a backed out terminal (1) is found, identify the terminal(s) on the **repair order**.
 - 5.2. Look at the connector in order to identify the number of the cavity with the backed out terminal. Refer to Wiring Systems and Power Management > Component Locator > Master Electrical Component List in SI.

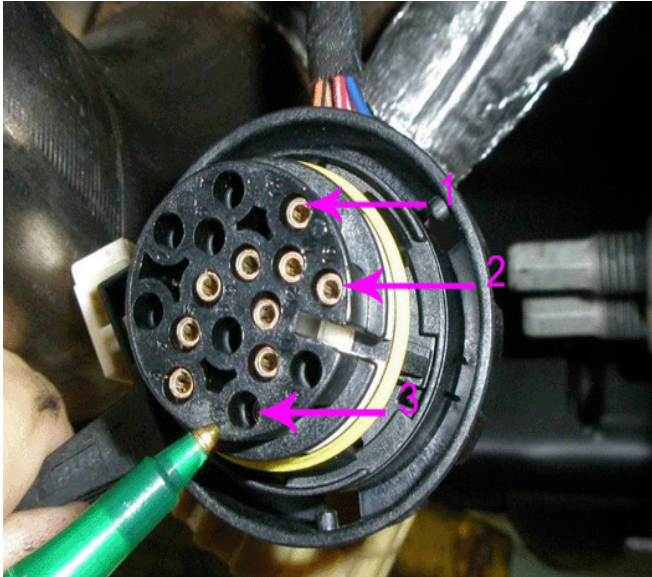
2807963

7. **Inspect** for any backed out terminals (3) as shown. Fully seated terminals (1,2) are shown for comparison.
 - 7.1. If a backed out terminal (3) is found, identify the terminal(s) on the **repair order**.
 - 7.2. Look at the connector in order to identify the number of the cavity with the backed out terminal. Refer to Wiring Systems and Power Management > Component Locator > Master Electrical Component List in SI.

8. Repair or replace the terminal(s) as necessary using the following procedure:

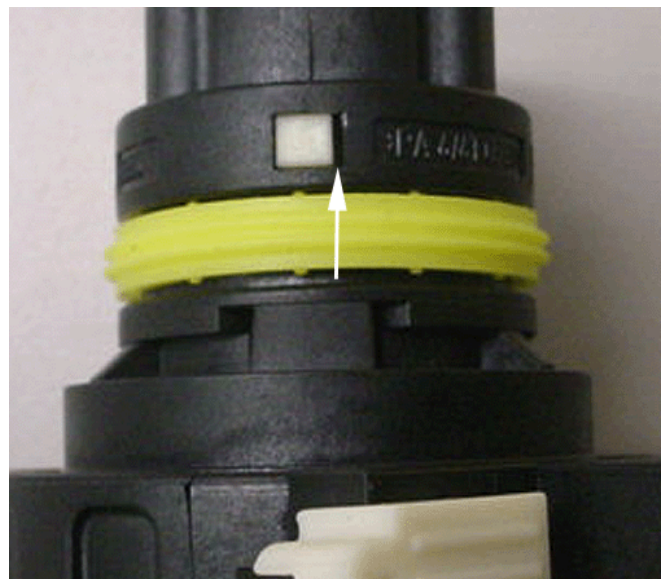
2089456

- If the TPA is off-center in the check window as shown, then it is only partially seated. Note the large gap at the arrow. Reseat the TPA lock and ensure that it is fully seated.

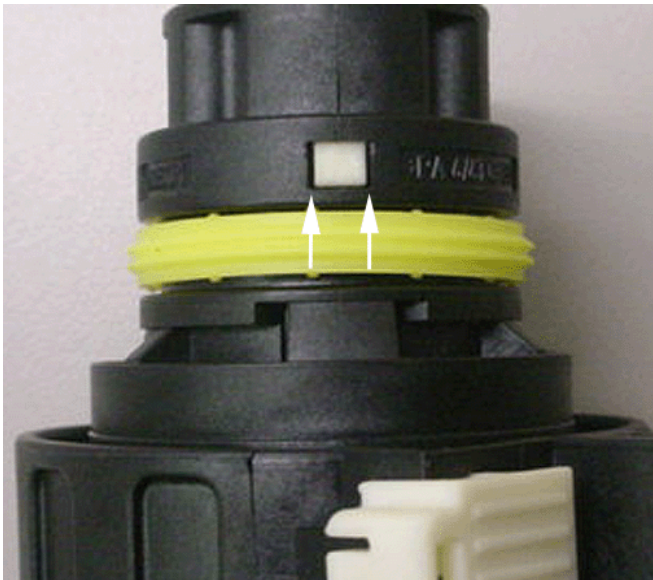
2089400

- If the TPA lock is centered in the window as shown, then it is fully seated. The gaps shown by the arrows should be even on both sides.

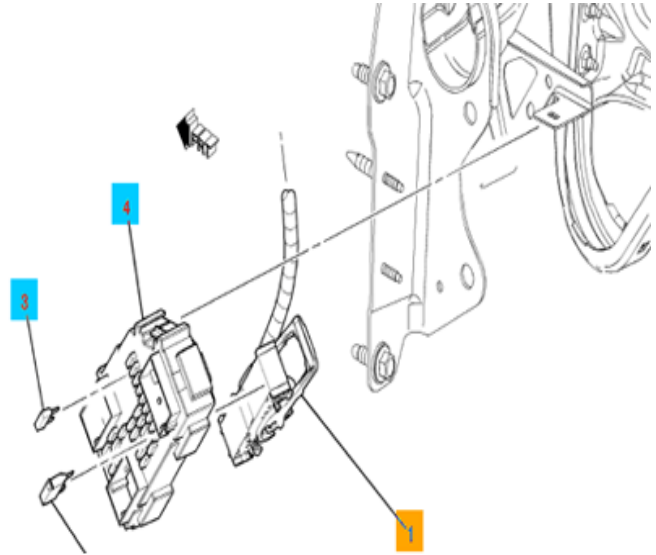
2077437

4. Inspect connector X1 (1) on the back of the fuse block for a loose connection. Secure the connector as needed.
5. Install the left side fuse block.
6. Connect the negative battery cable. Refer to Battery Negative Cable Disconnection and Connection in SI.
7. Clear any DTCs that may be present with a scan tool and verify the proper operation of the vehicle.

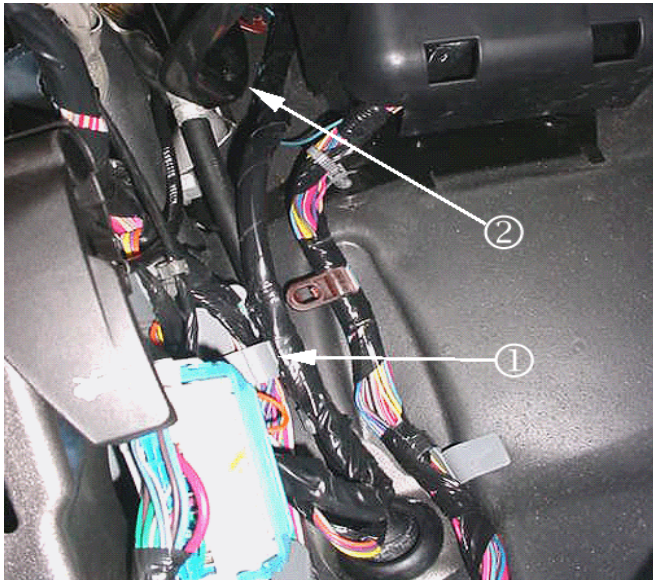
2002643

- The IP wiring branch to C202 may have been routed outboard of the junction block (left IP) and the retaining clip (1) off the branch may not have been fully seated. Possible point of contact (2).

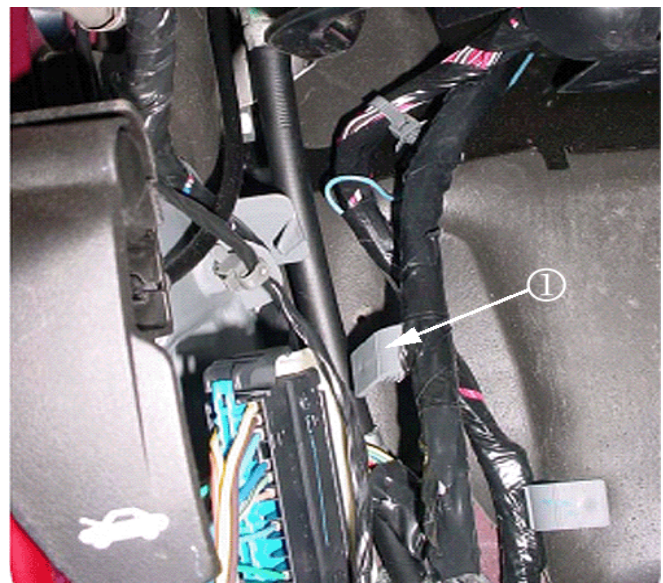
2002647

- The IP wiring branch to C202 may not have been secured into place as the gray retaining clip (1) off the branch was never seated.

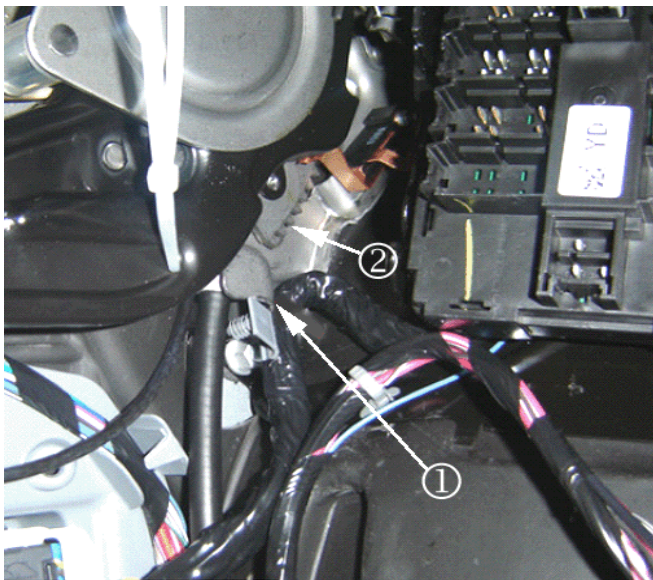
2002646

- The IP wiring branch to C202 may have been pushed up and forward into the park brake assembly and the retaining clip off the branch may not have been fully seated. Possible points of contact (1, 2).

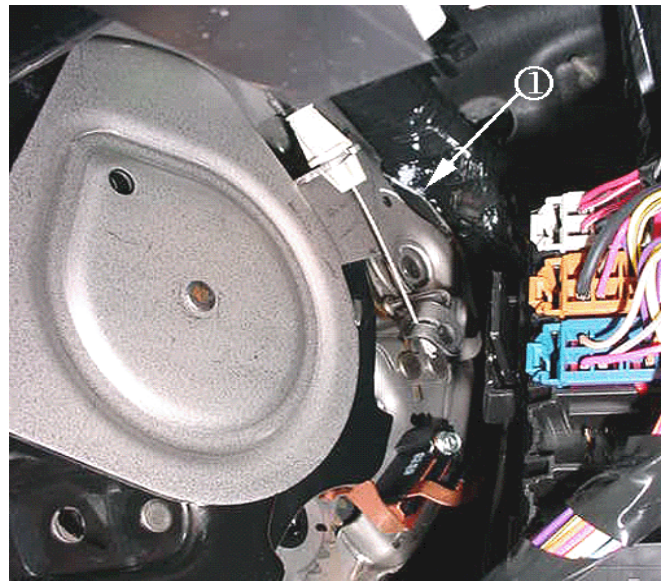
2002648

- The IP harness may be in hard contact with the top rear edge (1) of the park brake assembly.

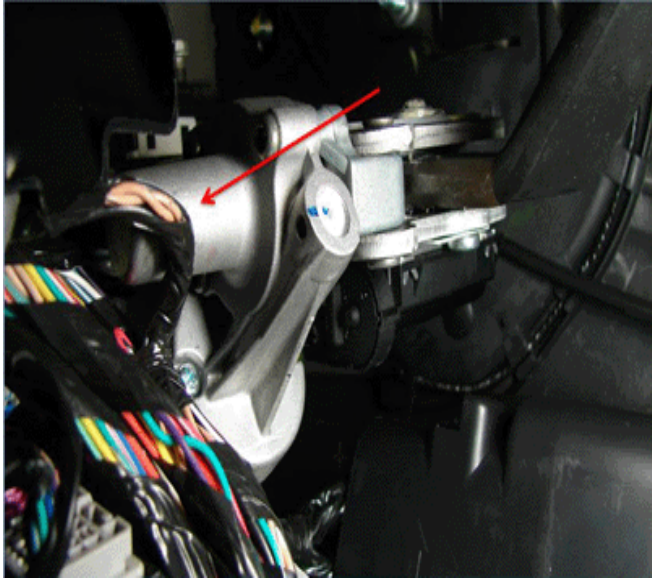
2264518

2. Inspect for chafed, damaged, pinched, open or shorted wiring at the adjustable pedals motor as shown.
3. If the wiring is damaged, repair as needed. Refer to Power and Signal Distribution > Wiring Systems and Power Management > Diagnostic Information and Procedures in SI. Protect the conduit by covering any sharp edge with butyl tape and the harness with woven polyester (PET) electrical tape. Secure the harness as needed.
4. Clear any DTCs that may be present with a scan tool and verify the proper operation of the vehicle.

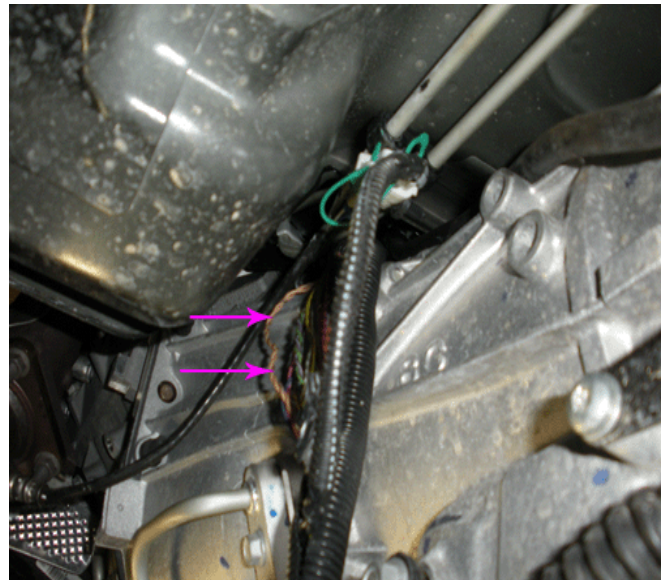
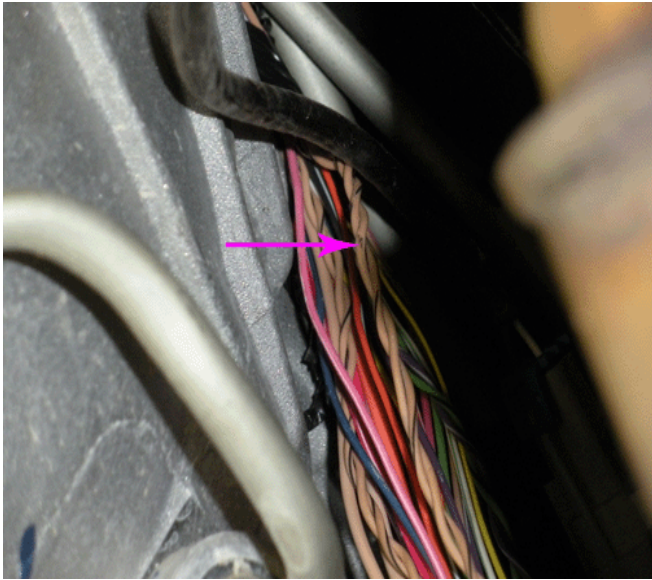
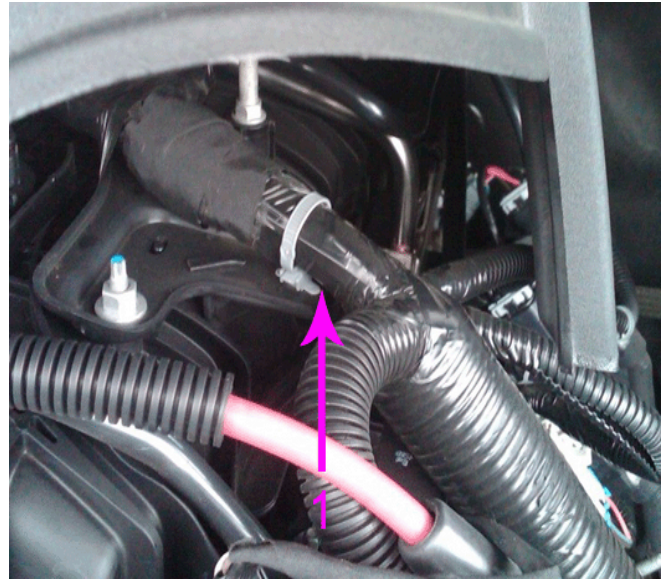
8. Examine the harness for wiring that may be exposed outside of the conduit. Inspect all areas for chafed, damaged, pinched, open or shorted wiring as shown. If damage to the wiring is not observed, then extract the wiring from the conduit and inspect all remaining areas as needed.

- ⇒ If the wiring is damaged, repair as needed. Refer to Power and Signal Distribution > Wiring Systems and Power Management > Diagnostic Information and Procedures > Wiring Repairs in SI. Protect the conduit by covering any sharp edge with butyl tape and the harness with woven polyester (PET) electrical tape. Secure the harness as needed.

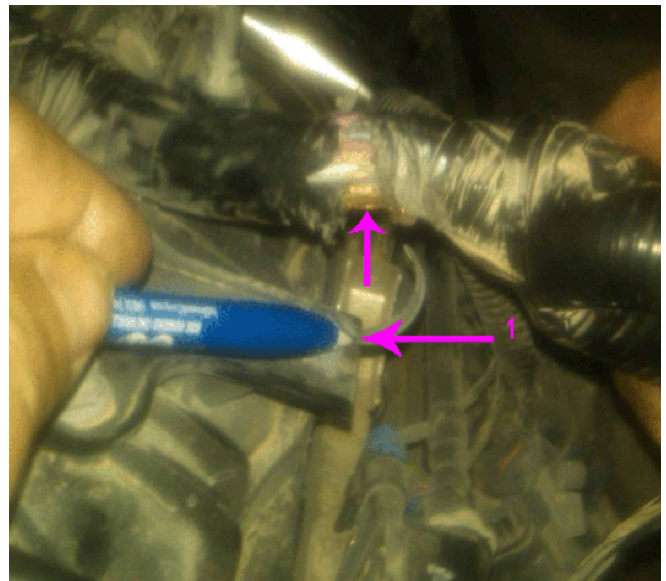
2808049

4. Inspect the wiring harness for damage from contact with the steel bracket (1).
 - ⇒ If the wiring is damaged, repair as needed. Refer to Power and Signal Distribution > Wiring Systems and Power Management > Diagnostic Information and Procedures > Wiring Repairs in SI.
5. Cover any sharp edge on the bracket with butyl tape and the harness with woven polyester (PET) electrical tape.

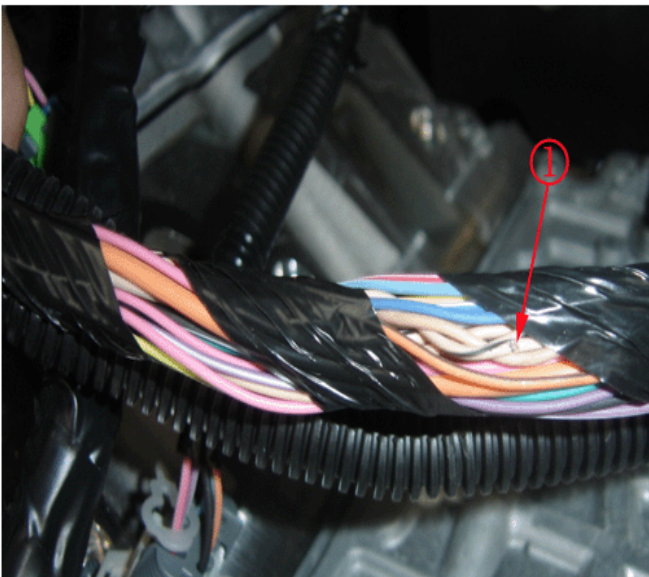
2328026

Inspect for chafed (1), damaged, pinched, open or shorted wiring. If damage is not observed, then extract the wiring from the conduit and inspect all of the remaining areas as needed.

⇒ If the wiring is damaged, repair as needed. Refer to Power and Signal Distribution > Wiring Systems and Power Management > Diagnostic Information and Procedures.

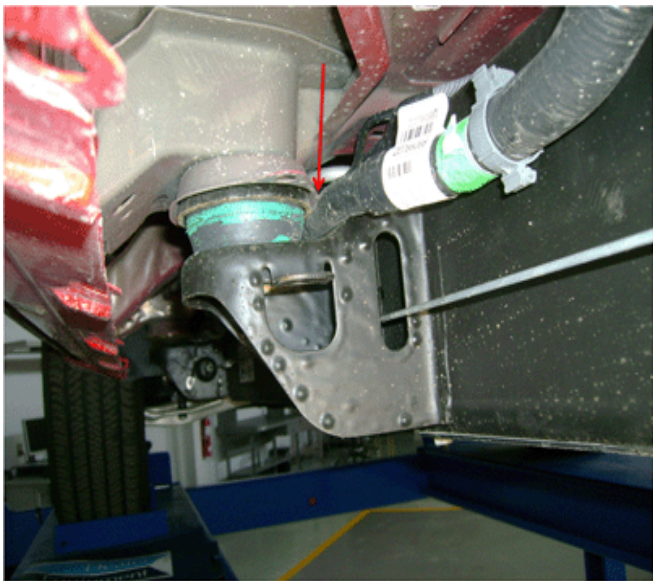
2268656

3. Inspect the wiring harness along the left side frame rail at the body mounts as shown for chafed, damaged, pinched, open or shorted wiring.
4. If the wiring is damaged, repair as needed. Refer to Power and Signal Distribution > Wiring Systems and Power Management > Diagnostic Information and Procedures. Protect the conduit by covering

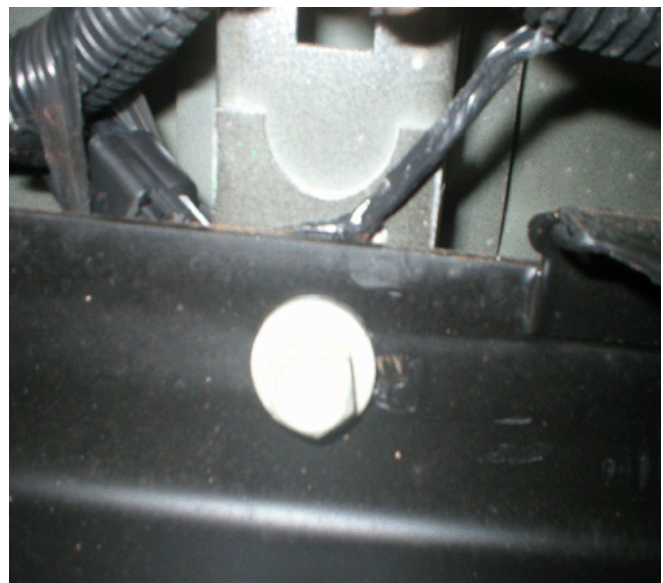
1991762

4. Inspect the wiring harness leading to the rear data link resistor 1, between the truck box and frame for chafed, damaged, pinched, open or shorted wiring as shown.

- ⇒ If the wiring is damaged, repair as needed. Refer to Power and Signal Distribution > Wiring Systems and Power Management > Diagnostic Information and Procedures. Protect the conduit by covering any sharp edge with butyl tape and the harness with woven polyester (PET) electrical tape. Secure the harness as needed. Proceed to Step 9.

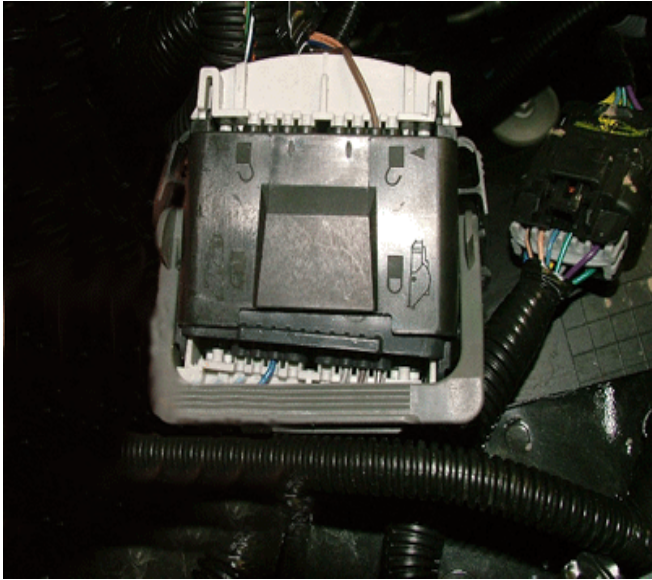
2264519

3. **Before** disconnecting, verify the connector is fully seated together even though the lever is locked down as shown.
If the connector is not fully seated, repair as needed. Refer to Power and Signal Distribution > Wiring Systems and Power Management > Diagnostic Information and Procedures > Connector Repairs in SI.
4. Inspect the connector for the following conditions:
 - Backed out terminals
 - Bent pins
 - Corrosion
 - Poor terminal tension (use the correct test probe)

⇒ If a condition is found, repair as needed. Refer to Power and Signal Distribution > Wiring Systems and Power Management > Diagnostic Information and Procedures in SI.

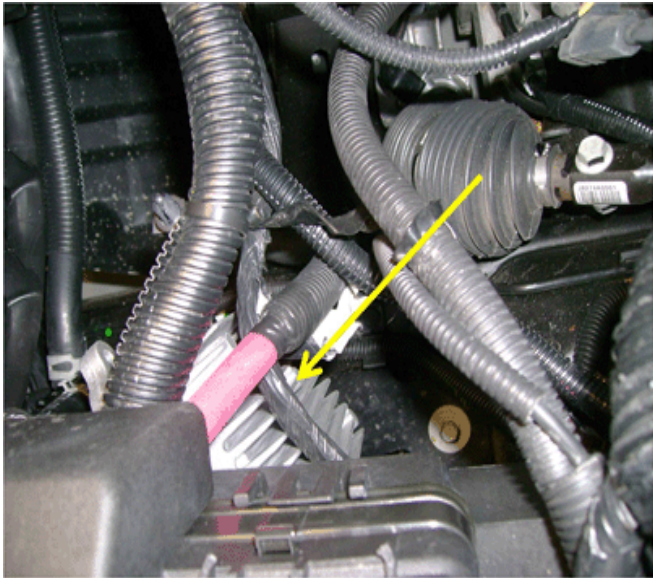
2297689

4. Inspect for a misrouted harness having chafed, damaged, pinched, open or shorted wiring from rubbing on the cooling fins of the Transmission Auxiliary Fluid Pump Control Module as shown.
 - ⇒ If the wiring is damaged, repair as needed. Refer to Power and Signal Distribution > Wiring Systems and Power Management > Diagnostic Information and Procedures in SI. Protect the conduit by covering any sharp edge with butyl tape and the harness with woven polyester (PET) electrical tape. Secure the harness as needed. Proceed to Step 8.
 - ⇒ If the wiring is not damaged, proceed to Step 5.

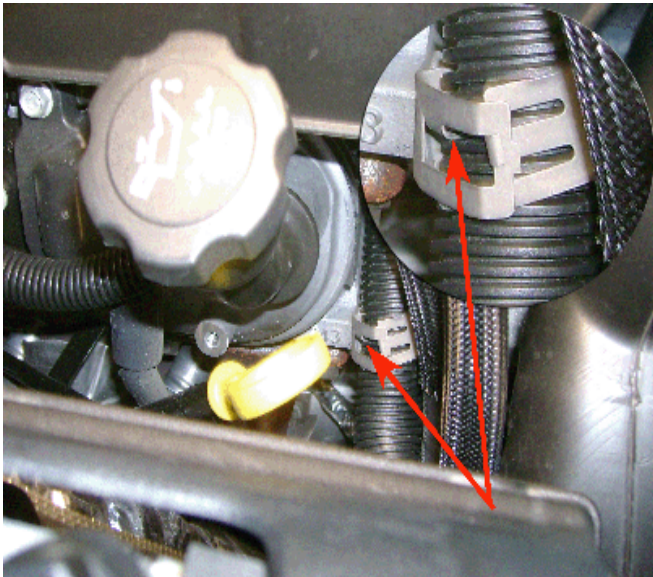
2305639

5. Inspect for chafed, damaged, pinched or shorted wiring caused by a mispositioned harness retaining clip as shown. This condition usually occurs when the tab of the clip is aligned with a slot in the conduit.

- ⇒ If the wiring is damaged, repair as needed. Refer to Power and Signal Distribution > Wiring Systems and Power Management > Diagnostic Information and Procedures in SI. Protect the conduit by covering any sharp edge with butyl tape and the harness with woven polyester (PET) electrical tape. Secure the harness as needed. Proceed to Step 8.

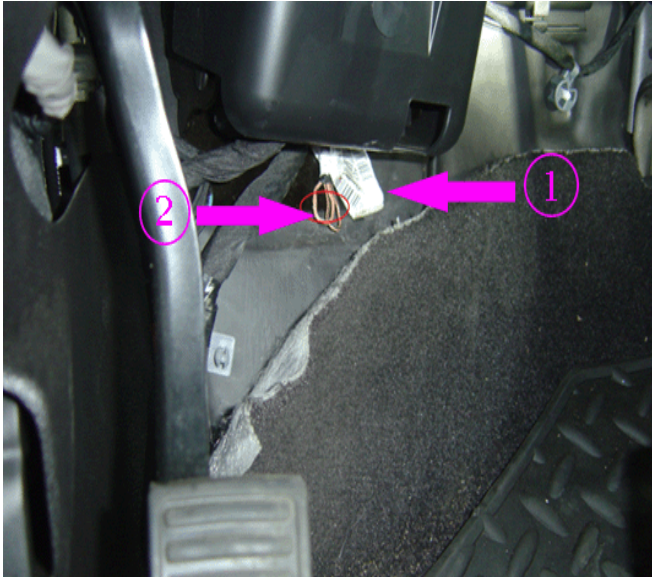
2658869

5. Inspect the jumper harness loop connector (1) for chafed (2), damaged, pinched, open or shorted wiring from contact with the IP brace.
