Technical Service Bulletin

57 Door cannot be opened from outside handle in cold weather

57 12 63 2020051/4 March 15, 2012. Supersedes Technical Service Bulletin Group 57 number 11 – 44 dated February 16, 2011 for reasons listed below.

Model(s)	Year	VIN Range	Vehicle-Specific Equipment
Audi Q7	2007 – 2010	All	Not Applicable

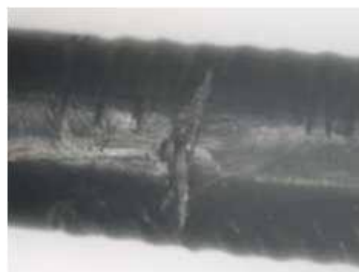
A plastic burr on the bearing bracket can cut the outer sheathing material of the Bowden cable. As a result, water can enter through the outside door handle and into the sheathing of the Bowden cable. In extremely cold weather, it is possible for the Bowden cable to freeze. In this condition, the door-opening function of the outside door handle may intermittently or consistently be inoperative until the vehicle is allowed to warm.

Figure 1. Cut in Bowden cable.

Remove all plastic burrs from the bearing bracket and apply a protective fabric cover over the cable to prevent the cable from being cut.

1. Obtain a new exterior door handle bearing bracket assembly, which includes the Bowden cable.

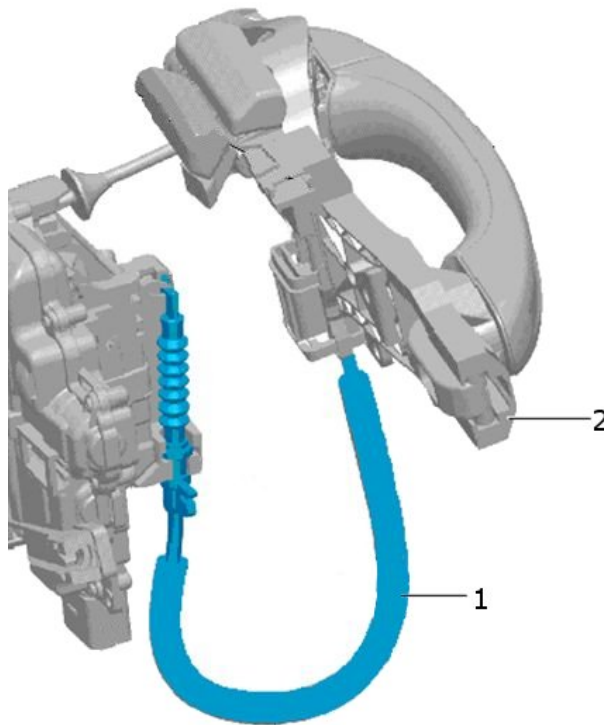
Figure 2. Bowden cable (1), and door handle mounting bracket (2).

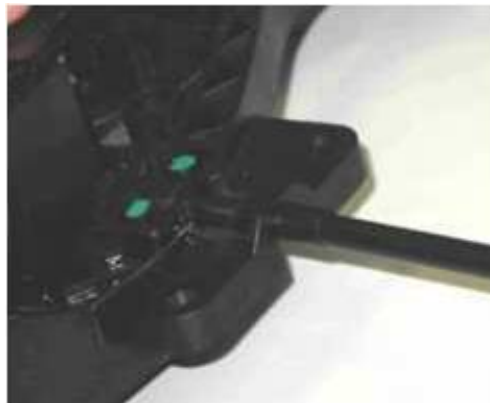
2. Determine whether the replacement part is reworked. The reworked parts are indicated by two green dots near the cable attachment point on the bearing bracket.

Figure 3. Bearing bracket with two green dots.

- If two green dots are present on the replacement parts, then proceed to step 3.

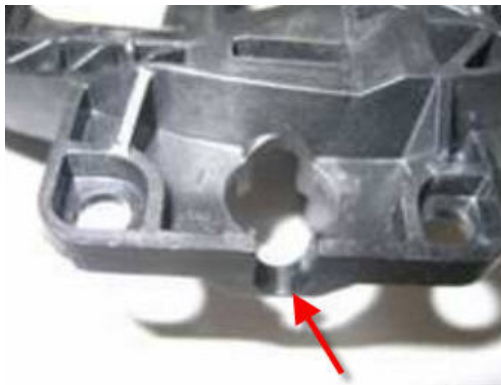
Figure 4. Location on bearing bracket to check for burrs.

- a. Check the bearing bracket for any sharp plastic burrs or sharp edges. Round the edges and remove any burrs with a small metal file.

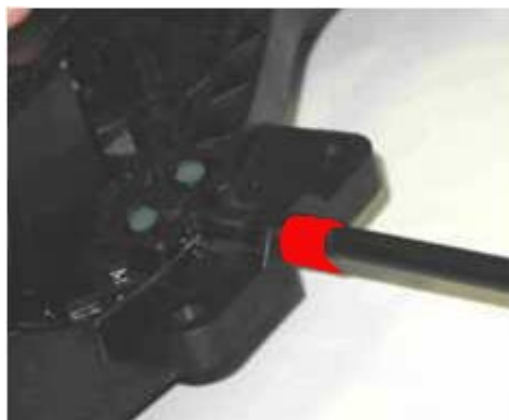
Figure 5. Location to apply Bowden cable fabric (red).

- b. Apply a protective fabric strip around the Bowden cable where it touches the bearing bracket.
