SI B63 03 12
Lights

Rear Light in the Side Panel Has Condensation

F30 (3 Series)

Vehicles produced to February 27, 2012

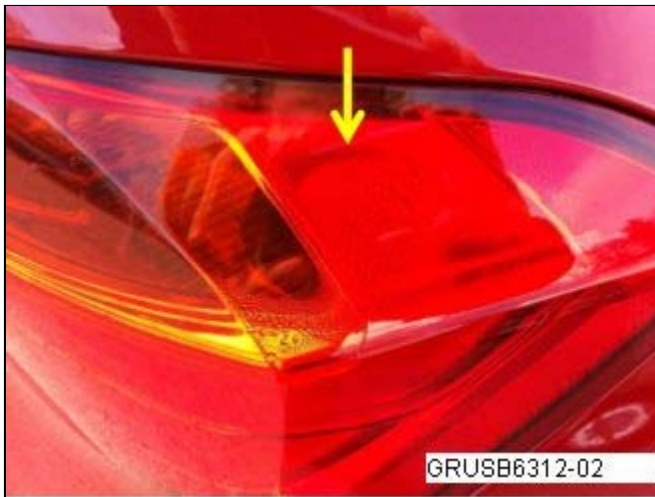
The left or right rear light in the side panel has condensation.

Improper sealing of the side panel rear light(s): The photo shows a cloudy lens caused by condensation.

Replace the affected rear light(s) in the side panel.
