# Service Bulletin No. 375

MODEL <b>E / J Series Coaches</b>	TYPE Field Change Program	SECTION/GROUP 3-Body	DATE Mar. 6, 2012
SUBJECT <b>PARCEL RACK SIDEWALL FASTENERS</b>			
CONDITIONS

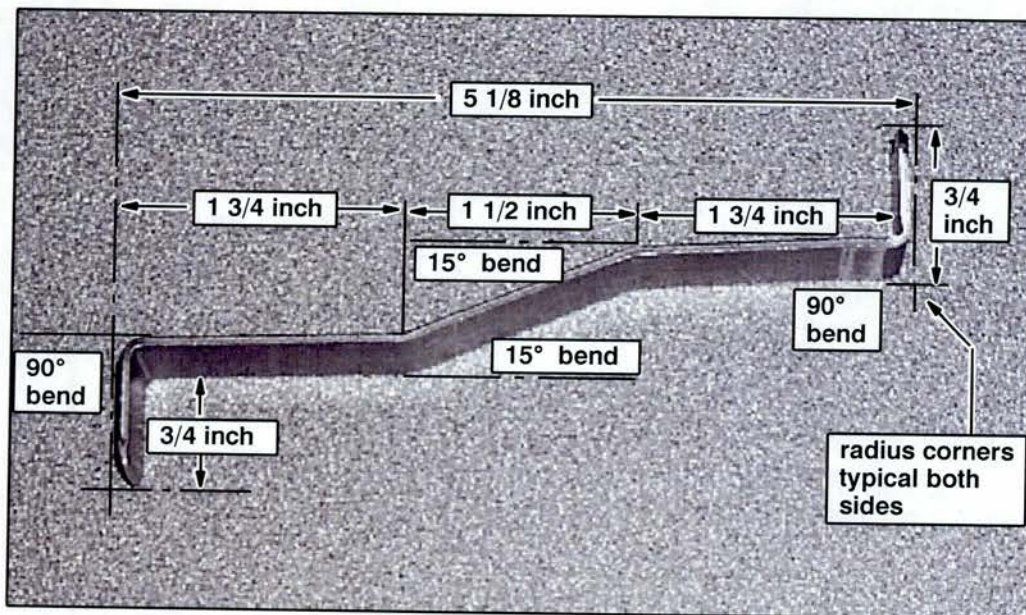
*This tool is required in order to properly remove the sidewall mouldings from the parcel rack without incurring any damage to the edge of the moulding.*

*This tool can be manufactured, using 16 gauge steel, following the specs. outlined in Figure 1, or tool can be purchased at SNAP ON / part number A192.*

7. Carefully remove and retain the sidewall mouldings using the tool shown in Figure 1.

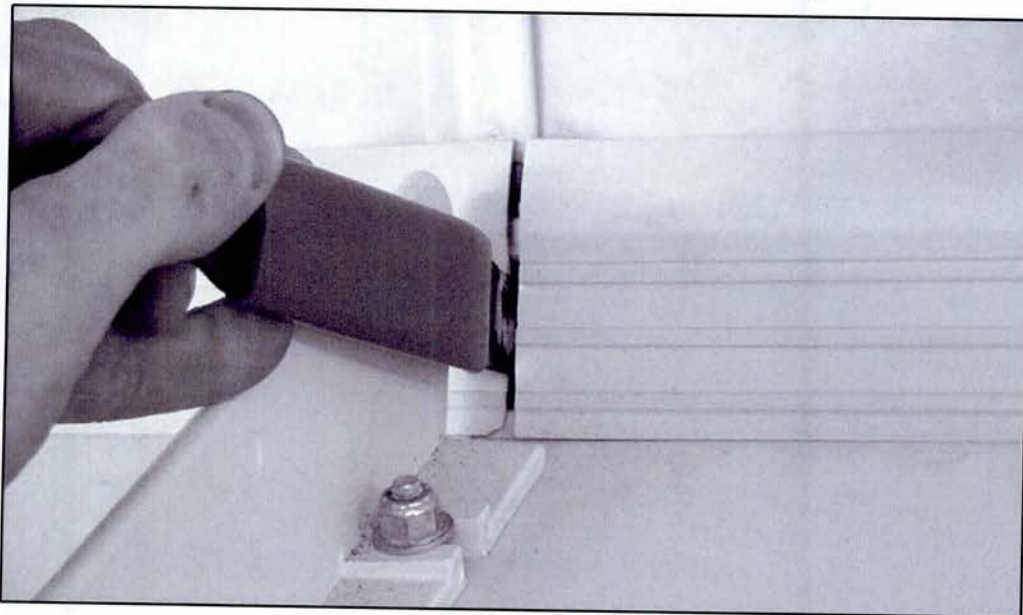
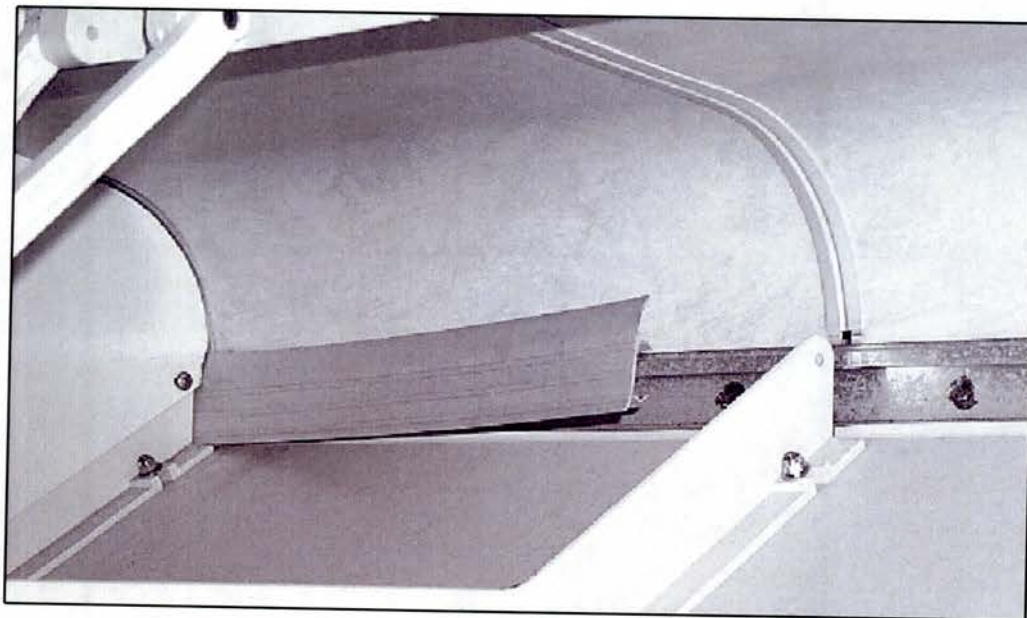
- 8. Visually check to ensure that there is no gap between the back of the parcel rack aluminum extrusion and the coach structure tube wall.

*Upon visual inspection, if there is a gap use a 7/32 drill bit to drill out the existing fastener and utilize a screw, p/n 19-1-779, to pull the parcel rack aluminum extrusion against the coach tube wall. Proceed to Step 9.*
