SB-10044336-9440

Engine ECU Software Update

MP7 US2010
LEU, MRU

PI0782, Engine Control Module (ECM) Software Update

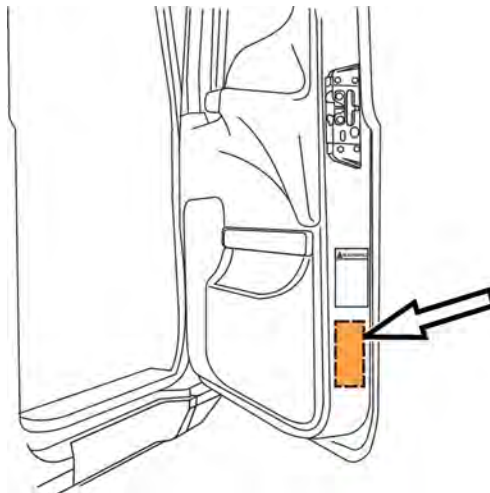
W8034103

Note: To signify that the campaign has been completed, using a permanent-type marker (such as a Sharpie®) to write the campaign number (**PI0782**) and completion date in the spaces provided on the Campaign Completion label located inside the cab as shown in the illustration below. If a label is not already affixed inside the cab, apply a label (part number TS897) and supply the information as required. Campaign Completion labels are available in packs of 50 and can be ordered by faxing a completed BR313 to Pacesetters Business Services at 610-264- 9465.
