## Engine VGT Actuator and TSS Sensor Connector, Relocation VN, VHD, VAH D13H

### SP 255-022, Engine VGT Actuator and TSS Sensor Connector Relocation

(June 2012)

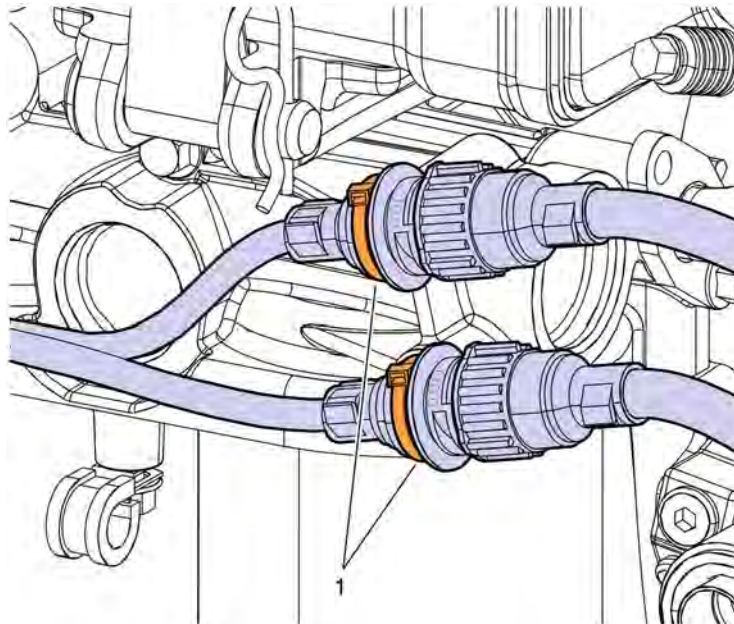
W2072567

A new campaign is available to prevent engine diagnostic trouble codes (DTCs) and missing signal from the Engine Variable Geometry Turbocharger Actuator (Engine VGT Actuator) on VOLVO D13 US2010 engines with a Mechanical transmission. This condition is caused by fretting of the connector pins in the engine VGT actuator connector. Relocation of the engine VGT actuator connector and a new mounting arrangement has been developed to eliminate this condition. See the table below for the list of parts required for this campaign.

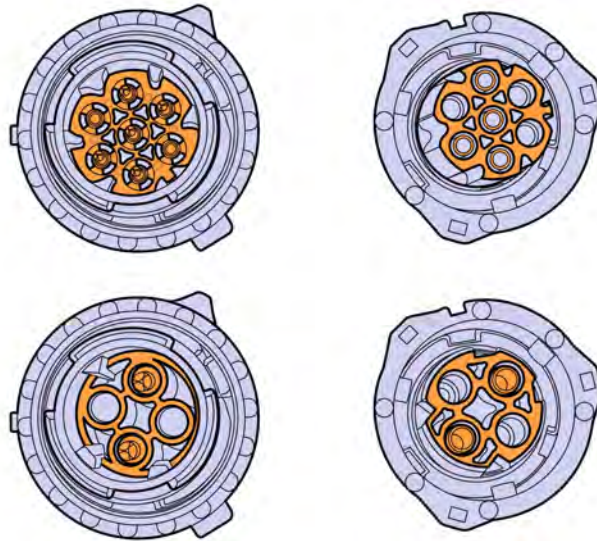
W2072325

- 7 Inspect connectors for green/brown dust on the pins or sockets.

**Note:** If green/brown dust is present in the areas highlighted in the figure below, clean the male and female engine VGT actuator and TSS sensor connectors with approved electrical solvent. Allow the connectors to thoroughly dry before assembly.
