Date	Group	No.	Release	Page
5.2012	255	022	02	1(6)

Engine VGT Actuator and TSS Sensor Connector, Relocation VN, VHD, VAH D13H

SP 255-022, Engine VGT Actuator and TSS Sensor Connector Relocation

(May 2012)

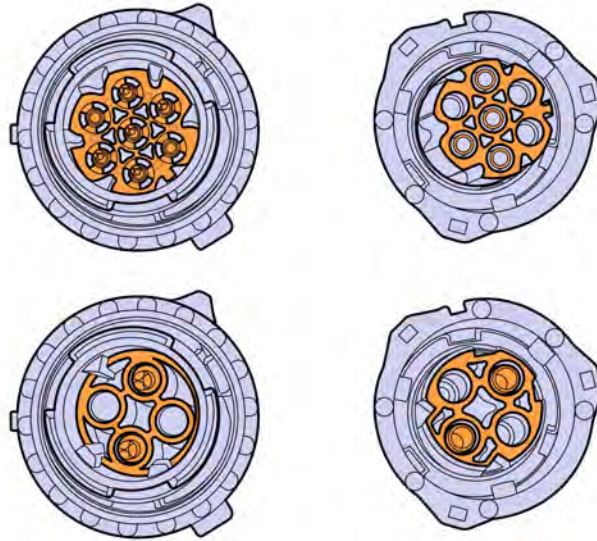
W2072325

- 7 Inspect connectors for green/brown dust on the pins or sockets.

Note: If green/brown dust is present in the areas highlighted in the figure below, clean the male and female engine VGT actuator and TSS sensor connectors with approved electrical solvent. Allow the connectors to thoroughly dry before assembly.

Note: If the Engine VGT Actuator Connector pins show signs of wear, replace the pins per "Engine VGT Actuator Connector Pin, Replacement" Field Service Bulletin PV729-FSB255-024_V (USA53614).
