Transmission Cooler Line O-Ring VN, VHD, VAH

SP 491-030, Transmission Cooler Line O-Ring

(MAY 2012)

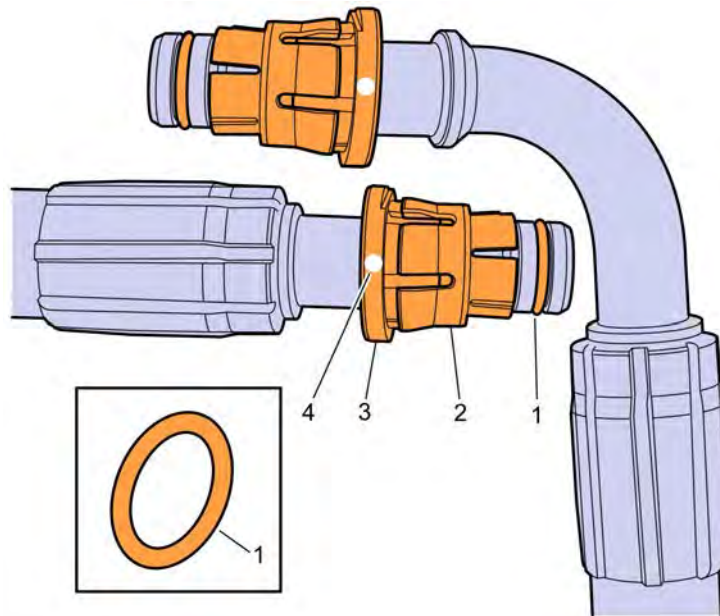
W4072905

Trucks built after March 05, 2012 were assembled with a replacement o-ring on the transmission cooler line fittings. A white dot on the shoulder of the fitting cap indicates a replacement o-ring was installed during assembly. See figure below. Visually inspect the truck for a white dot on the shoulder of the fitting cap. If the white dot is visible, only an inspection for the white dot is required. If the white dot is not visible on the fitting cap, replace the existing o-ring with a new green o-ring (part number 21866819). See the o-ring replacement procedure on page 2.

Transmission Cooler Line Fitting Components		
Item #	Part Number	Description
1	21866819	O-Ring
2	85129501	Locking Collar
3	85131659	Cap
4	N/A	Visual Inspection Mark (White Dot)

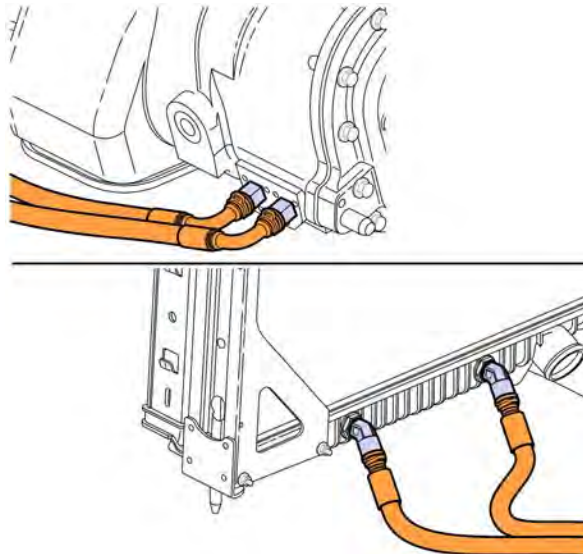
W4072906

- 1 Apply parking brake and place shift lever in neutral.
- 2 Raise hood.
- 3 Disconnect all cables from the negative (ground) battery terminals to prevent personal injury from electrical shock and prevent damage to electrical components.
- 4 Inspect the transmission cooler line fittings cap for the white dot at the transmission and the radiator.

Note: If a White Dot is visible on the cap, the inspection is complete. If the White Dot is not visible on the cap, continue onto step 5.
