Date	Group	No.	Release	Page
6.2012	491	030	02	1(7)

Transmission Cooler Line O-Ring VN, VHD, VAH

SP 491-030, Transmission Cooler Line O-Ring

(June 2012)

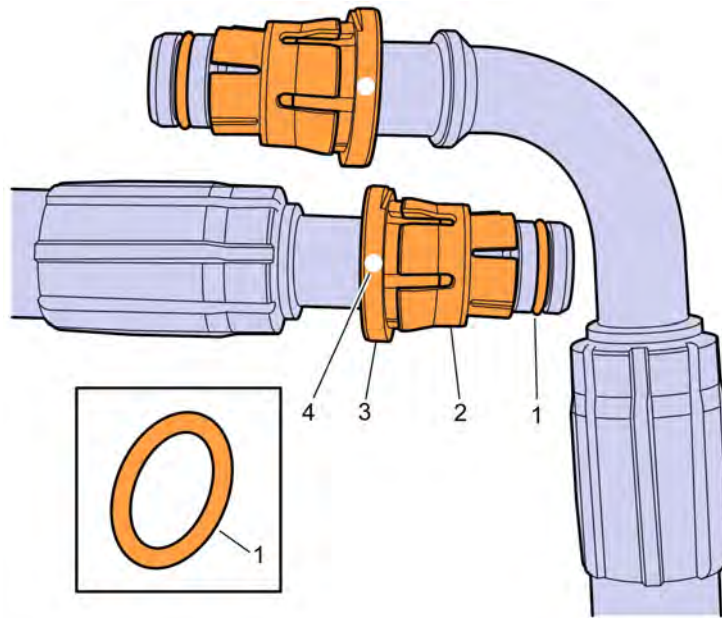
W4072905

Trucks built after March 05, 2012 were assembled with a replacement o-ring on the transmission cooler line fittings. A white dot on the shoulder of the fitting cap indicates a replacement o-ring was installed during assembly. See figure below. Visually inspect the truck for a white dot on the shoulder of the fitting cap. If the white dot is visible, only an inspection for the white dot is required. If the white dot is not visible on the fitting cap, replace the existing o-ring with a new green o-ring (part number 21866819). See the o-ring replacement procedure on page 2.

Transmission Cooler Line Fitting Components		
Item #	Part Number	Description
1	21866819	O-Ring
2	85129501	Locking Collar
3	85131659	Cap
4	N/A	Visual Inspection Mark (White Dot)

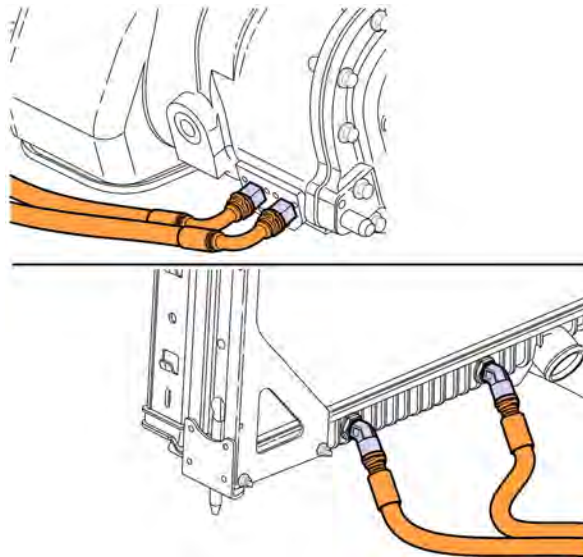
W4072906

- 1 Apply parking brake and place shift lever in neutral.
- 2 Raise hood.
- 3 Disconnect all cables from the negative (ground) battery terminals to prevent personal injury from electrical shock and prevent damage to electrical components.
- 4 Inspect the transmission cooler line fittings cap for the white dot at the transmission and the radiator.

Note: If a White Dot is visible on the cap, the inspection is complete. If the White Dot is not visible on the cap, continue onto step 5 and replace the four o-rings for the radiator and the transmission fittings.
