Service Action: Left-Hand Rear Lamp LED Failure

XF (X250)

VIN: R00001 - R61290

Model Year: 2009 - 2010

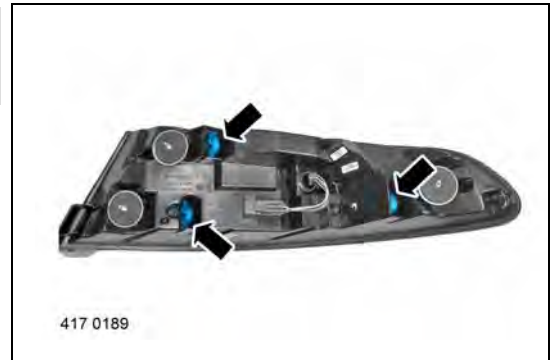
Situation: On a limited number of 2009 – 2010 model year Jaguar XF vehicles within the VIN range above, the light emitting diode (LED) within the left-hand (LH) rear lamp assembly may fail due to corrosion of the silver lead frame.

3. Replace the vent tubes:
 - Release and remove the three (3) vent tubes from the lamp assembly.
 - Install three (3) new vent tubes to the lamp assembly.
