SECTION: 417

Service Action: Left-Hand and Right-Hand Rear Lamps LED Failure

XF (X250)

VIN: R00001 - R61290
Model Year: 2009 - 2010

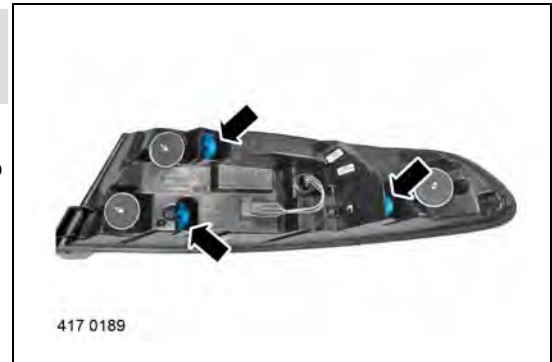
Situation: On a limited number of 2009 – 2010 model year Jaguar XF vehicles within the VIN range above, the light emitting diode (LED) within the left-hand (LH) and right-hand (RH) rear lamp assemblies may fail due to corrosion of the silver lead frame.

△ NOTE: Lamps not being replaced must have the vent tubes replaced. New vent tubes are of a different material specification.

3. Replace the vent tubes:
 - Release and remove the three (3) vent tubes from the lamp assembly.
 - Install three (3) new vent tubes to the lamp assembly.
