Service Bulletin

Subject: AIR BAG SYSTEM WARNING ILLUMINATION WITH DTCs B1994 / B1998	Bulletin No: 08-001/12
	Last Issued: 05/17/2012

2007-2012 CX-7 vehicles equipped with side air bags

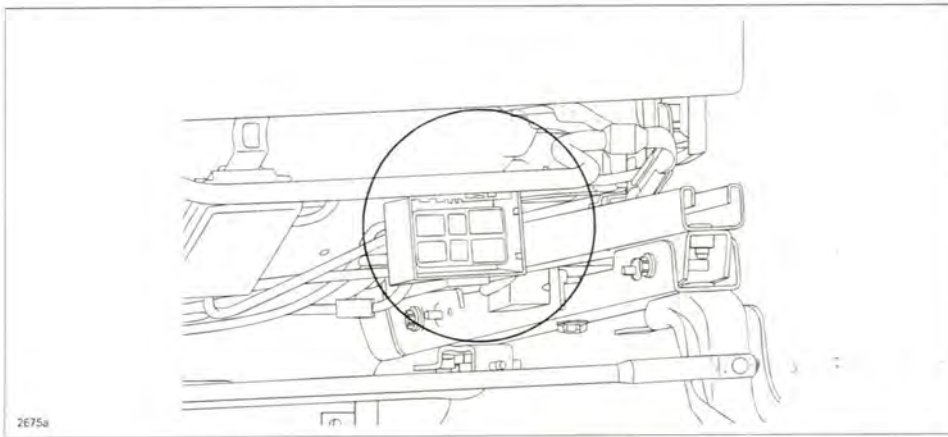
7. Disconnect the seat harness connector.

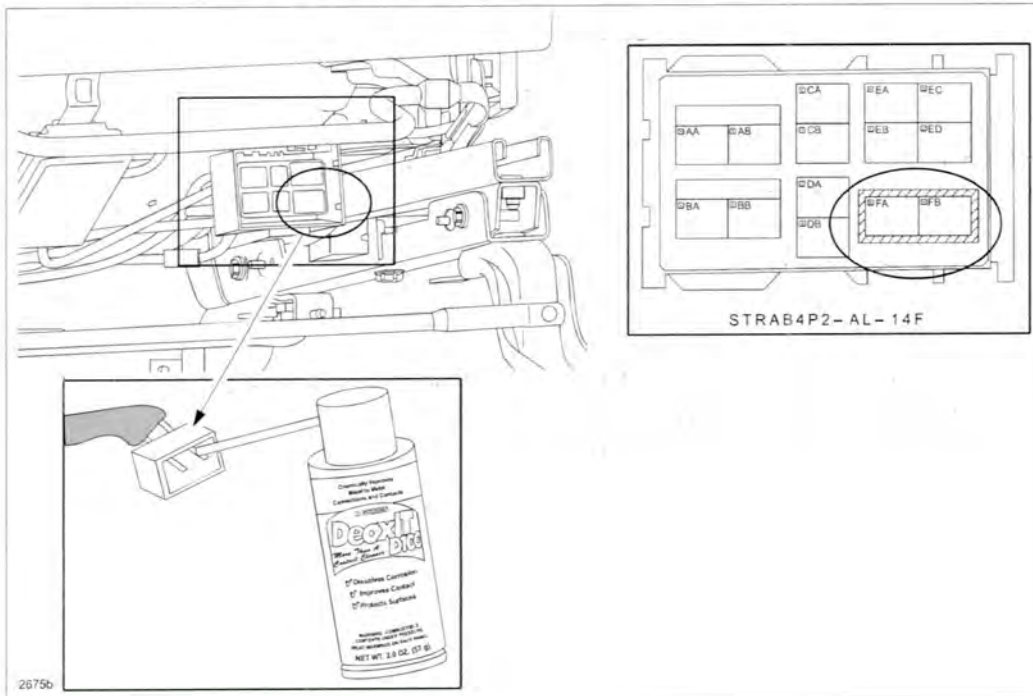
The DTCs may be due to poor contact between the side air bag connector terminals.

8. Spray electrical contact cleaner "DeoxIT #D100S-2" onto both sides of the male and female terminals as shown below.
