# Service Bulletin

<b>Subject:</b> <b>RATTLE NOISE FROM STEERING SYSTEM</b>	<b>Bulletin No:</b> 06-002/12
	<b>Last Issued:</b> 05/11/2012

2011-2012 Mazda2 vehicles with VINs lower than JM1 DE 1\*\*\*\*\* 140732 (produced before December 10, 2011)

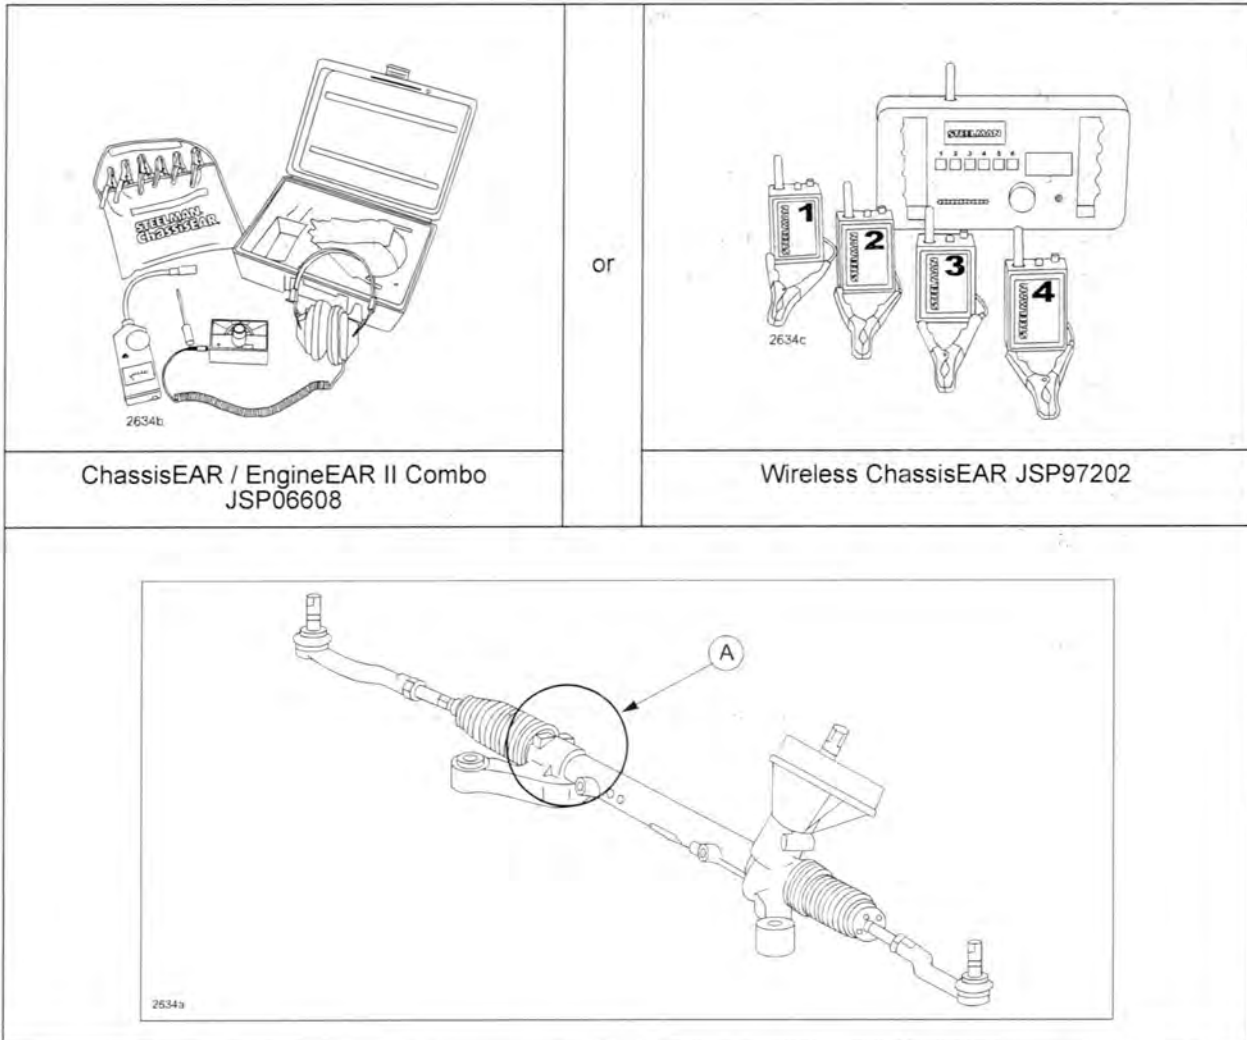
When driving straight on a rough road at approximately 6-19 mph (10-30 km/h), some vehicles may exhibit a rattle noise from the front passenger side floor.

2. Use Special Service Tool (SST) ChassisEAR / EngineEAR II Combo JSP06608 or Wireless ChassisEAR JSP97202 to confirm rattle noise is coming from the rack end bushing (A) (shown below):

3. If step 1-2 apply, replace the steering gear assembly according to MS3 online or Workshop Manual (section 06-13 STEERING GEAR AND LINKAGE REMOVAL/INSTALLATION).
4. Verify repair.
