Service Bulletin No. 386

MODEL E4500 / J4500 Series Coaches	TYPE Field Change Program	SECTION/GROUP 6-Cooling	DATE June 1, 2012
SUBJECT FAN CLUTCH BUSHING			
CONDITIONS

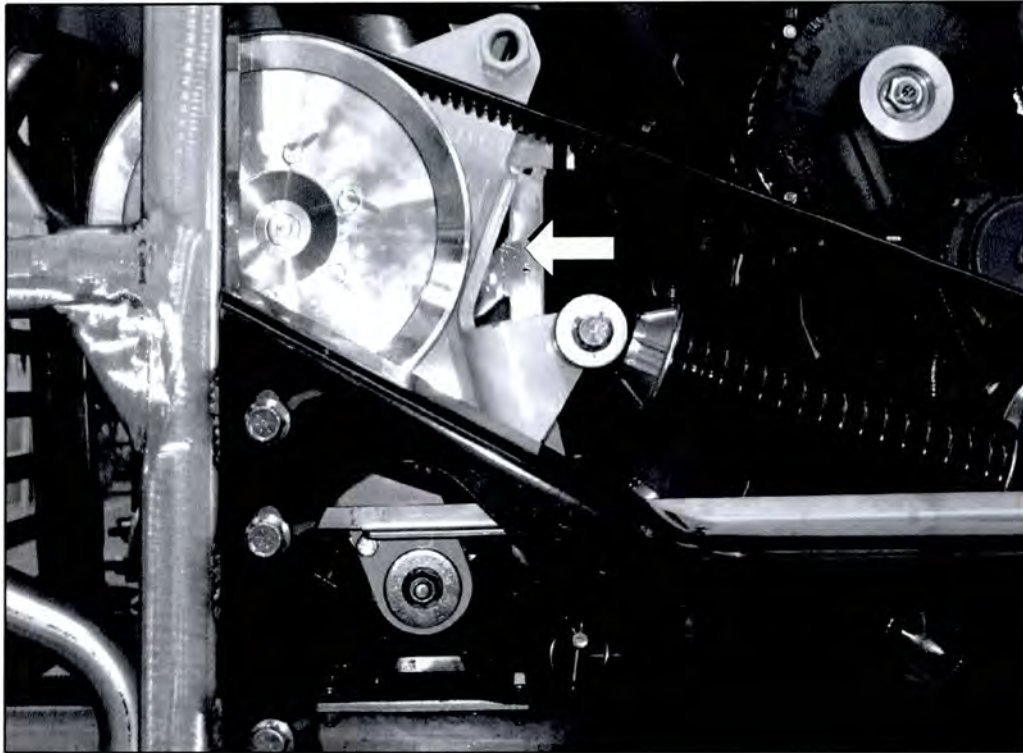
Figure 1.

1. Activate the disconnect feature of the main battery disconnect (MDS) system by pressing (for one second only) the momentary toggle switch on the MDS module to OFF. An audible click can be heard from the main solenoids in the MDS module. Position the rotary switch to the DOWN (OFF) position.
2. Chock both sides of the tires.
3. Open the engine compartment door.
4. Locate the fan clutch, on the roadside section of the engine compartment (refer to Figure 1).

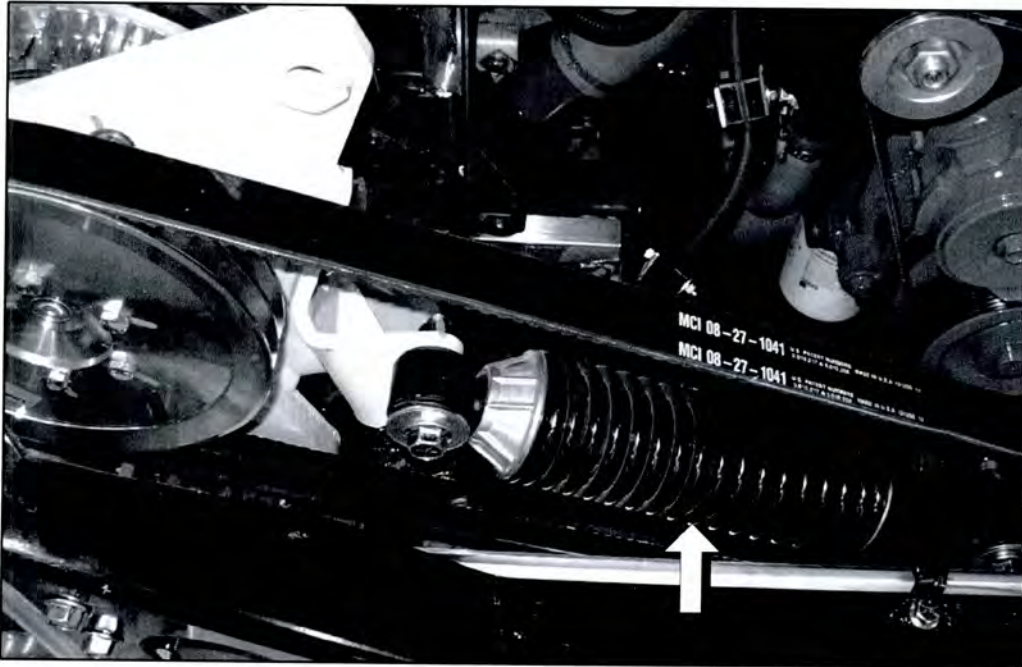
Figure 2.

5. Locate the belt tension shock assembly connected to the fan clutch installation (refer to Figure 2).

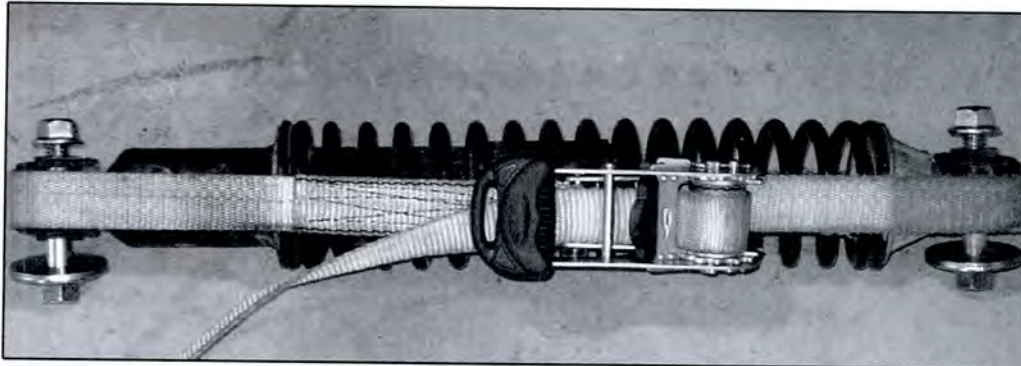
Figure 3. Reference photo of ratchet strap compressing the shock.

6. Using a ratchet strap, carefully compress the shock to achieve enough slack for belt removal from the fan clutch pulley (refer to Figure 3).

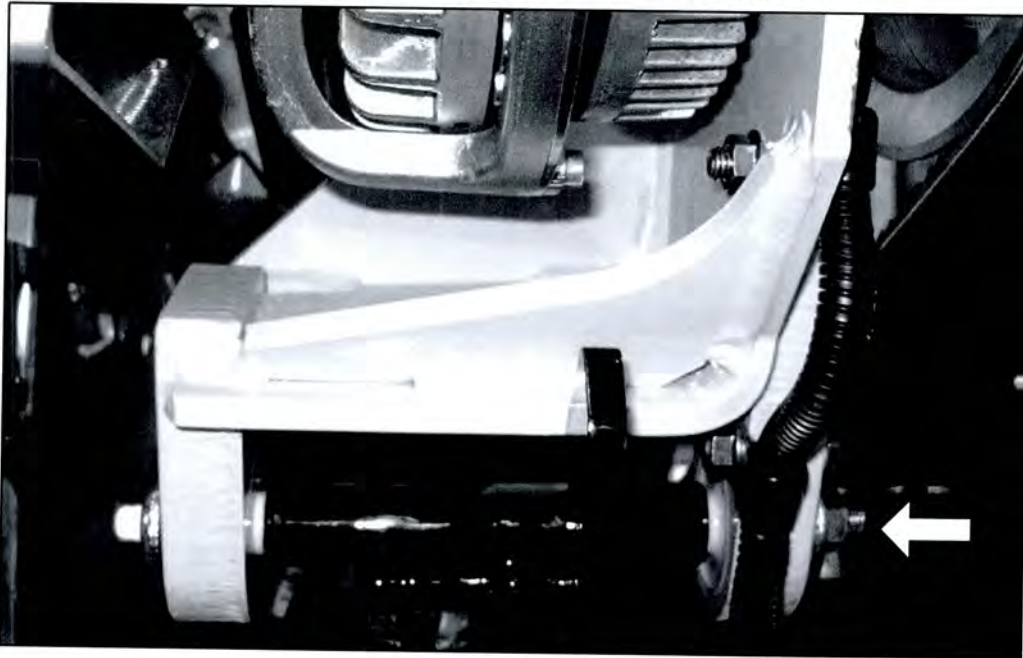
Figure 4.

8. Locate the fan clutch bracket mounting bolt, at the base of the assembly (refer to Figure 4).
9. Remove and discard the fan clutch bracket mounting bolt and mounting hardware.

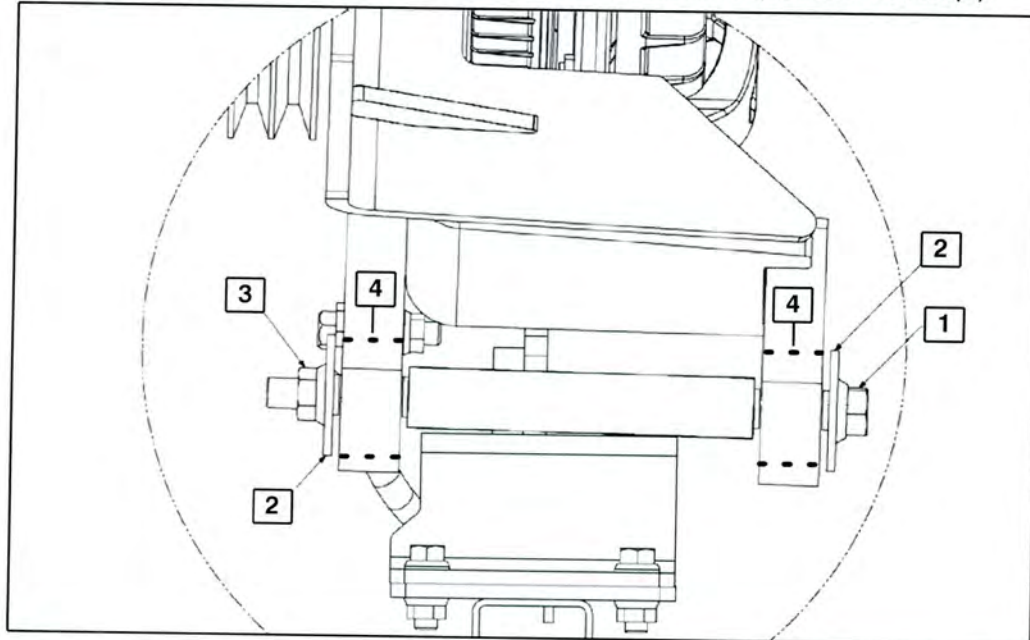
Motor Coach Industries ("MCI") has become aware that the fan clutch bracket bushing on certain E4500 and J4500 coaches may walk out of the bracket, which may allow clutch mis-alignment and belt failure.

The cause is due to the absence of a washer.

If the bushings located at the fan clutch bracket (refer to Item 4 in Figure 5) show visible signs of any damage or lateral displacement, take a digital photo and contact the MCI Fleet Support Technical Center at 1-800-241-2947 for further information.

10. Orient and install new capscrew, p/n 19-01-1518, washers, p/n 19-02-0388, and nut, p/n 19-03-0497 as shown in Figure 5. Tighten nut to secure installation (the nut will be torqued at a later step).

11. Orient and re-install the belt on the fan clutch pulley.
12. Torque the nut, p/n 19-03-0497, to 80–88 ft-lbs.
13. Carefully release the tension from the ratchet strap compressing the shock.
14. Close the engine compartment door.
