Mack Trucks, Inc.
Greensboro, NC USA

Service Program Trucks

Static Fill Coolant Pipe

PI0790, Static Fill Coolant Pipe

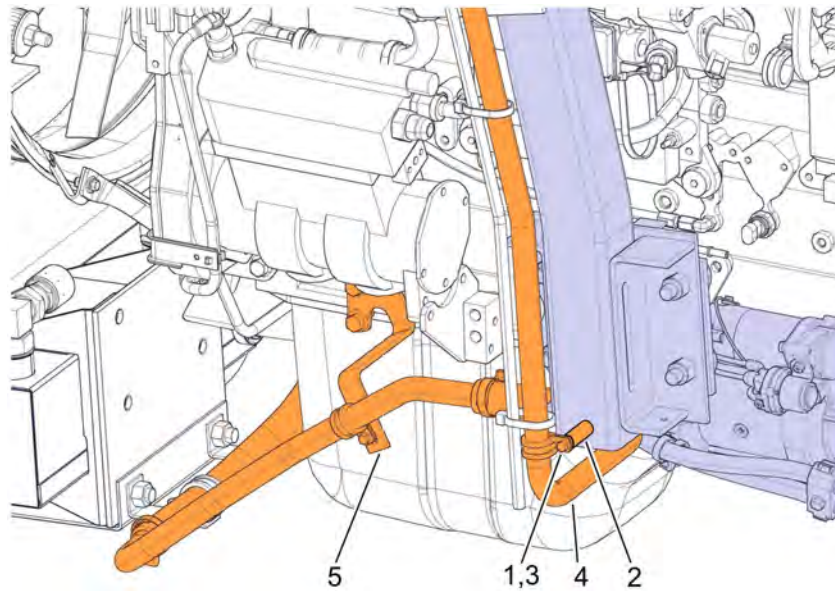
W2073199

The static fill coolant pipe from the expansion tank can make contact with the starter solenoid wire and rub through the wire insulation on some MACK LEU and MRU trucks equipped with a Cummins ISL-G natural gas engine. A spacer (part number 25106640), fastener (part number 995455), and nut (part number 990939) will be used to relocate the static fill pipe away from the starter solenoid wire. Additionally, if any starter solenoid wires are exposed, the starter must be replaced with a new starter (part number 21398109).

Static Fill Coolant Pipe Parts			
Item #	QTY	Part Number	Description
1	1	995455	Fastener, M6 X 50
2	1	25106640	Spacer
3	1	990939	Nut
4	1	N/A	Static Fill Coolant Pipe
5	1	N/A	Stand-Off Bracket

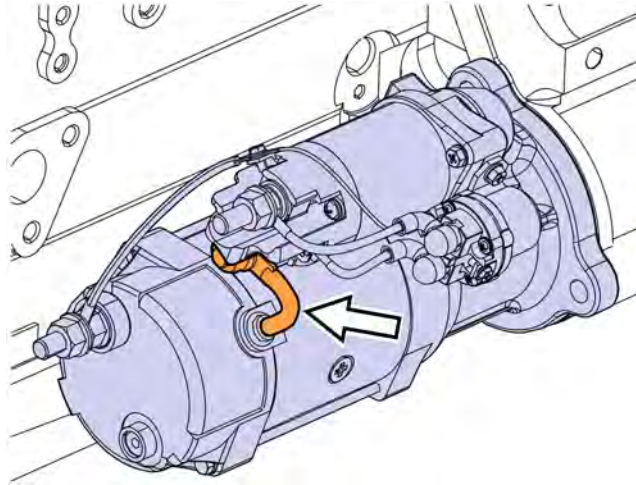
W2073204

- 8 Visually inspect the starter solenoid wire for any exposed wires.

Note: If any wires are exposed, replace the starter (part number 21398109). Place a separate claim for starter replacement toward this service program if replaced.
