# Service Bulletin

Bulletin No.: PI0746A

**Subject:** Malfunction Indicator Lamp (MIL) On, Poor Acceleration, Throttle Body Freezing, Multiple DTCs Set, Ice Deposits and/or Oil Deposits Present in Air Inlet Duct

**Models:** 2008-2011 Buick Enclave  
 2007-2011 Chevrolet Malibu  
 2008-2011 Chevrolet Traverse  
 2007-2011 GMC Acadia  
 2007-2010 Saturn OUTLOOK  
 Equipped with 3.6L Engine (RPOs LY7, LLT)

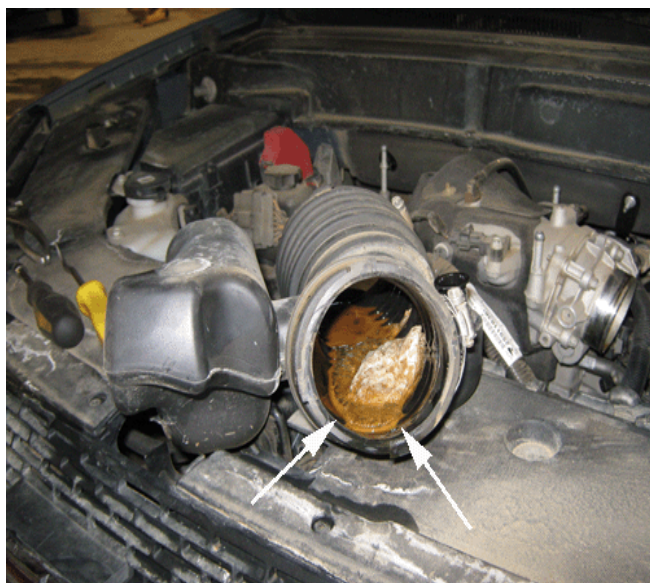
2837688

Technicians may find the presence of DTCs P0101, P0171, P0172, P0174, P0175, P1516, P2177, P2178, P2179, P2180, P2187, P2188, P2189, and/or P2190 along with either ice or oil deposits in the air inlet duct.

Ice formation is caused by condensation freezing at the base of the throttle body with additional collection of ice formation deposits in the air inlet duct. Freezing condensation forms after the vehicle has been driven and then parked in low ambient temperatures.

Oil deposits are the collection of the engine vapors, fuel dilution and oil mist at the base of the throttle body with additional formation collecting in the duct.

1. Remove both camshaft covers for servicing of the PCV system. Refer to Camshaft Cover Replacement Left and Right Side in SI.
2. Clean the PCV orifice with low VOC brake cleaner. Allow to air dry with compressed shop air.
3. Replace the bank1 camshaft cover gasket.
4. Reassemble the bank1 camshaft cover.
