Service Bulletin

Bulletin No.: PI0746B

Date: October, 2012

Subject: Malfunction Indicator Lamp (MIL) On, Poor Acceleration, Throttle Body Freezing, Multiple DTCs Set, Ice Deposits and/or Oil Deposits Present in Air Inlet Duct

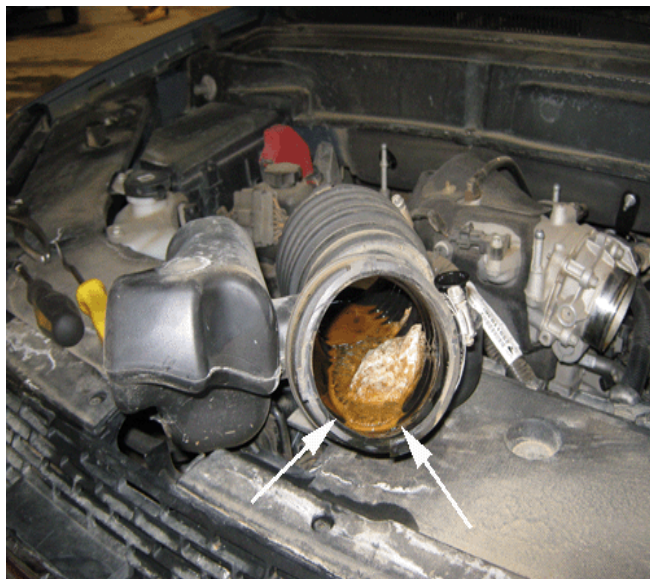
2837688

Technicians may find the presence of DTCs P0101, P0171, P0172, P0174, P0175, P1516, P2177, P2178, P2179, P2180, P2187, P2188, P2189, and/or P2190 along with either ice or oil deposits in the air inlet duct.

Ice formation is caused by condensation freezing at the base of the throttle body with additional collection of ice formation deposits in the air inlet duct. Freezing condensation forms after the vehicle has been driven and then parked in low ambient temperatures.

Oil deposits are the collection of the engine vapors, fuel dilution and oil mist at the base of the throttle body with additional formation collecting in the duct.
