# Service Bulletin

Bulletin No.: PI0746D

**Subject:** Malfunction Indicator Lamp (MIL) On, Poor Acceleration, Throttle Body Freezing, Multiple DTCs Set, Ice Deposits and/or Oil Deposits Present in Air Inlet Duct

**Models:** 2008-2011 Buick Enclave  
 2007-2011 Chevrolet Malibu  
 2009-2011 Chevrolet Traverse  
 2007-2011 GMC Acadia  
 2007-2010 Pontiac G6  
 2007-2009 Saturn AURA  
 2007-2010 Saturn OUTLOOK  
 Equipped with 3.6L Engine (RPOs LY7, LLT)

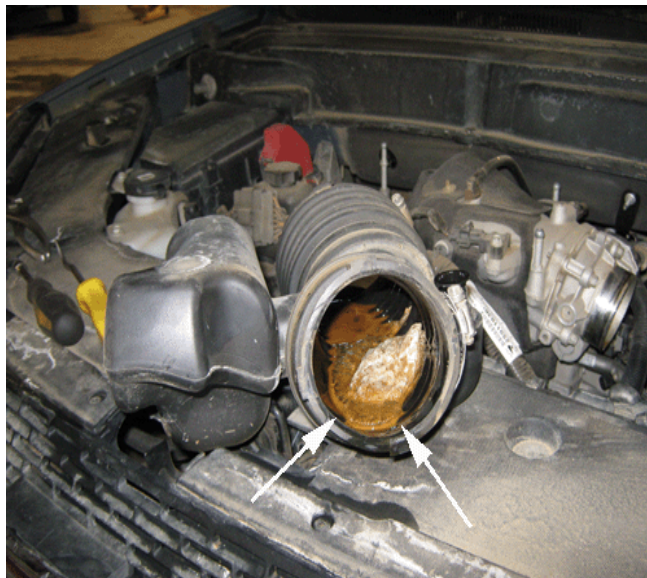
2837688

Technicians may find DTCs P0101, P0171, P0172, P0174, P0175, P1516, P2177, P2178, P2179, P2180, P2187, P2188, P2189 and/or P2190 along with either ice or oil deposits in the air inlet duct.

Ice formation is caused by condensation freezing at the base of the throttle body with additional collection of ice formation deposits in the air inlet duct. Freezing condensation forms after the vehicle has been driven and then parked in low ambient temperatures.

Oil deposits are the collection of the engine vapors, fuel dilution and oil mist at the base of the throttle body with additional formation collecting in the duct.

1. Remove both camshaft covers for servicing of the PCV system. Refer to Camshaft Cover Replacement Left and Right Side in SI.
2. Clean the PCV orifice with low VOC brake cleaner. Allow to air dry with compressed shop air.
3. Replace the bank1 camshaft cover gasket.
4. Reassemble the bank1 camshaft cover.
