Service Bulletin

PRELIMINARY INFORMATION

Subject: Malfunction Indicator Lamp (MIL) On, Poor Acceleration, Throttle Body Freezing, Multiple DTCs Set, Ice Deposits and/or Oil Deposits Present in Air Inlet Duct

Models: 2008-2011 Buick Enclave
 2007-2011 Chevrolet Malibu
 2009-2011 Chevrolet Traverse
 2007-2011 GMC Acadia
 2007-2010 Pontiac G6
 2007-2009 Saturn AURA
 2007-2010 Saturn OUTLOOK
 2008-2010 Saturn VUE
 Equipped with 3.6L Engine (RPOs LY7, LLT)

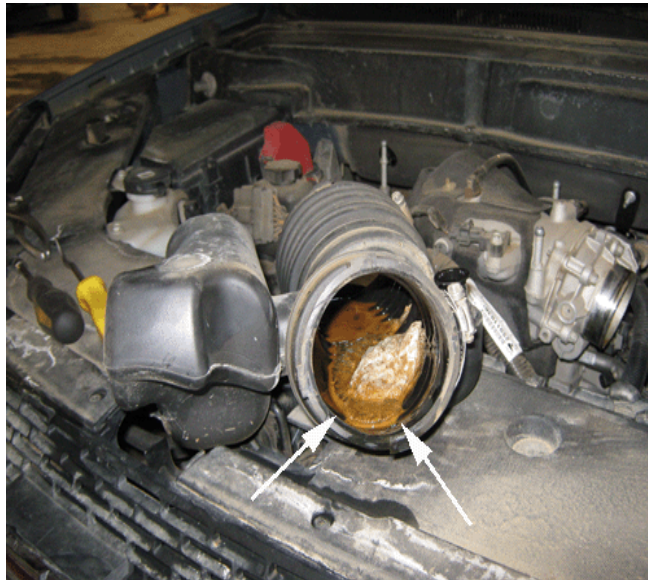
2837688

Technicians may find DTCs P0101, P0171, P0172, P0174, P0175, P1516, P2177, P2178, P2179, P2180, P2187, P2188, P2189 and/or P2190 along with either ice or oil deposits in the air inlet duct.

Ice formation is caused by condensation freezing at the base of the throttle body with additional collection of ice formation deposits in the air inlet duct. Freezing condensation forms after the vehicle has been driven and then parked in low ambient temperatures.

Oil deposits are the collection of the engine vapors, fuel dilution and oil mist at the base of the throttle body with additional formation collecting in the duct.
