Liftgate reverses direction at the bottom when closing

Topic number	LI72.20-P-053761
Version	1
Design group	72.20 Rear door, tailgate
Date	06-07-2012
Validity	MODEL 251 from VIN end number A123392 to A145873
Reason for change	Validity adapted
Reason for block

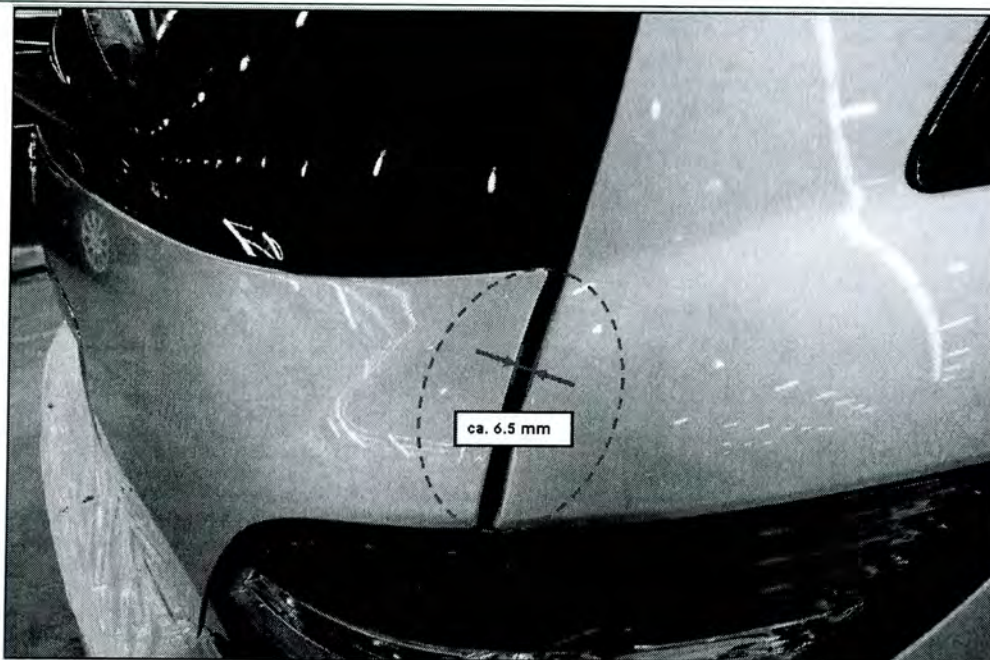
Bild 1.jpg:

The automatic liftgate reverses direction at the lower end position when being closed.

During the closing sequence the liftgate collides with the obstruction sensor strip, which triggers the anti-pinch protection function.

The gap between the liftgate and the side wall should measure approx. 6.5 mm (see Figure 1).

Adjust the liftgate by adjusting the striker.

It must be ensured that when the liftgate is closed there is a gap between the liftgate and the obstruction sensor strip along its entire length. This can be verified if it is possible to slide a piece of paper along the gap with no resistance.
