Engine VGT Actuator and TSS Sensor Connector Relocation

VN, VHD, VAH
D13

SP 255-024, Engine VGT Actuator and TSS Sensor Connector Relocation

(June 2012)

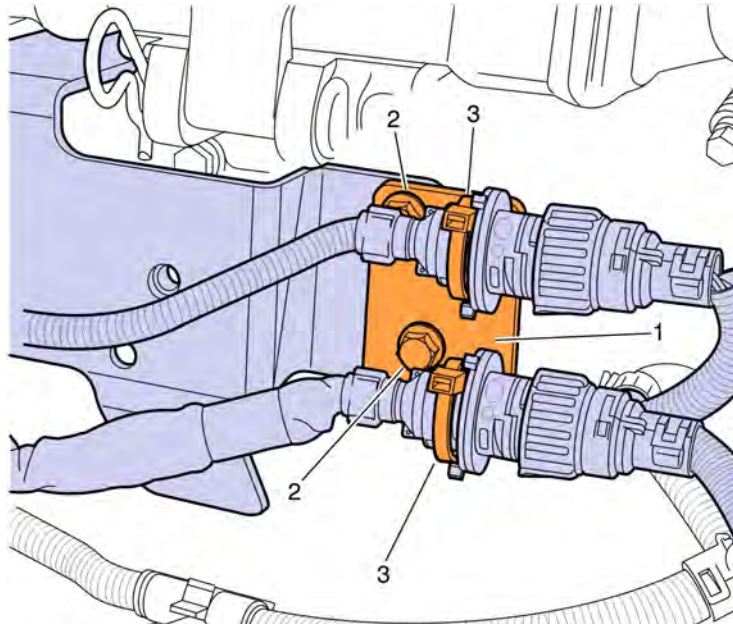
W2072321

A new campaign is available to prevent engine diagnostic trouble codes (DTCs) and missing signal from the Engine Variable Geometry Turbocharger Actuator (Engine VGT Actuator) on VOLVO D13 US2010 engines with an Allison transmission. This condition is caused by fretting of the connector pins in the engine VGT actuator connector. Relocation of the engine VGT actuator connector and a new mounting arrangement has been developed to eliminate this condition. See the table below for the list of parts required for this campaign.

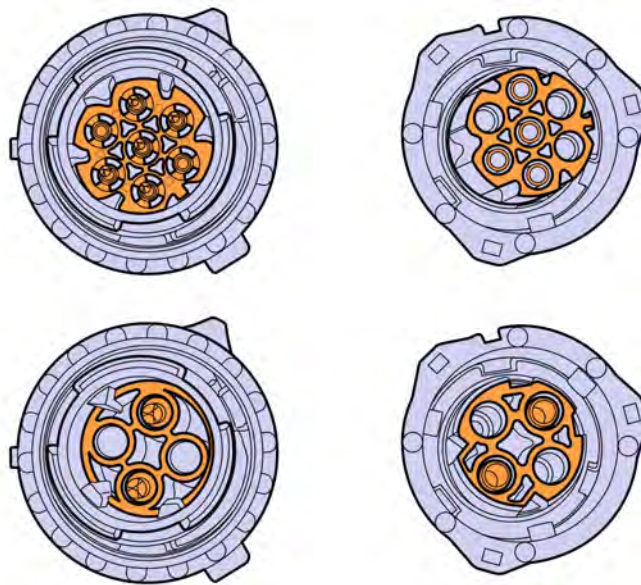
W2072325

- 7 Inspect connectors for green/brown dust on the pins or sockets.

Note: If green/brown dust is present in the areas highlighted in the figure below, clean the male and female engine VGT actuator and TSS sensor connectors with approved electrical solvent. Allow the connectors to thoroughly dry before assembly.
