Product Update: Roof Molding Is Loose

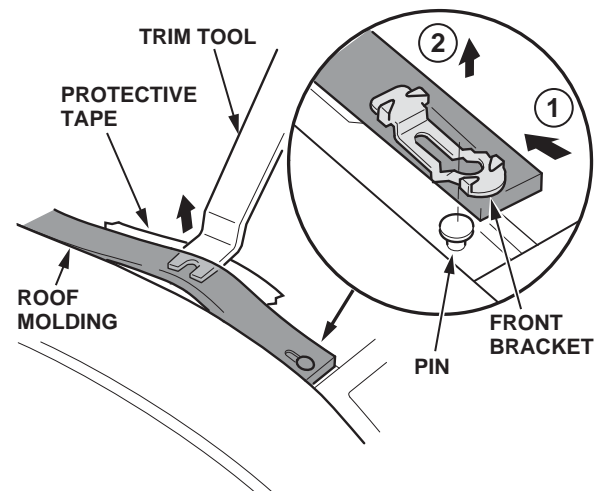
1. Apply protective tape to the body.
1. Using the appropriate trim tool, slide the roof molding rearward to release the front bracket from the pin and pull up on the front portion of the molding.

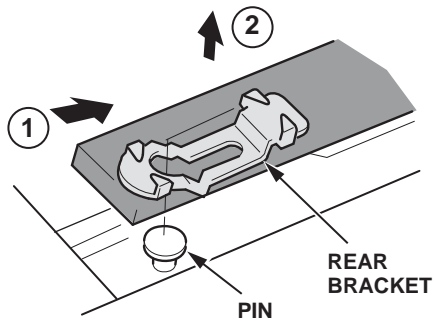
- At the rear of the molding, pull up and release the rear bracket from the pin.

- Inspect the rear bracket.
 - If the bracket comes off the roof molding or the molding is damaged, remove the molding and go to step 6 to install a new roof molding.
 - If the bracket is OK, go to step 6.
- Clean the roof molding and the front and rear pins on the body using a shop towel dampened in water.
