ITB12-053a

VOLUNTARY SERVICE CAMPAIGN 2013 JX35 METER BACK LIGHT ILLUMINATION AND DISTANCE TO EMPTY INACCURACY

CAMPAIGN ID #: P2538**APPLIED VEHICLE:** 2013 JX35 (L50)

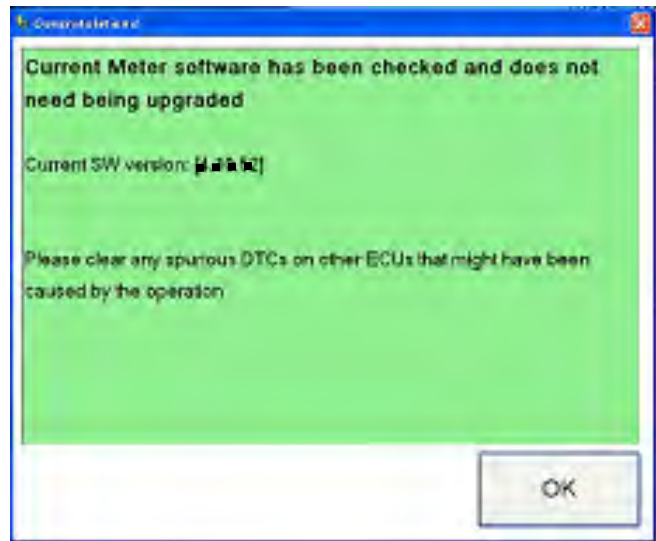
NOTE: If the screen in Figure 4 displays, reprogramming is not needed for this vehicle or it has already been done:

- a. Select OK.
- b. Close the reprogramming tool/software.
- c. Skip to step 16.

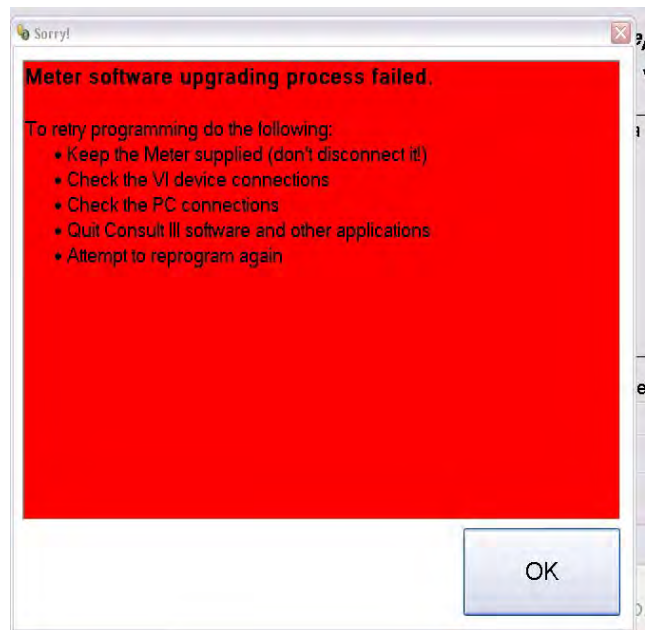
NOTE: If the screen in Figure 5 displays the reprogramming has failed.

- a. Select OK and close the reprogramming tool/software.
- b. Restart the Service Procedure from the beginning. Make sure all steps are completed correctly.
