ITB12-053b

January 23, 2013

VOLUNTARY SERVICE CAMPAIGN 2013 JX35 METER BACK LIGHT ILLUMINATION AND DISTANCE TO EMPTY INACCURACY

CAMPAIGN ID #: P2538**APPLIED VEHICLE:** 2013 JX35 (L50)

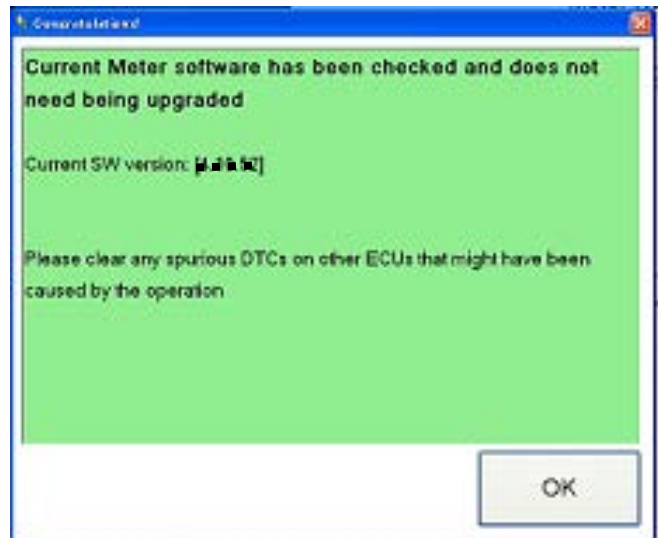
NOTE: If the screen in Figure 4 displays, reprogramming is not needed for this vehicle or it has already been done:

- a. Select OK.
- b. Close the reprogramming tool/software.
- c. Skip to step 16.

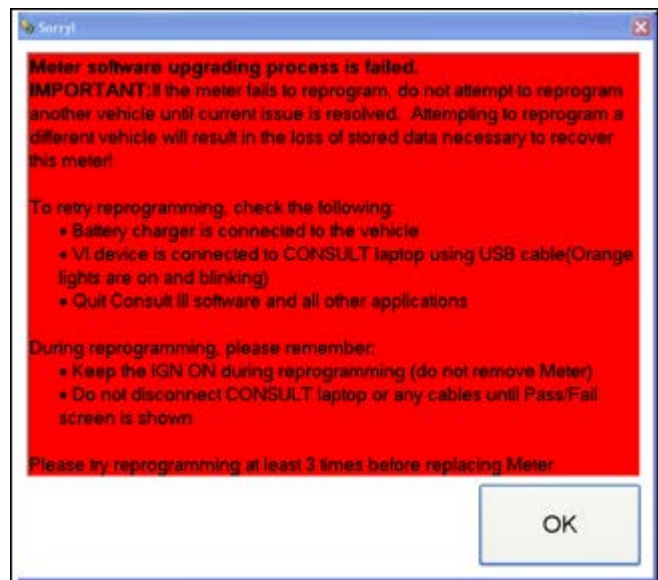
NOTE: If the screen in Figure 5 displays:

IMPORTANT: If you get the screen in Figure 5 above:

Try reprogramming at least 3 more times.

- a. Select OK and close the reprogramming tool/software.
- b. Restart this Service Procedure from the beginning.
 - **Make sure all steps are completed correctly.**
 - CONSULT software and all other applications are closed.
 - Plus VI is securely connected to the vehicle and USB cable is connected.
 - Battery charger is connected to the vehicle.

- Make sure to complete all reprogramming attempts on the current vehicle before moving to another vehicle.
- Using the reprogramming tool on another vehicle will erase all data for the current vehicle, and the meter for the current vehicle will not be reprogrammable (recoverable).
