Service Bulletin

Subject: AIR BAG SYSTEM WARNING LIGHT ON WITH DTC B1933 OR B2233	Bulletin No: 08-003/12
	Last Issued: 08/24/2012

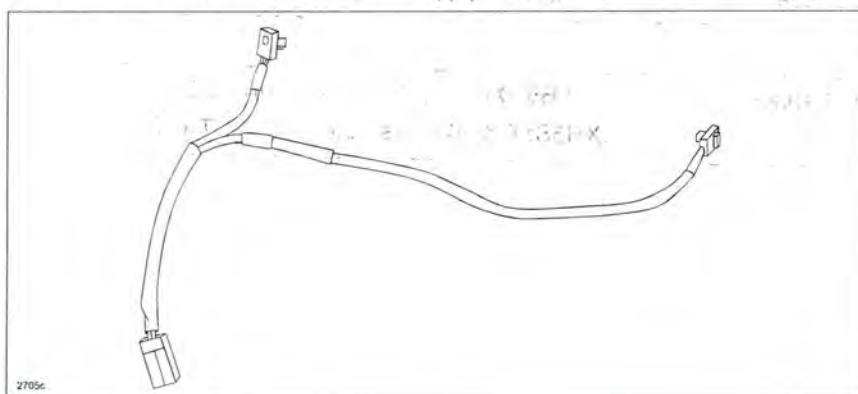
This is caused by poor contact at the terminals of the short harness that exists between the passenger-side air bag module and the SAS control module. To correct the problem, the terminals installation procedure has been changed.

1. Verify customer concern.
2. Disconnect the negative battery cable and wait for at least 1 minute.
3. Remove the glove box.
4. Replace the short harness of the passenger-side air bag with a modified one.
