# SERVICE CAMPAIGN BULLETIN

NTB12-081

## VOLUNTARY SERVICE CAMPAIGN 2013 ALTIMA TCM REPROGRAM

**CAMPAIGN ID #:** PC186**APPLIED VEHICLES:** 2013 Altima (L33) with QR25 engine only**Check Service COMM to confirm campaign eligibility.**

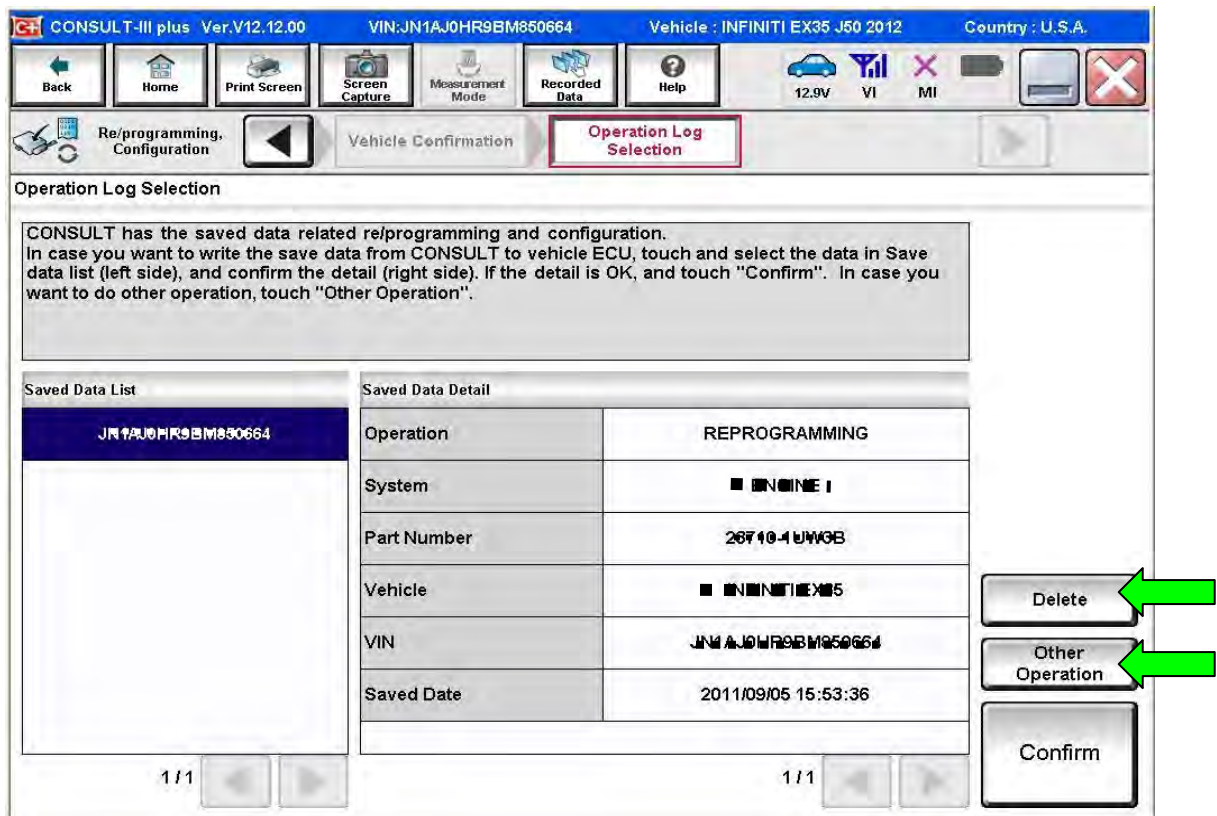
Figure 1A

During the initial “Reprogramming Confirmation” set-up, if you get this screen (Figure 1A):

1. Select **Delete**, then
2. Select **Other Operation**, then
3. Continue with the reprogramming procedure.

**NOTE:** If reprogramming does not complete, this screen can display for reprogramming recovery. Do not select Delete if this screen displays during reprogram recovery.

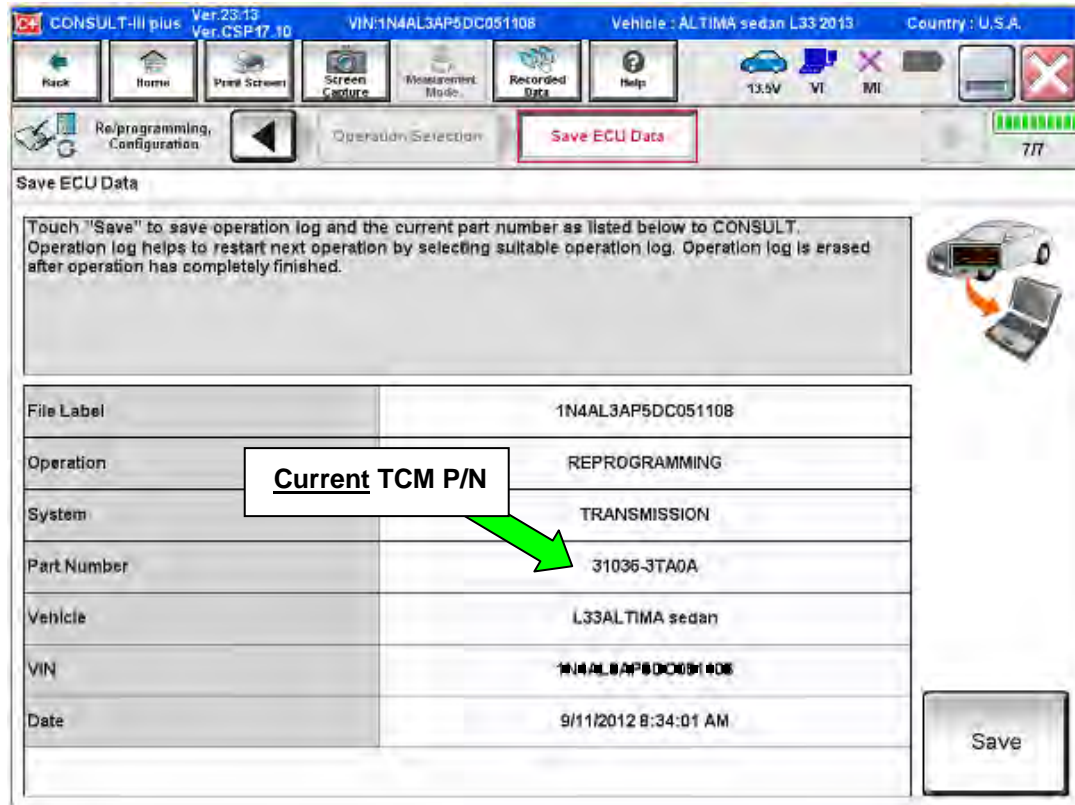
Figure 2

6. When you get to the screen shown in Figure 2, confirm this bulletin applies as follows:

A. Find the TCM **Part Number** and write it on the repair order.

B. Compare the P/N you wrote down to the numbers in the **Current TCM Part Number** column in **Table A** below.

- If there is a match, this bulletin applies. Continue with the reprogramming procedure.
- If there is not a match, this campaign does not apply, or it has already been done. Check Service COMM to confirm campaign eligibility.

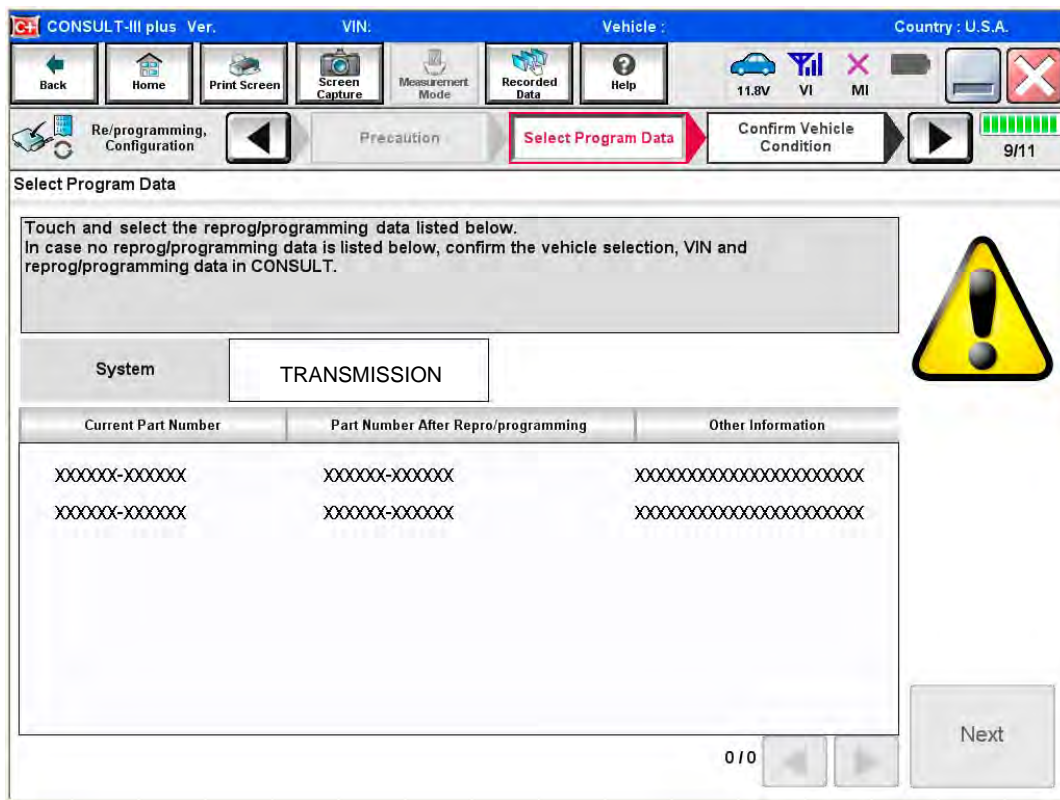
- In some cases, more than one new P/N for reprogramming is available.
  - In this case, the screen in Figure 3 displays.
  - Select and use the reprogramming option that **does not** have the message “Caution! Use ONLY with NTBXX-XXX”.
- If you get this screen and it is blank (no reprogramming listed), it means there is no reprogramming available for this vehicle.

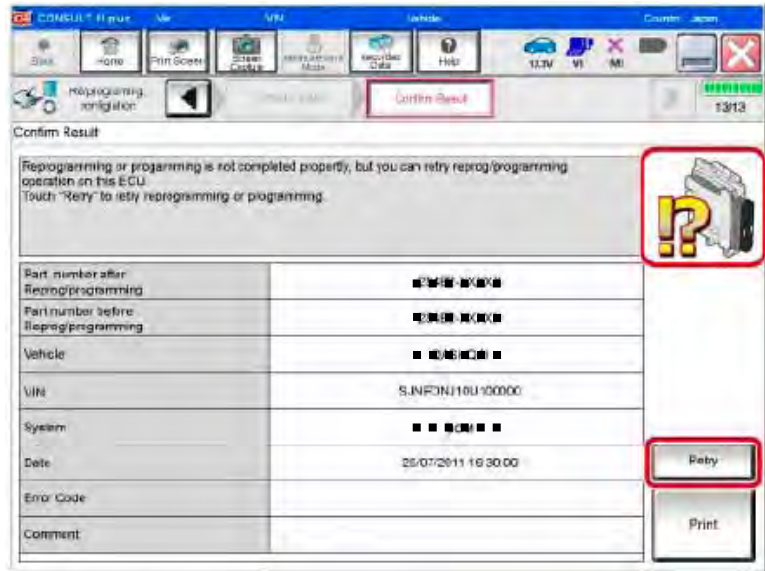
Figure 5

If reprogramming does not complete and the “!?” icon displays as shown in Figure 5:

- Check battery voltage (12.0–15.5 V).
- Ignition is ON, engine OFF.
- External Bluetooth® devices are OFF.
- All electrical loads are OFF.
- **Select retry and follow the on screen instructions.**
- “Retry” may not go through on first attempt and can be selected more than once.

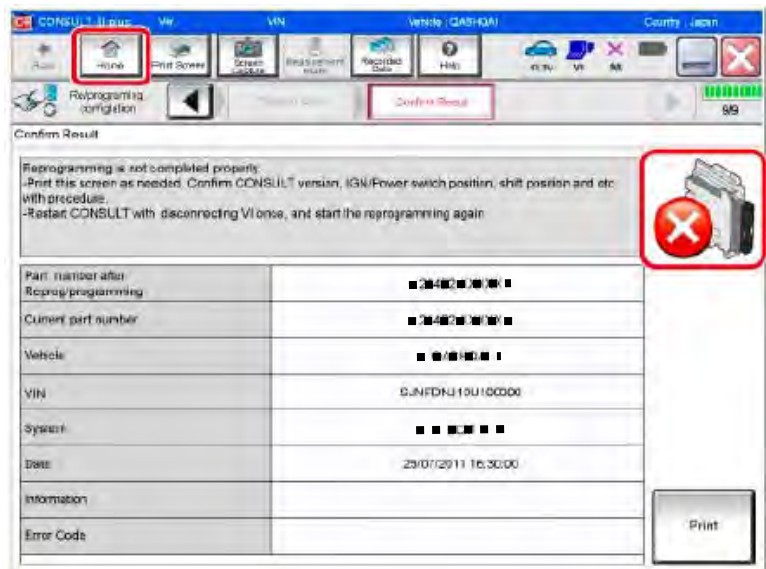
Figure 6

If reprogramming does not complete and the “X” icon displays as shown in Figure 6:

- Check battery voltage (12.0 – 15.5 V).
- CONSULT A/C adapter is plugged in.
- Ignition is ON, engine OFF.
- Transmission is in Park.
- All C-III plus / VI cables are securely connected.
- All C-III plus updates are installed.
- **Select Home, and restart the reprogram procedure from the beginning.**

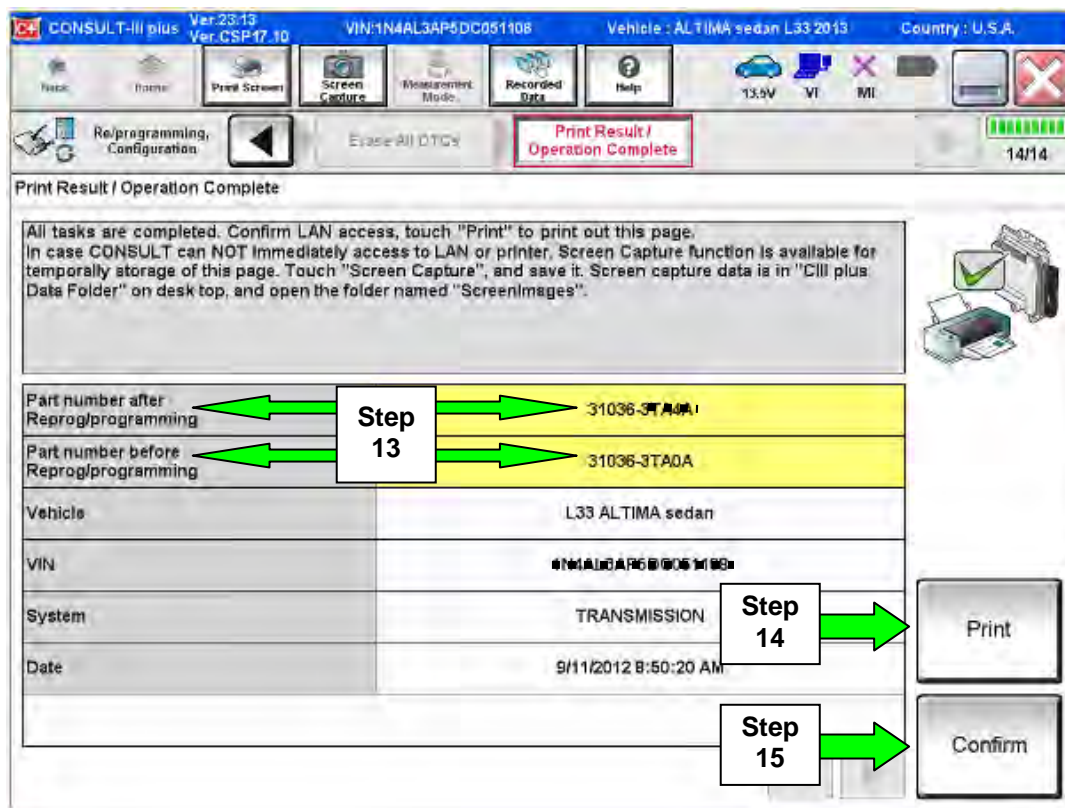
12. When the entire reprogramming process is complete, the screen in Figure 7 will display.

13. Verify the before and after part numbers are different.

14. Print a copy of this screen (Figure 7) and attach it to the repair order for warranty documentation.
