Service Bulletin

PRELIMINARY INFORMATION

Subject: Various Concerns Related To The IP Backlighting Cruise Control Steering Wheel Controls Horn

Models: 2007-2013 Cadillac Escalade Models
2007-2013 Chevrolet Avalanche, Silverado, Suburban, Tahoe
2007-2013 GMC Sierra, Yukon Models

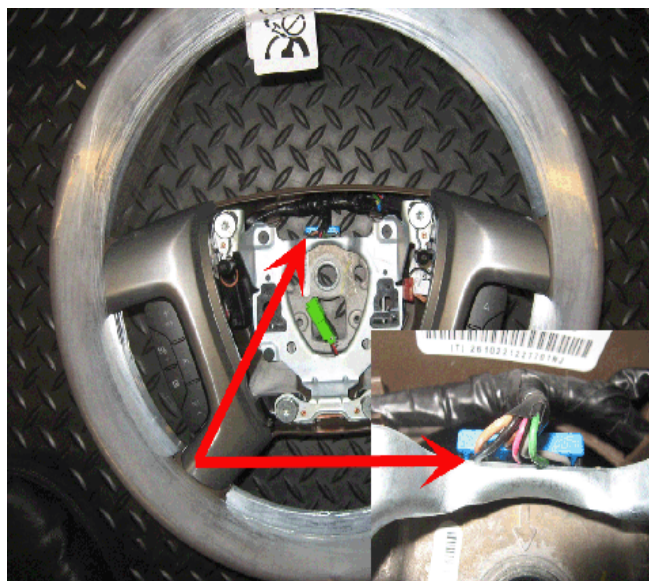
2917745

Inspect for a short to ground on the steering wheel near the SIR coil connector X2, see picture below. Depending on which circuit is shorted, this will cause any of the various symptoms mentioned above.

Make necessary repairs to any shorted circuits and then position the wiring so it will no longer make contact with the steering wheel.
