Campaign No. 2012070002, September 2012

SUBJECT: **Models 164, 171, 203, 204, 207, 209, 211, 212, 216, 219, 221, 230, 251, 463**
Engines 272 and 273
Model Years 2005 - 2011
Retrofit Adapter Wiring Harness on Camshaft Adjustment Solenoids

Order No. S-SC-2012070002

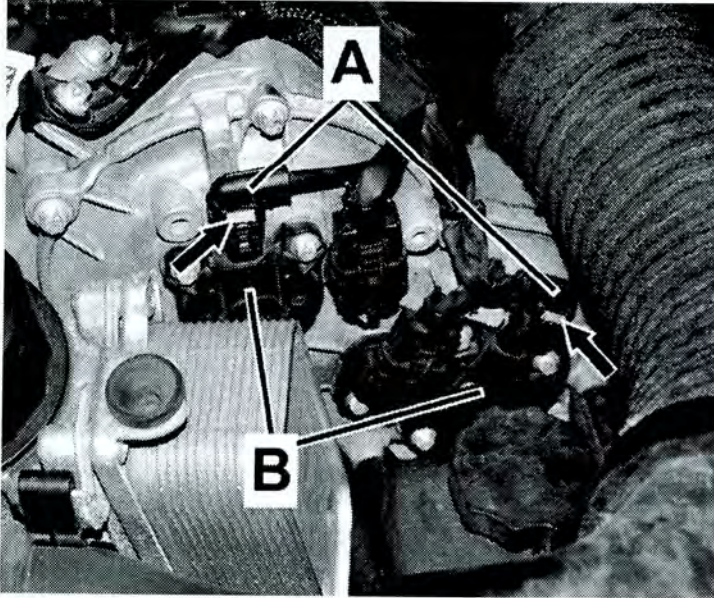
Figure 1

This Service Campaign has been initiated because Daimler AG (DAG), the manufacturer of Mercedes-Benz vehicles, has determined that due to the settling properties of the seal, oil may leak from the camshaft adjustment solenoid. Dealers will retrofit four adapter harnesses onto the engine wiring harness as a precautionary measure at the next workshop visit

1. Remove top engine cover to get access to camshaft adjustment solenoids as required.
2. Disconnect camshaft adjustment solenoids from engine harness connectors (A, Figures 1 and 2):
 - Carefully unlock engine harness connectors (A) by squeezing and **partially** pulling out locking tabs (arrows) using pocket screw driver.
 - Disconnect camshaft adjustment solenoid connectors (A) from camshaft solenoids (B).

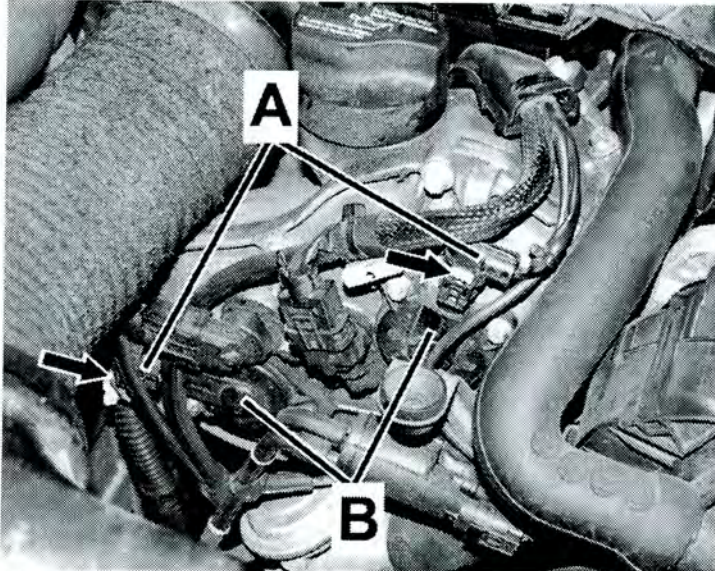
Figure 2

Note: Shown on engine 272

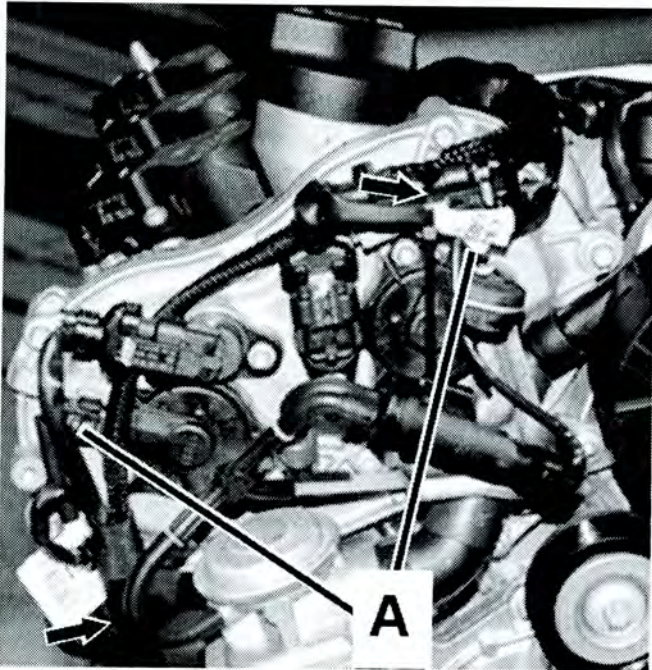
Figure 3

Ensure harness adapters are properly secured using cable ties (arrows, Figures 3 and 4) to prevent wire chafing and/or damage from hot engine parts, (e.g. oil cooler [B]).

3. Connect adapter harnesses (A, Figures 3 and 4):
 - Connect adapter harnesses (A) between connector on camshaft adjustment solenoid and engine harness.
 - Push locking tabs (arrows, Figures 1 and 2) into connectors to secure (total of 8 locking tabs).
4. Secure adapter harnesses with cable ties.
