SB-10048279-9800
Service Campaign Bulletin

Campaign No. 2012070002, September 2012

SUBJECT: **Models 164, 171, 203, 204, 207, 209, 211, 212, 216, 219, 221, 230, 251, 463**
Engines 272 and 273
Model Years 2005 - 2011
Retrofit Adapter Wiring Harness on Camshaft Adjustment Solenoids

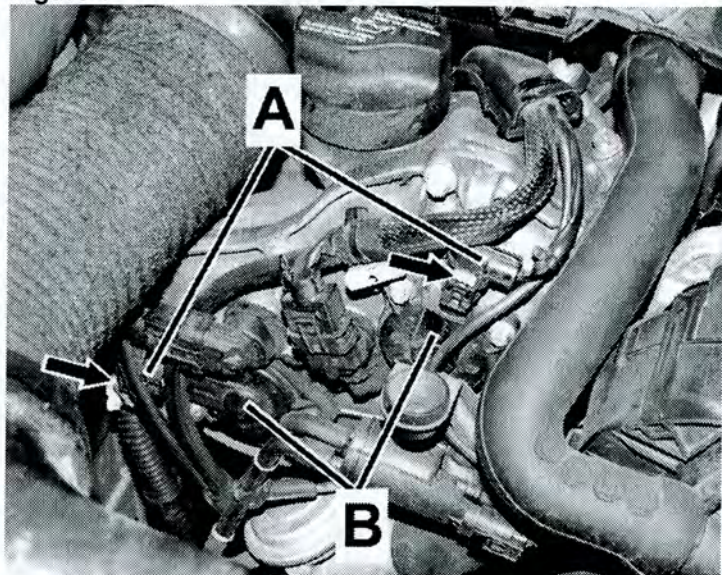
Figure 2

Note: Shown on engine 272

1. Remove top engine cover to get access to camshaft adjustment solenoids as required.
2. Disconnect camshaft adjustment solenoids from engine harness connectors (A, Figures 1 and 2):
 - Carefully unlock engine harness connectors (A) by squeezing and **partially** pulling out locking tabs (arrows) using pocket screw driver.
 - Disconnect camshaft adjustment solenoid connectors (A) from camshaft solenoids (B).

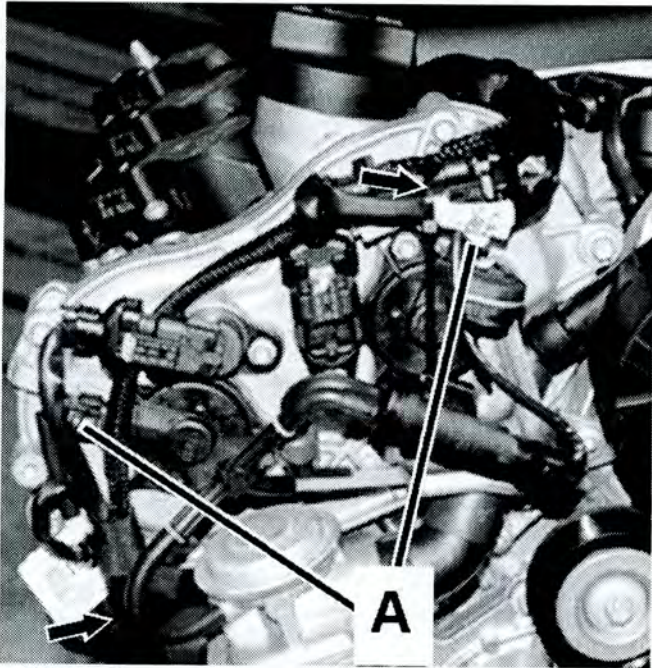
Figure 3

Ensure harness adapters are properly secured using cable ties (arrows, Figures 3 and 4) to prevent wire chafing and/or damage from hot engine parts, (e.g. oil cooler [B]).

3. Connect adapter harnesses (A, Figures 3 and 4):
 - Connect adapter harnesses (A) between connector on camshaft adjustment solenoid and engine harness.
 - Push locking tabs (arrows, Figures 1 and 2) into connectors to secure (total of 8 locking tabs).
4. Secure adapter harnesses with cable ties.
