**SERVICE BULLETIN**

**APPLICABILITY:** 2013MY Legacy and Outback Models Equipped With 2.5L FB Engine      **NUMBER:** 11-122-12  
**DATE:** 11/02/12

**SUBJECT:** Difficulty Starting, Rough Idle, Cam Position or Misfire DTCs  
 DTCs P0340, 341, 345 or 346, P0301, 302, 303 or 304

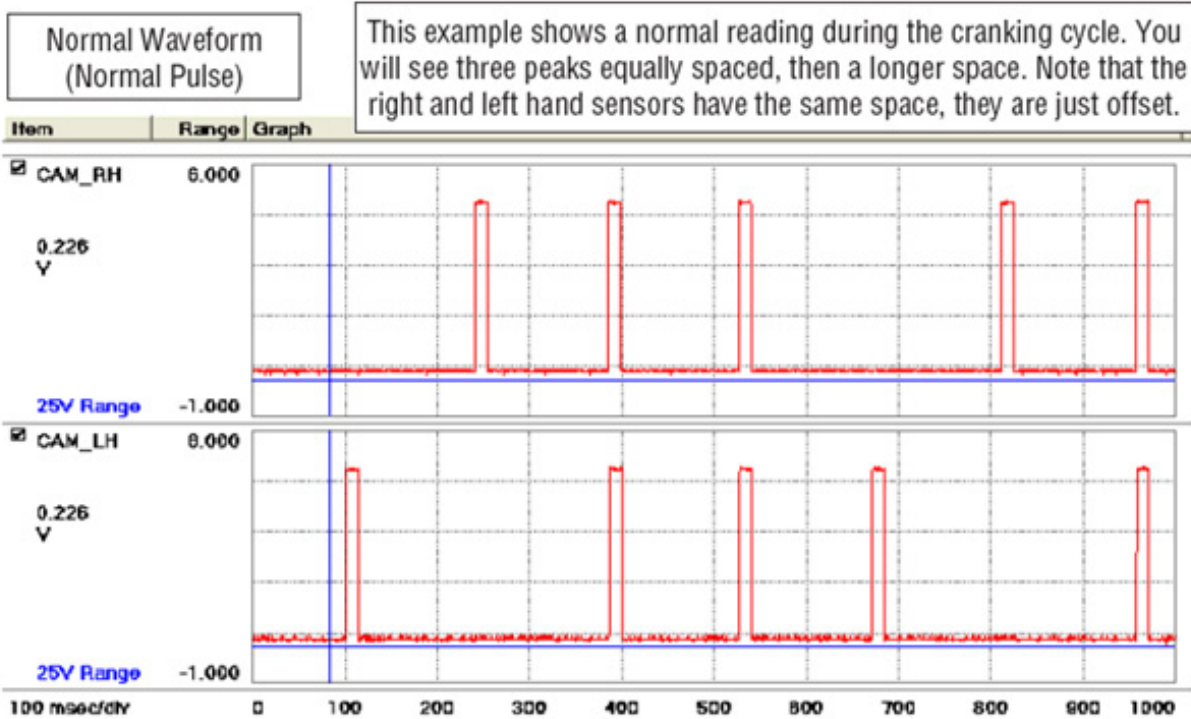
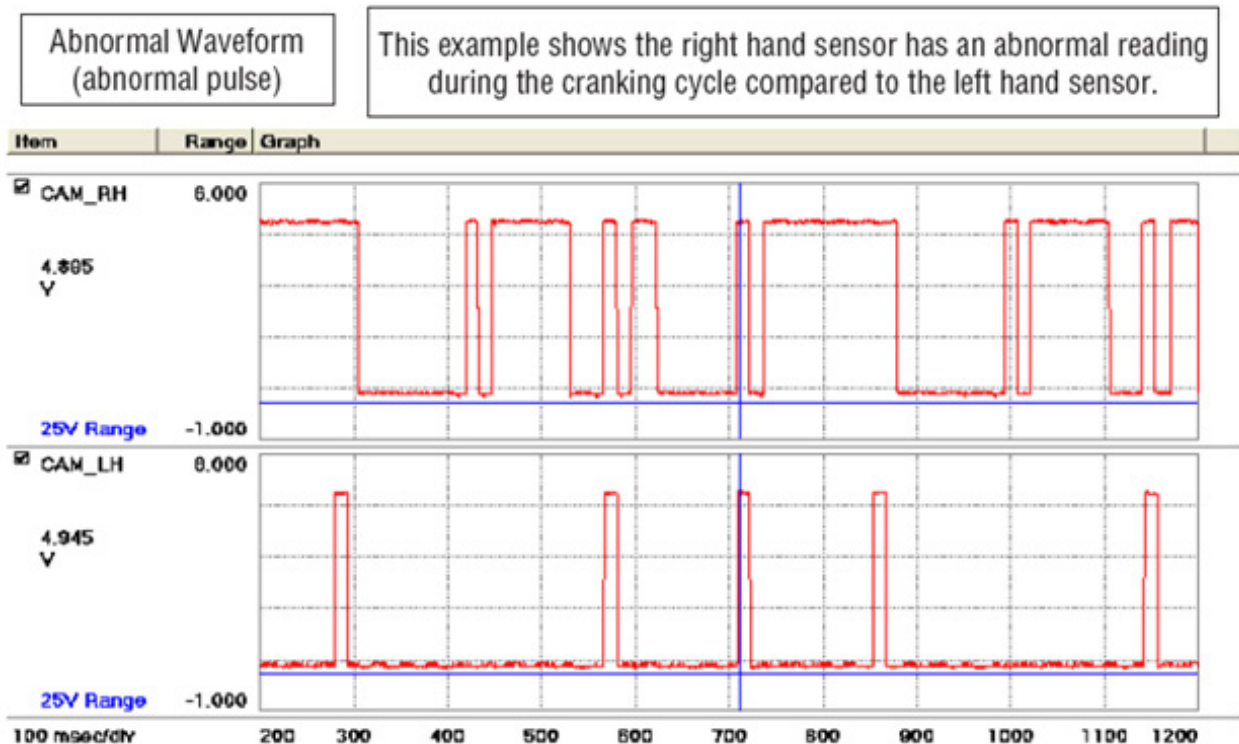
The following illustrations show a normal oscilloscope pattern followed by an abnormal pattern.

If an abnormal pattern is verified similar to those shown in the illustration above, measure the clearance between the end of the camshaft position sensor and the sensor plate using the following procedure. If the oscilloscope pattern is normal, refer to the applicable Service Manual for additional troubleshooting and diagnostic procedures.

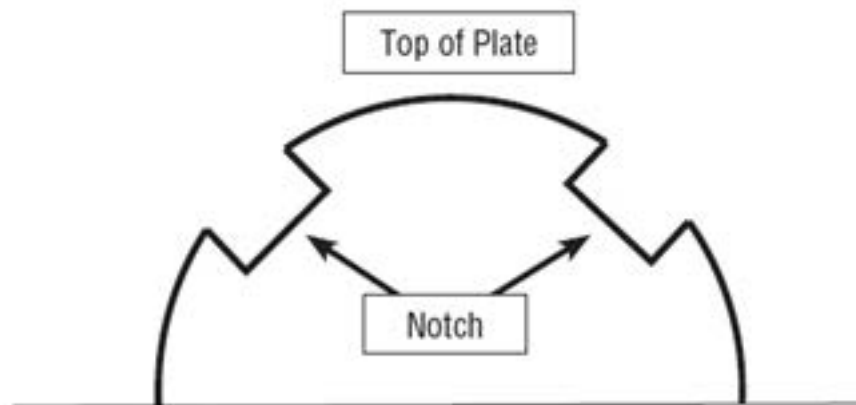
**NOTE:** When measuring “A”, make sure you are measuring to the outside diameter or “top” of the sensor plate and not to the bottom of a notch as shown below. Be sure to record all measurements.

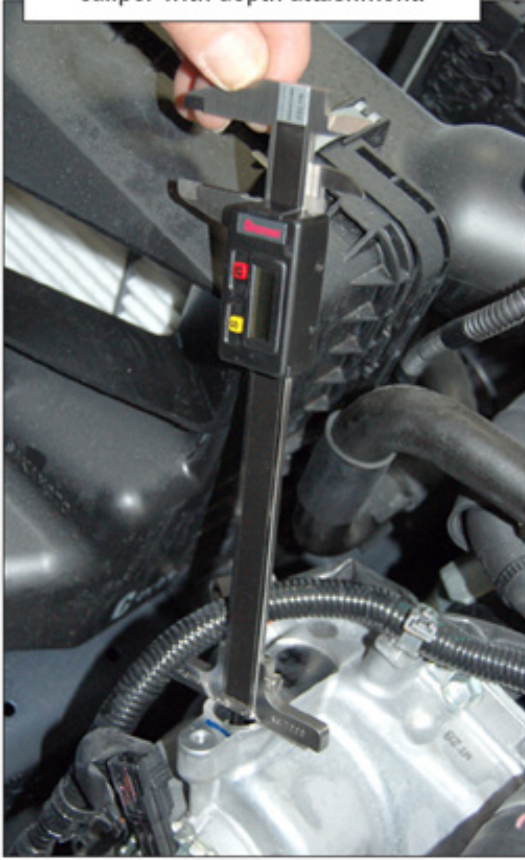
Measurement taken using digital caliper with depth attachment.

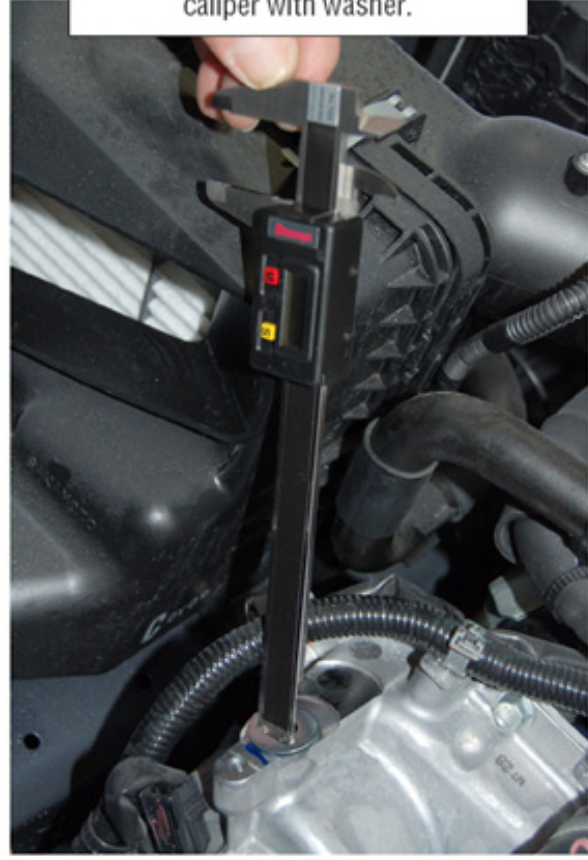
Measurement taken using digital caliper with washer.

**IMPORTANT:** When using the flat washer, make sure the washer is fully seated on the machined surface of the timing cover or your measurements will not be accurate.
