S-SB-0025-12

October 15, 2012

Intermittent MIL "ON" DTC P0335

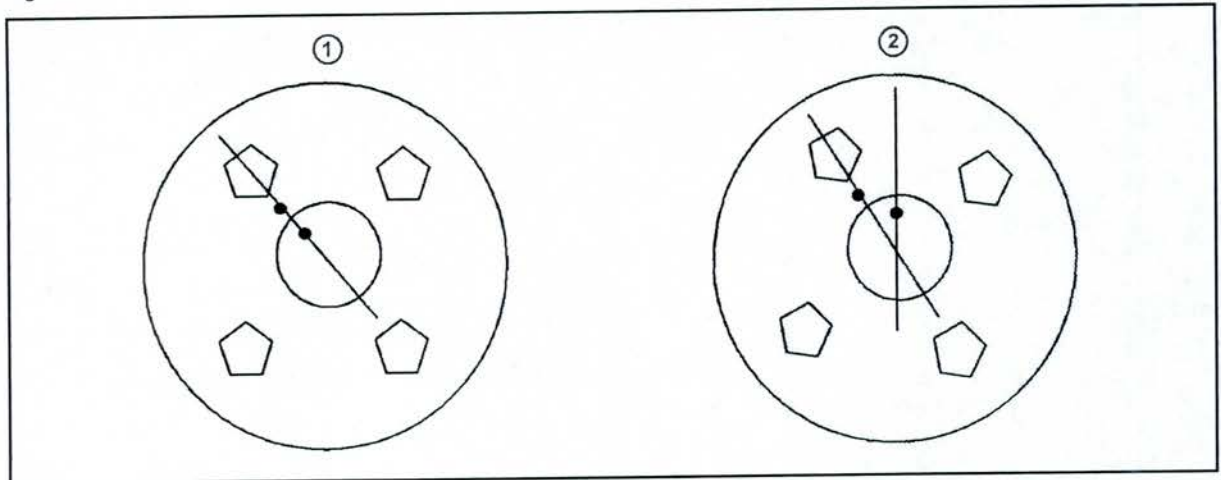
Figure 1.

3. Identify whether the camshaft timing gear is unlocked or locked. (See Figure 1).

1	Dots Aligned – Locked (Must Unlock Before Installing)	2	Dots Misaligned – Unlocked (OK to Install and Tighten Camshaft Bolt)
---	--	---	---

- If the camshaft timing gear is unlocked, it is ready to install.
- If it is LOCKED, follow the steps below to unlock the camshaft timing gear **before** installing.

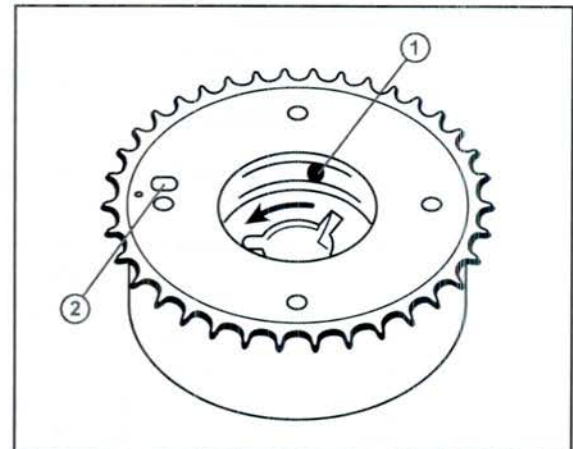
Figure 2.

1	Oil Feed Hole
2	Oval Slot

- A. To disengage the camshaft timing gear lock pin, apply and hold approximately 21 psi of air pressure at the oil feed hole located 90 degrees clockwise of the oval slot. (See Figure 2.)

The lock pin is inside the gear, NOT the one located in the oval slot.

- B. With the 21 psi of air still applied to the gear, turn the interior assembly counterclockwise. (See black arrow in Figure 2.)
- C. Install the timing gear assembly onto the camshaft with the straight pin slightly to the right of the key groove as shown in Figure 3.

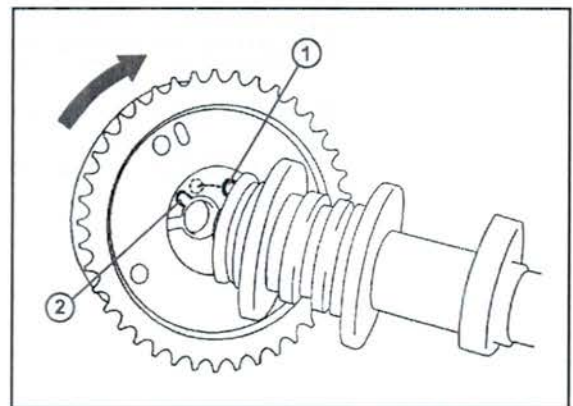
Figure 3.

1	Straight Pin
2	Key Groove

- D. Turn the camshaft timing gear assembly while pushing it lightly against the camshaft until the straight pin engages the key slot.

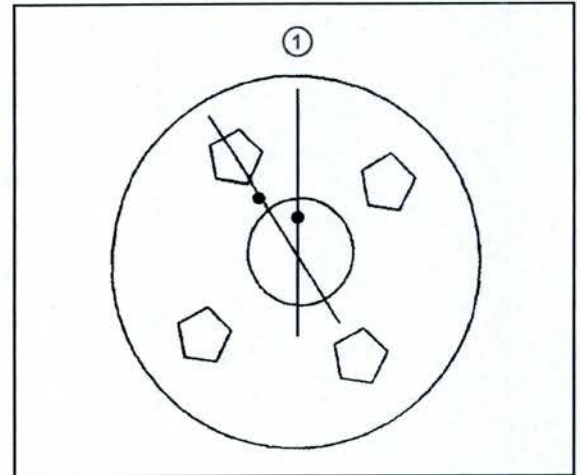
Figure 4.

1	Dots Misaligned – Unlocked (OK to Install and Tighten Camshaft Bolt)
---	---

- E. Check that the camshaft timing gear is fully seated on the camshaft and that there is no clearance between the end of the camshaft and the timing gear. Install the camshaft bolt finger tight.

Check to make sure that the camshaft timing gear is still unlocked **BEFORE** tightening the camshaft bolt. The lock pin **MUST** be unlocked to prevent damage to the camshaft timing gear lock pin during tightening.

- F. While holding the camshaft with a wrench, torque the camshaft bolt.

Torque: 54 N*m (551 kgf*cm, 40 ft*lbf)

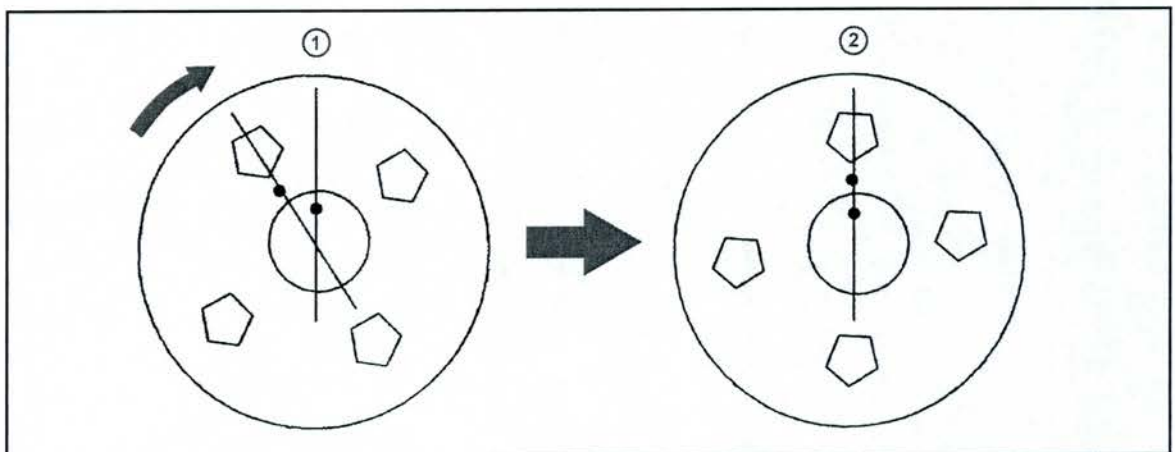
Figure 5.

1	Dots Misaligned – Unlocked
---	----------------------------

2	Dots Aligned – Locked
---	-----------------------

- G. After torquing the camshaft bolt, rotate the camshaft timing gear clockwise while holding the camshaft stationary until the dots are aligned, to engage the camshaft timing gear lock pin.
