Inside door handle inoperative

Topic number	LI72.10-P-055044
Version	1
Design group	72.10 Front door
Date	11-13-2012
Validity	Model series 207 up to VIN end no. F 174 511
Reason for change	
Reason for block

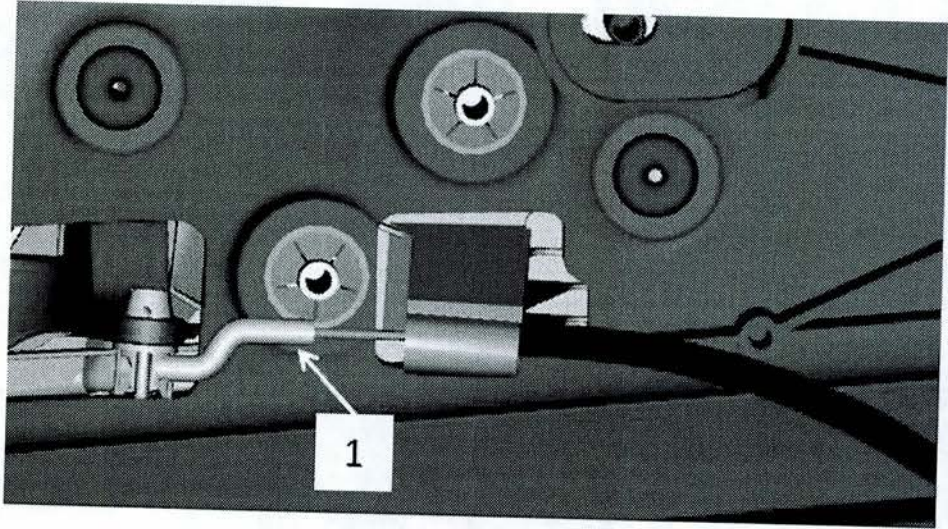
Bild 1.JPG:

Cause:  
Hook of Bowden cable (1) unhooked from clip on inside door handle (2), see Figure 1

Remedy:  
Replace Bowden cable and clip
