Mack Trucks, Inc.
Greensboro, NC USA

Field Service Bulletin Trucks

Hose, Engine Oil Fill Tube
LEU, MRU
Cummins ISL-G

FSB 221-009, Hose, Engine Oil Fill Tube

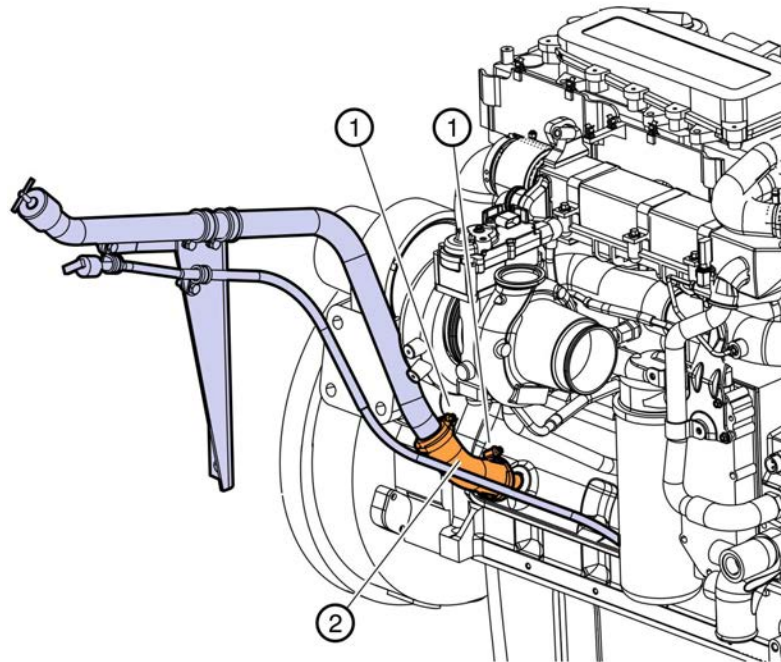
W2079924

Certain Mack MRU and LEU trucks equipped with Cummins ISL-G engines built before February 11, 2013 may exhibit minor oil seepage from the engine oil filler tube hose or display stress cracks in the hose. This condition is caused by improper installation of the engine oil fill tube hose during assembly. Trucks built after February 11, 2013 have engine oil fill tube hoses of the same construction which include index marks to aid in proper assembly. Using the part numbers listed in the table below, replace the engine oil fill tube hose and clamps to repair minor oil seepage or stress cracks in the existing hose. Follow the installation instructions contained in this bulletin for proper clocking/indexing of the new hose.
