Date	Group	No.	Release	Page
SB-10051570-7636	2.2013	652	006	1	1(4)

Rear Suspension Adjustment Washers CHU, CXU, GU, TD

PI0812, Rear Suspension Adjustment Washers

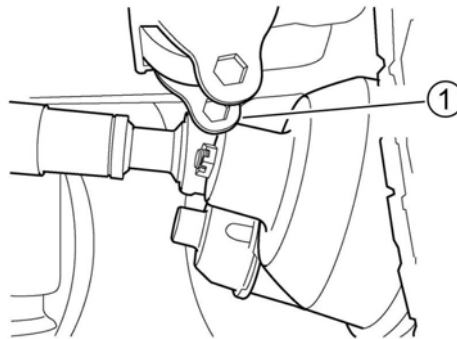
W6079024

It has been determined that certain vehicles built with Maxlite suspensions and MGM LTR-L3 brake chambers interference can occur during suspension articulation between the brake chamber and the suspension adjustment washer. Replacement of the suspension adjustment washers is required.

1 Area of contact
