# Service Bulletin

Bulletin No.: 13-08-116-001

**Subject:** Aftermarket ALDL or DLC Interface Devices Causing Multiple Issues

**Models:** 2006-2013 GM Passenger Cars and Trucks

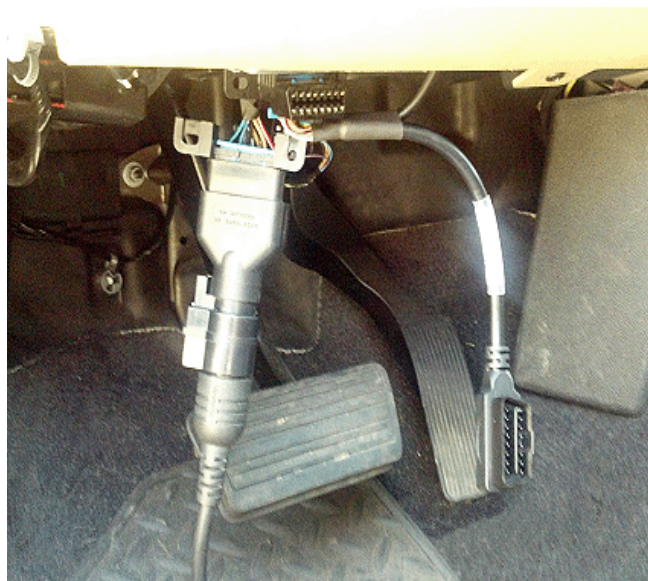
3260852

#### Device W/Secondary DLC Connector

This device has another DLC connector on it. The rest of the harness along with the device can be placed out of sight hidden from the technician, who may not notice the diagnostic connector is not in the factory location.

If the device is available, attempt to duplicate the condition, then remove the device to determine if the condition is eliminated. If confirmed, inform the customer of the issue and that they need to work with the supplier of the device for further resolution.

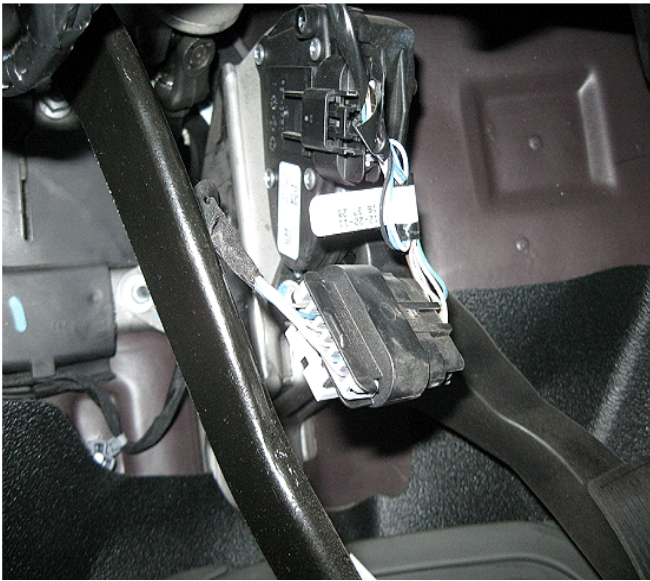
3260861

**Pedal Mounted Aftermarket Cruise Control Interface**

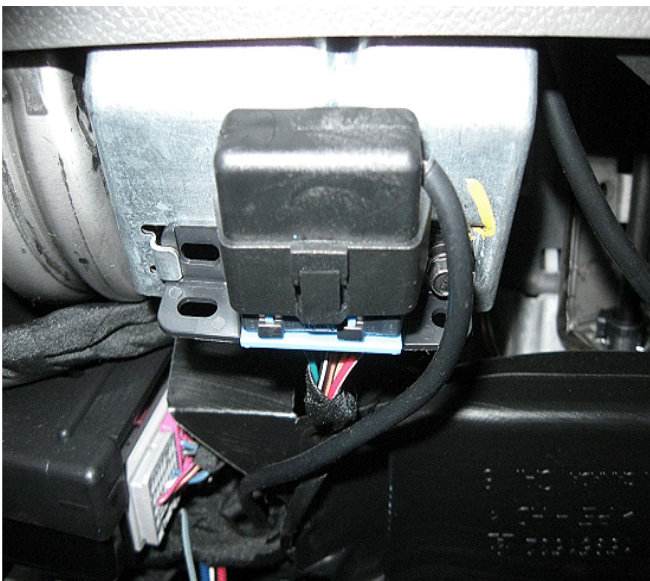
3260880

**Aftermarket Cruise Control Interface at ALDL**

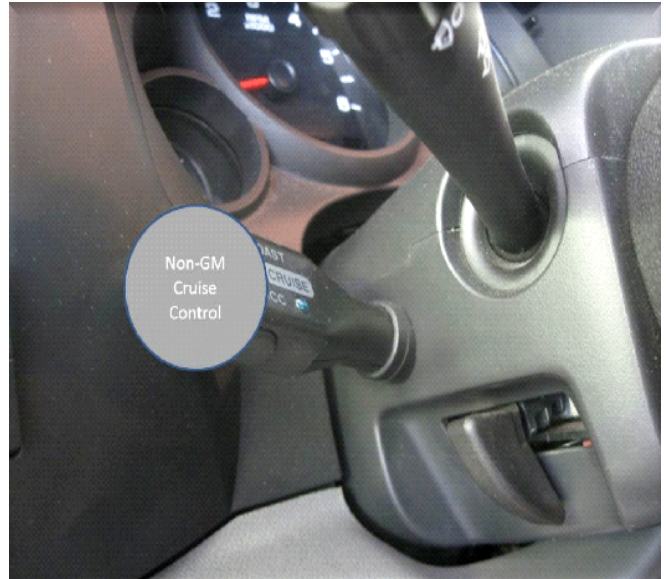
3260934

**Aftermarket Cruise Control Switch**

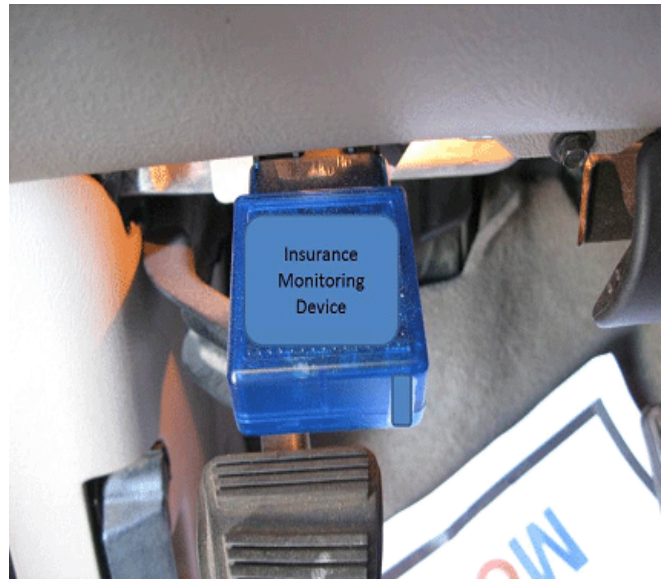
3260916

**Insurance Monitoring Device**

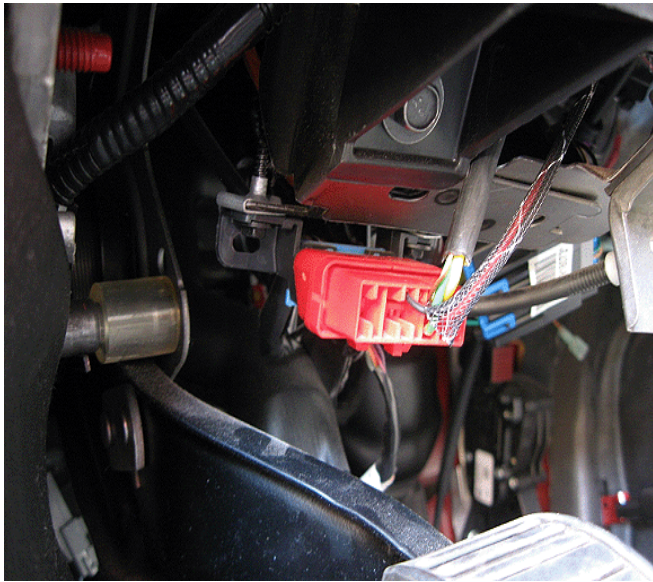
3260960

**Fleet Tracking Device Interface (May Include Rental and Lease Vehicles)**

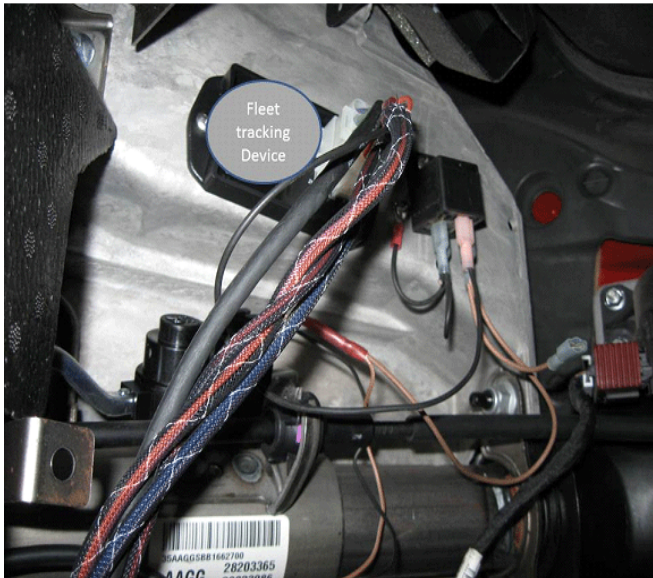
3260973

**Fleet Tracking Device Plugged Into the DLC**
