Subject: New Push-In Style Speed Sensors

Document Number: TAIB0842

Date: November 19, 2012

Service Bulletin – Product

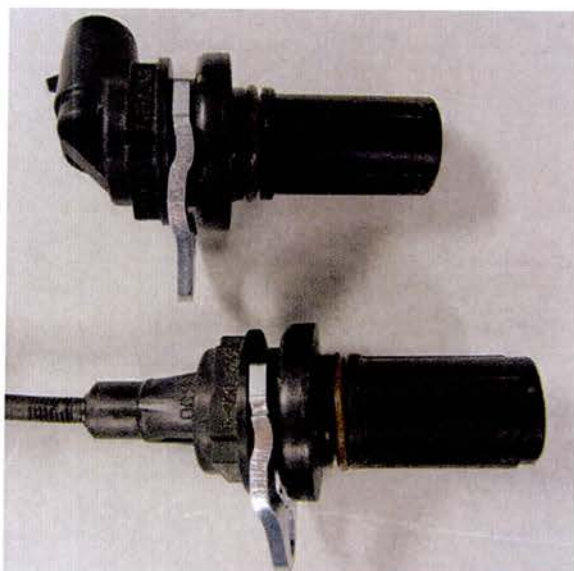
A redesigned speed sensor has been released into production and service. External changes include a sensor body designed to minimize corrosion seizing and integrated retaining clip that will not distort the sensor when the retaining cap screw is tightened. Sensor output signal, harness connector interface and 14142 O-ring are all interchangeable with current design sensors.

New Sensor

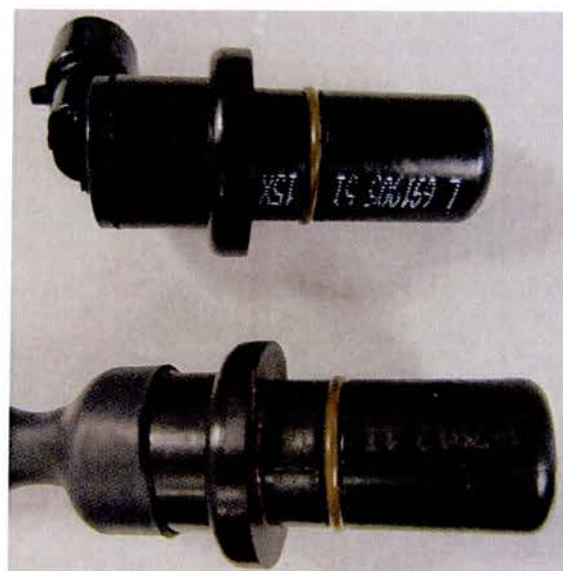
Current Sensor

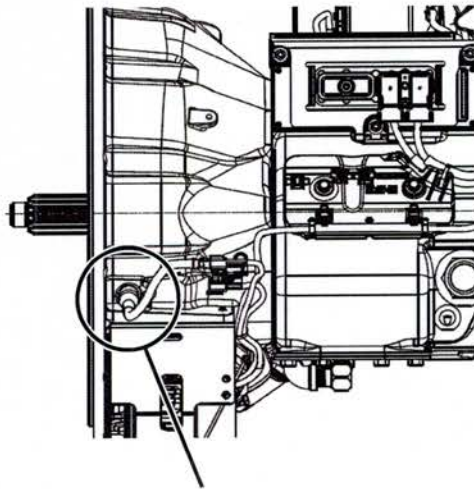
Speed Sensor

The sensor retaining clip **must** be removed and discarded when replacing the clutch housing speed sensor on early production UltraShift *PLUS* models. A clearance issue between the new retaining clip and clutch housing prevents the sensor from being fully seated, resulting in repeat speed sensor fault codes. The hex drive cap screw (0.250"-20x 0.625") with washer must be reused when the retaining clip is removed.

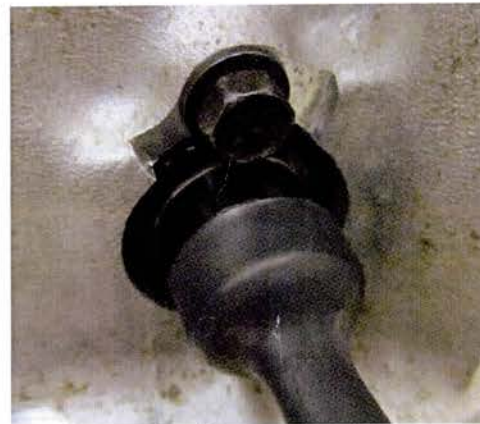
Early production sensor without retaining clip

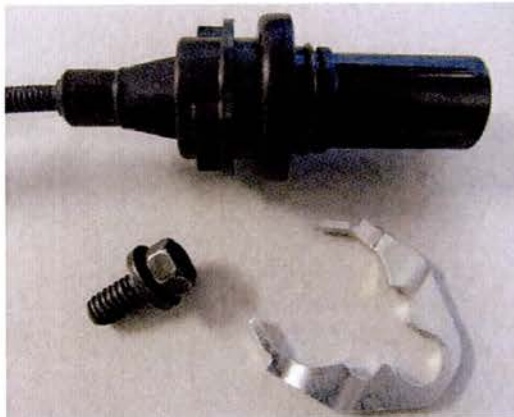
New sensor with clip removed

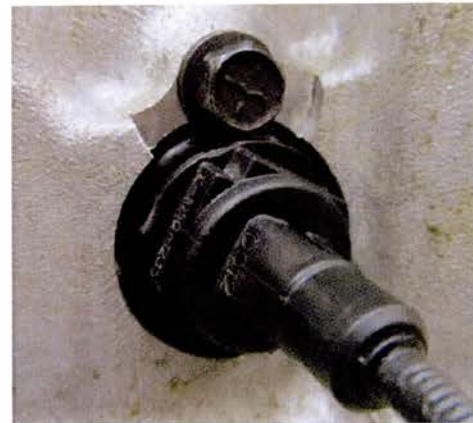
New sensor installed without retaining clip
