August 9, 2013

SUBJECT: **DEMONSTRATION / DELIVERY HOLD - Application Performance Upgrade 12A04 – Supplement #4**

Certain 2011-*2014* Model Year Vehicles Equipped with SYNC® and MyFord/MyLincoln Touch™
Application Performance Upgrade

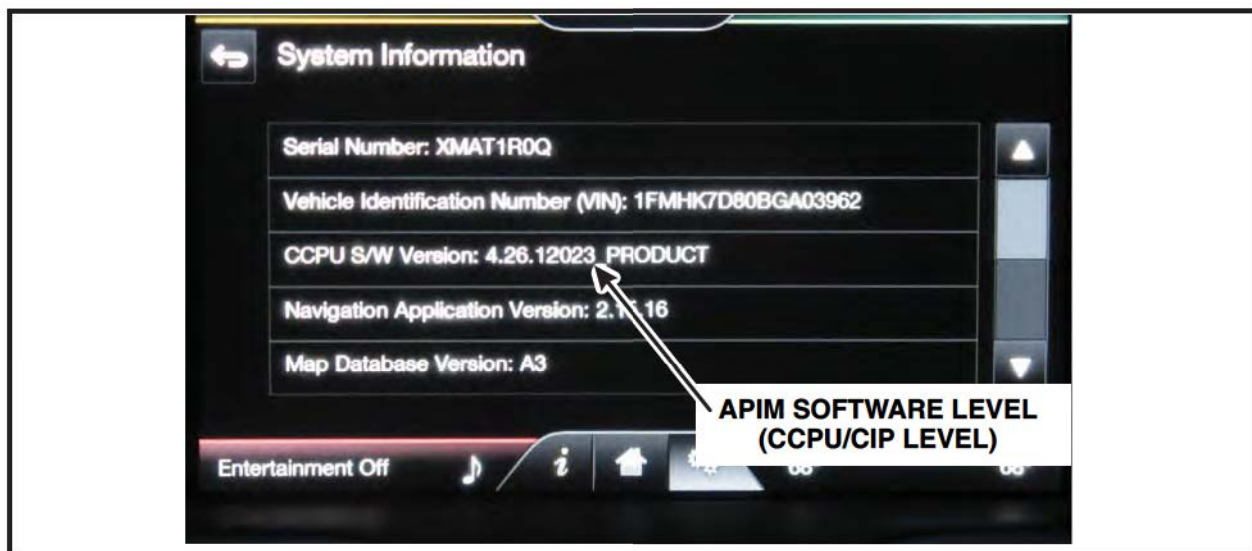
FIGURE 1

1. Determine the vehicle's current Accessory Protocol Interface Module (APIM) software level (CCPU/CIP level). See Figure 1.
 - a. On the Front Display Interface Module (FDIM), select "Menu" then select "Help".
 - b. Select "System Information".
 - c. Note the last five digits of the CCPU/CIP#. See Figure 1.
- If the last five digits **are "13171"** or higher, the APIM is at the latest level. Return the system to the home screen, and release the vehicle to the customer.
- If the last five digits **are less than "13171"** (e.g. 12023), proceed with the Service Procedure.

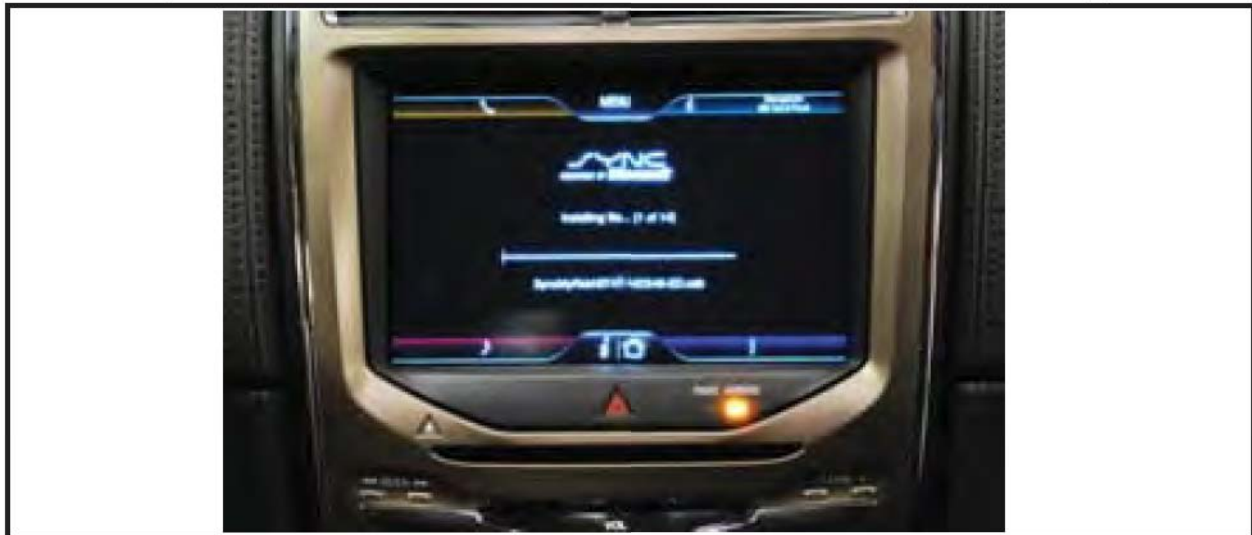
FIGURE 2

1. Start the vehicle so that the battery saver mode will not activate while performing the reprogramming procedure.
2. Wait for the system to boot up, remove any connected devices, and for the home screen to appear on the FDIM.
3. Install the USB drive containing *BD/13171/V3.6.2* software level into one of the vehicle's USB ports. The reprogramming procedure will start automatically. See Figure 2.

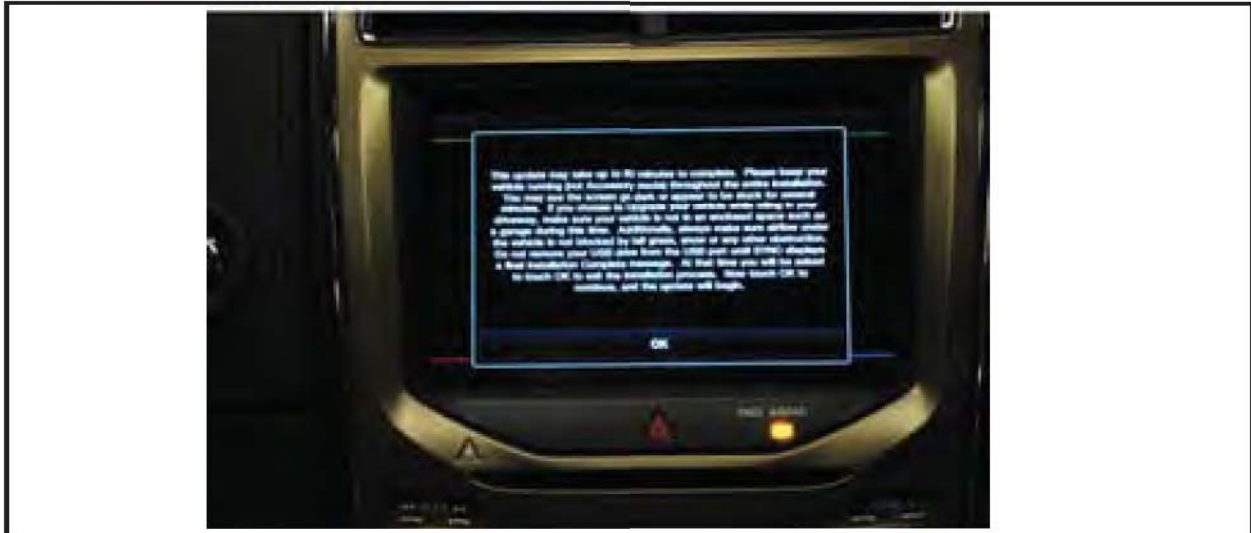
FIGURE 3

4. After the installation starts, a verbal and onscreen message will confirm that the installation is about to start, tap "OK". See Figure 3.

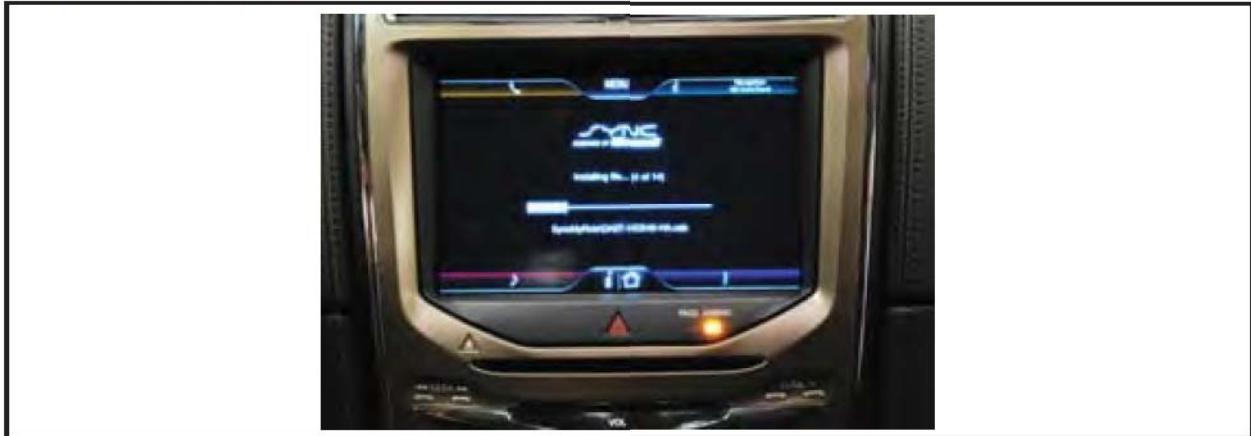
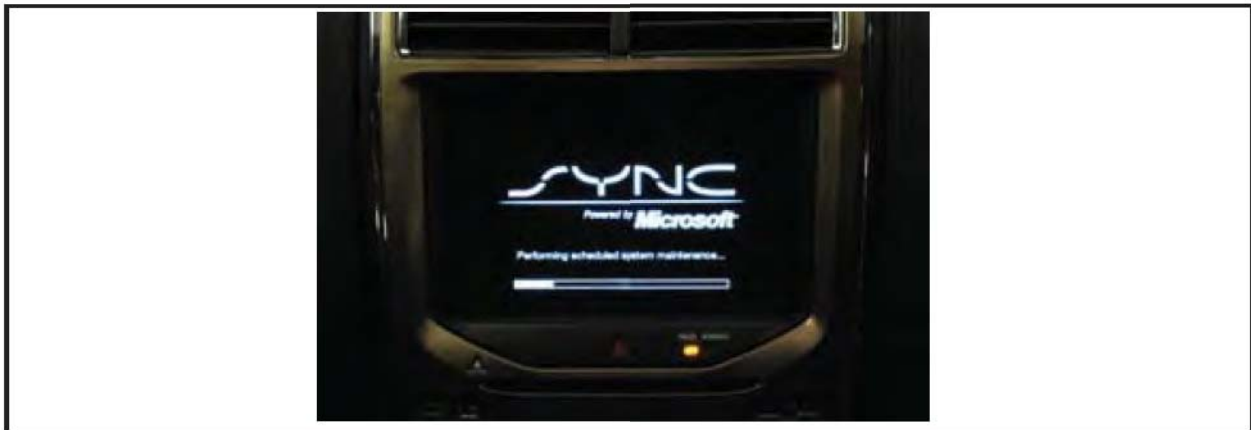
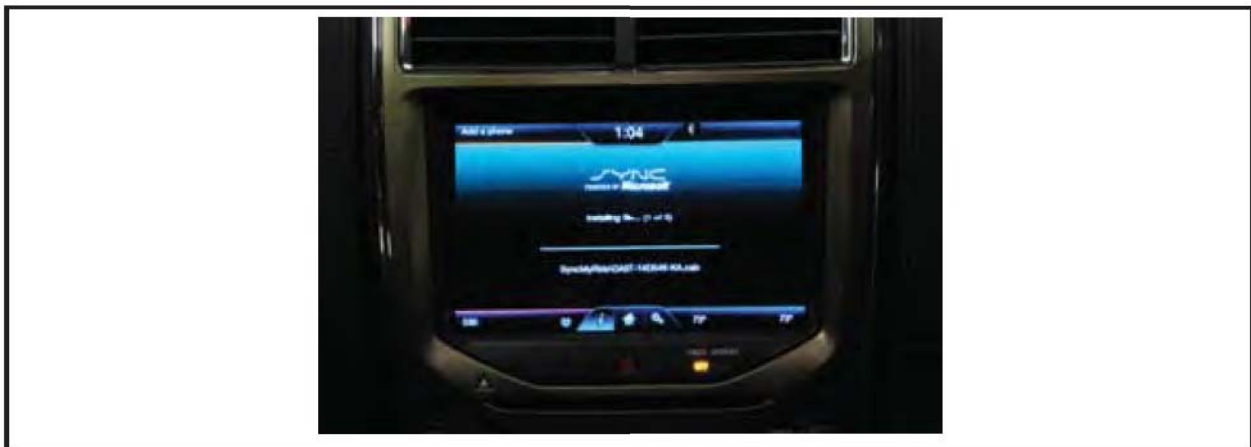
5. During the reprogramming process a series of screens may appear and/or the system will reboot with a blank screen. See Figures 4, 5, and 6.

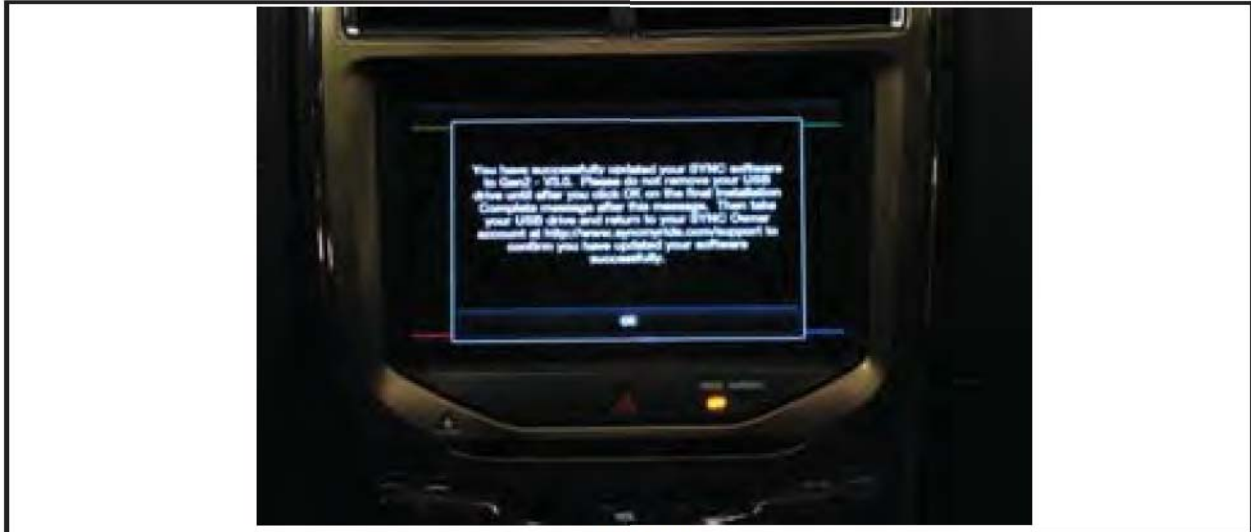
FIGURE 7

6. When the programming is completed, a screen stating the software update was successful will appear, tap "OK". See Figure 7.

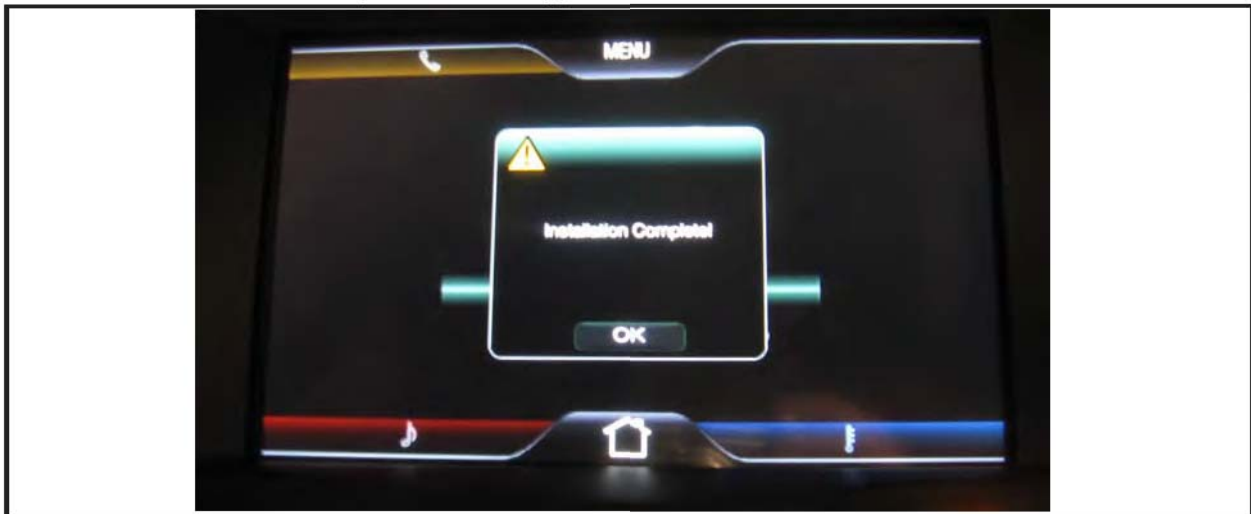
FIGURE 8

7. When the "Installation Complete!" screen appears tap "OK". See Figure 8.
