SR-10051928-1748
Service Program
Trucks

Incorrect Hardware on Front Engine Mount
MRU

PI0821, Incorrect Hardware on Front Engine Mount

(March 2013)

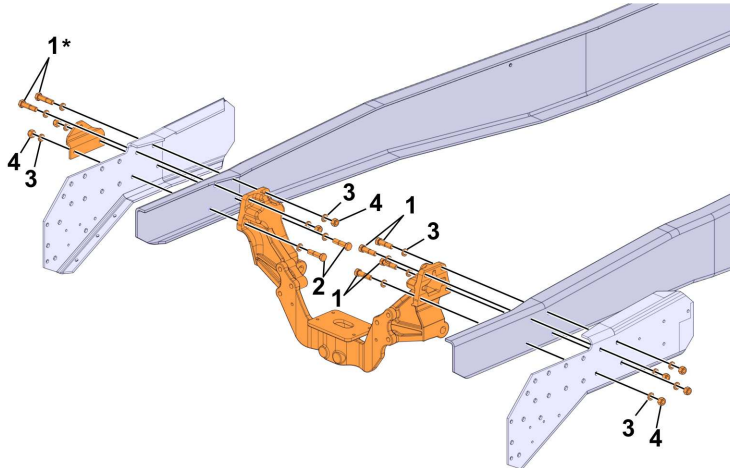
MRU, Engine Mount Installation (Mack Engines)

Certain MRU vehicles may have been assembled using the incorrect grade and/or length of bolts in the front engine mount for both the left and right side of the vehicle. Bolt part numbers and length vary depending on the engine model installed on the vehicle. To complete the repair and install the proper bolts, utilize the installation drawings and part number lists included in this document.

Description	Part Number	Quantity	Illustration Number
Shoulder Bolt	25087900	6	1
Shoulder Bolt	25012714	2	2
Washer	25088675	14	3
Hexagon Nut	20760812	8	4

Note: * Bolt head located outside of the frame. All other bolt heads located inside of the frame.
