# SB-10051970-3216

SI B61 03 13  
General Electrical System

**High Battery Discharge Warning: Battery Needs Replacement**

F01

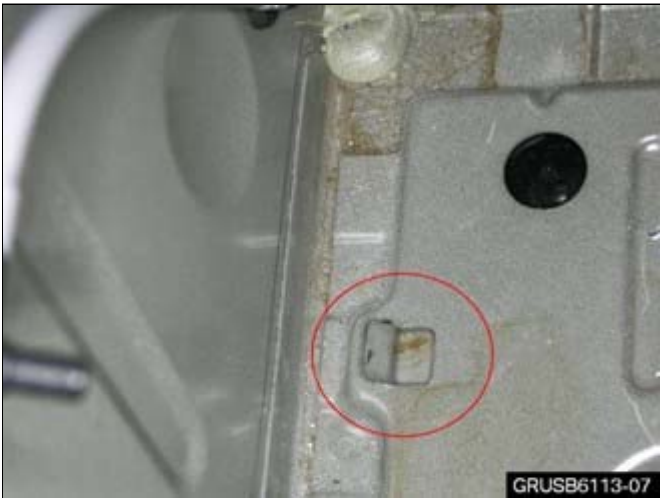
<p>GRUSB6113-07</p>	<p><b>Important Note:</b> Before mounting the battery in place, bend the metal tab down flush with the battery tray. In some cases, a longer battery vent tube must also be installed in order to facilitate the larger battery.</p>
<p><b>NEW</b></p>

4. Replace the originally equipped 90 AH AGM battery with a 105 AH AGM battery. Refer to ISTA Repair Manual “61 00 ... Notes for disconnecting and connecting battery.”

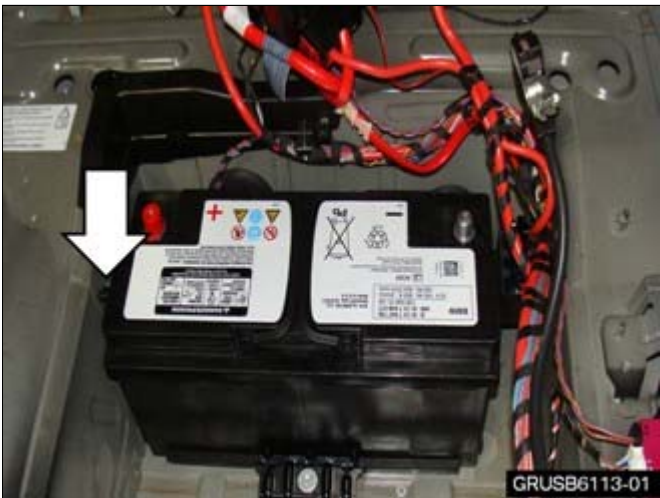
<p>GRUSB6113-01</p>	<p>Before mounting the battery in place, make sure the battery vent hose is connected as indicated by the arrow. The short end of the elbow should be connected to the battery to gain some extra clearance. Record the matrix and supplier code from the label of the battery for entry in the next step. The original battery hold-down clamp can be used with the new battery.</p>
