Technical Bulletin

Model(s)	Year	Eng. Code	Trans. Code	VIN Range From	VIN Range To
Routan	2012	3.6L (CJRA)	All	All	All

01 13 08 March 5, 2013 2030688

MIL ON DTC P0108 Manifold Absolute Pressure Sensor Circuit High Stored in ECM Fault Memory

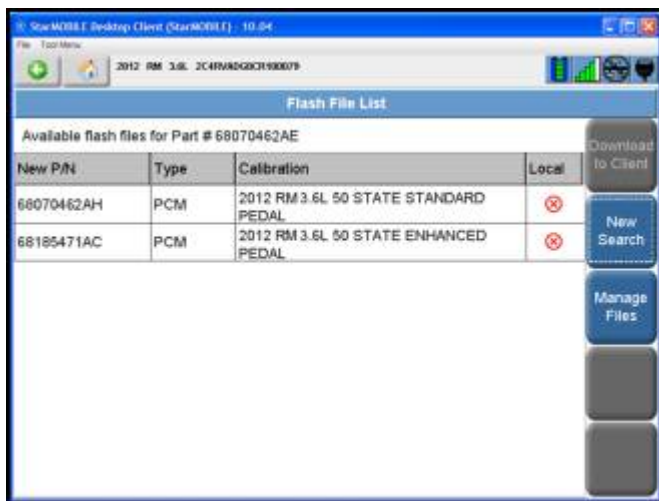
On some vehicles there are two updates available.

If there are two updates available, as shown on this screen (left), **ONLY** the **68070462AH** software should be selected and installed.

Installing the wrong software update into the PCM will change the driving characteristics of the vehicle and can result in a customer complaint.
