**Model: Elise/Exige & Evora fitted with Bosch ESP8 brake modules**

**Number: 2013/04**

Generation of C0460 Pressure sensor failure fault code.

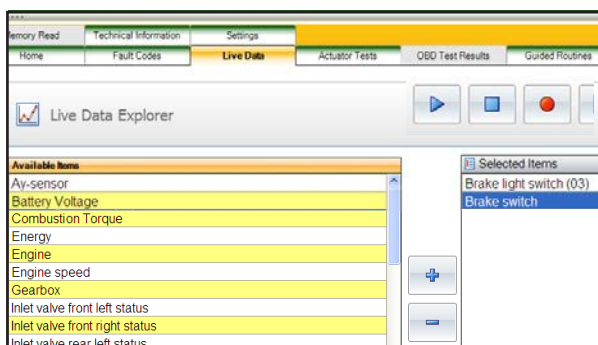
1. With TechCentre connected to the vehicle and ignition on select ABS brakes>Live Data:
2. From the 'Available Items' table, select:
  - Brake light switch (03).
  - Brake switch.

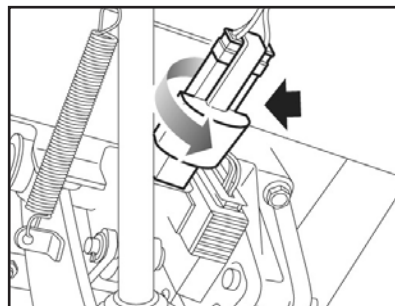
4. Gently push the brake light switch plunger inwards towards the housing until light resistance is met, select the 'play' option from Lotus TechCentre and then gently release the plunger whilst examining the readings shown on the live data screen.

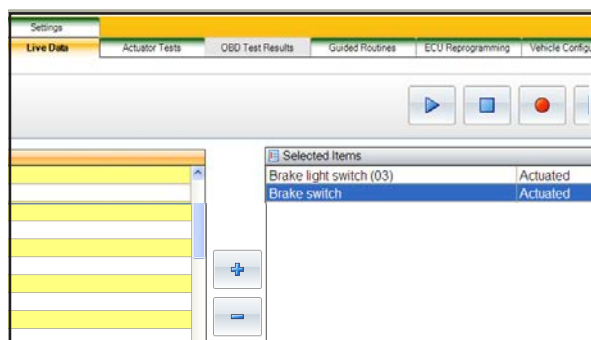
If the switch is operating correctly then the TechCentre live data readings should change in this order:

- Brake switch: (1st stage) - Actuated
- Brake Light Switch (03): (2nd stage) - Actuated

If moving the switch plunger produces the correct readings then it should be adjusted and refitted to the vehicle so it can be retested in situ, see adjustment procedure below.

If the correct readings cannot be displayed then the brake switch should be replaced, operation of the new switch checked (as above) before adjusting and fitting on the vehicle.

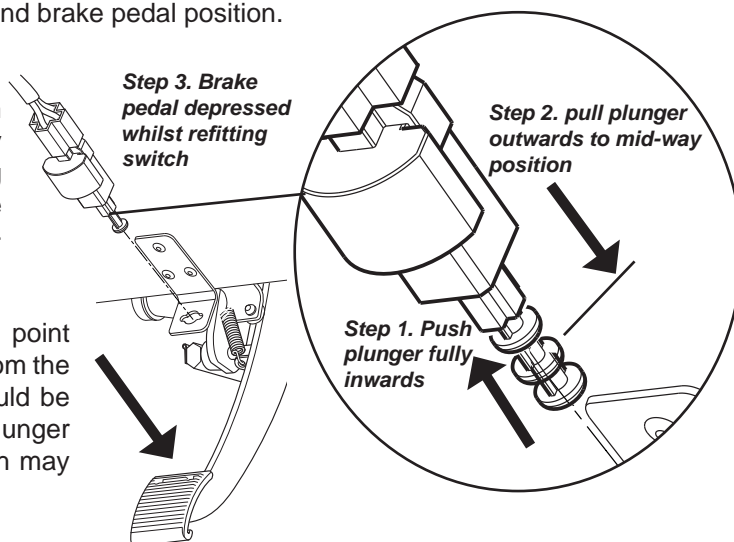
2. Pull the plunger outwards to its mid point setting (approximately half way out from the switch housing, 5 audible clicks should be heard as it is being pulled) note, the plunger is on a stiff ratchet mechanism which may take some effort to extend.

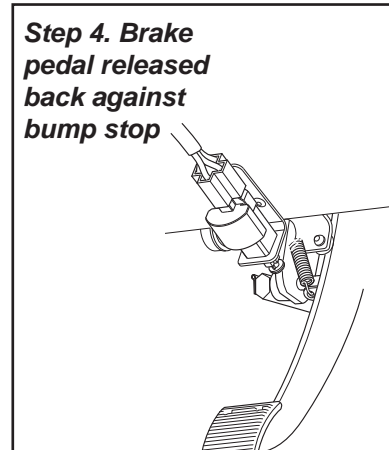
4. Gently release the brake pedal back to its normal position against its bump-stop.
5. From the available items in Live Data, select 'Pressure Sensor' in addition to the options already selected.
6. Select the 'play' option and gently depress and release the brake pedal to simulate normal braking operations and examine the value readings displayed on ABS live data in relation to:
  - 'Brake Switch' (1st stage)
  - 'Brake Light Switch (03)' (2nd stage)
  - 'Pressure Sensor' (ABS brake line pressure).

7. If the readings are not within range then remove the brake light switch again repeating step 2 of the adjustment procedure but adjusting the plunger inwards or outwards against its ratched mechanism as necessary until the correct readings are achieved.
